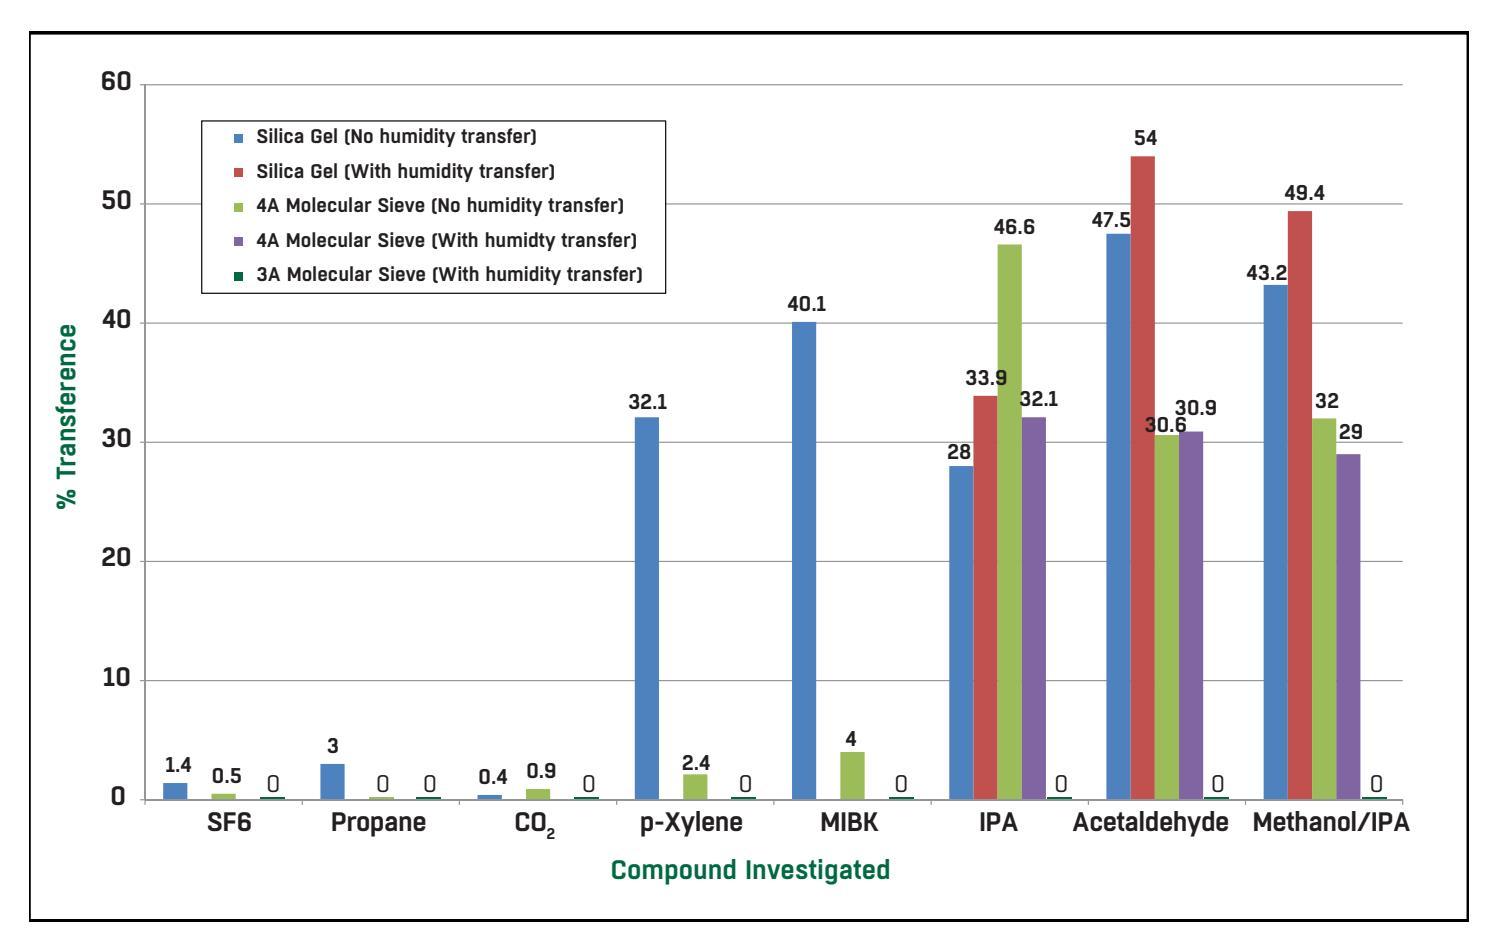
FIGURE 3. Results from the GTRI Report entitled "The Importance of the Desiccant in Total Energy Wheel Cross-contamination" comparing the resultant carry-over of three identical wheels using different desiccants.

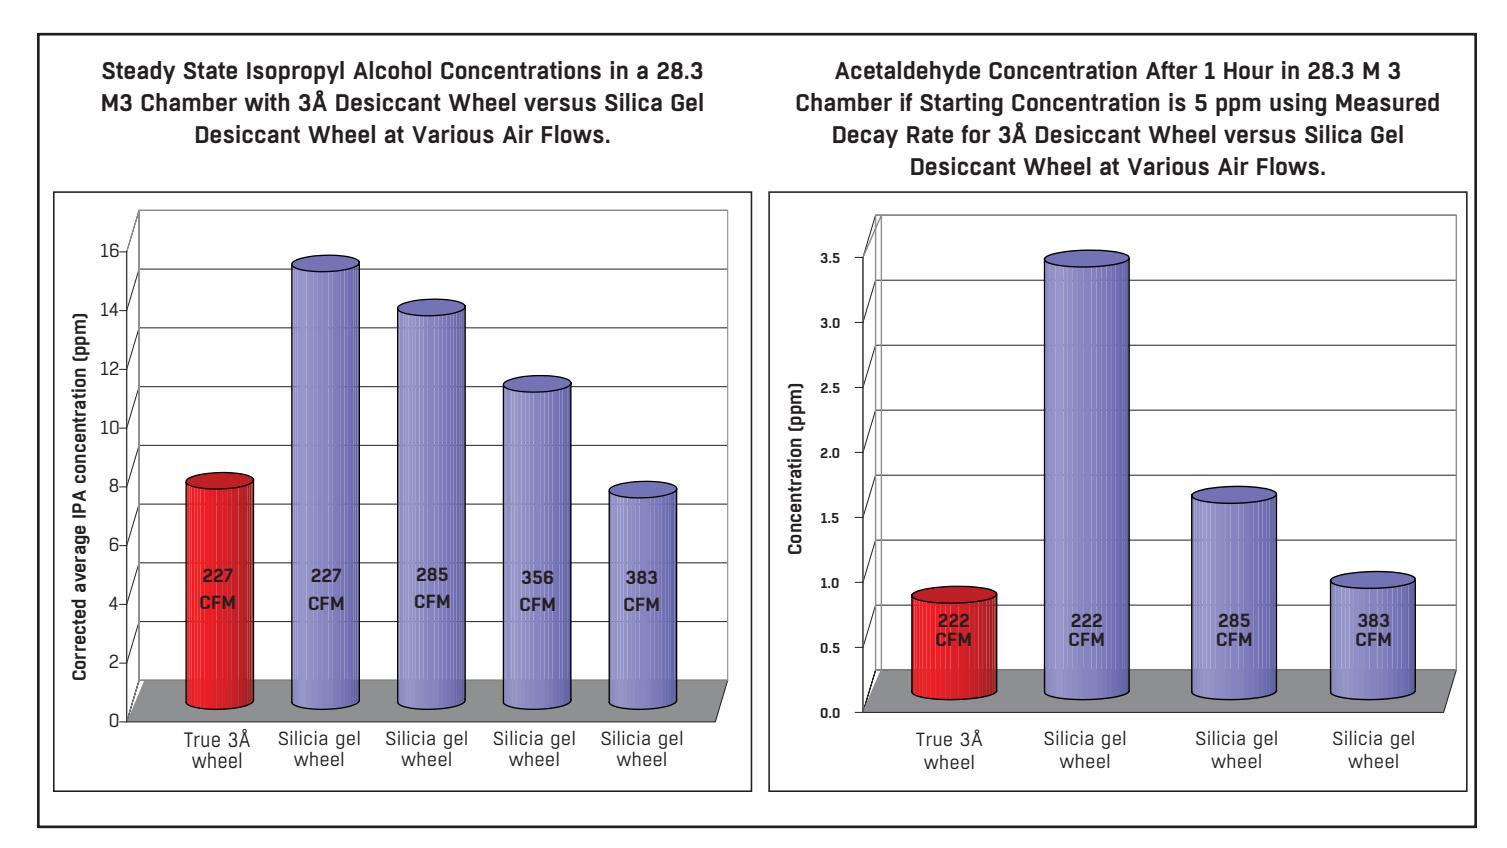
FIGURE 4. Isopropyl Alcohol and Acetaldehyde results from the GTRI final report. The data shows the significant impact that the desiccant used by a total energy recovery wheel can have on ventilation effectiveness and indoor air quality.
