# Case Study: Making an Impact on Energy Costs and Improving Occupant Comfort

#### **Holborn Bars**

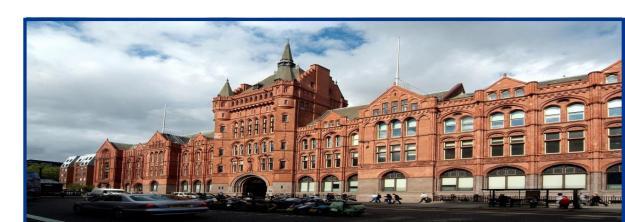
ISSUE	EQUIPMENT	STATUS	ТҮРЕ	BUILDING	OCCURANCE FIRST/LAST	TOTAL COST	-SAVINGS	FAILURE COST	REPORT	
		open 🔹	Equipment •	All Buildings						
Leaking, Stuck, or Overridden Cooling Valve	A-R9-LG-16 VAV AHU	open	Air Handling Unit Equipment	Holborn Bars	Jul 6th 2017 Aug 15th 2017	~\$755	~\$1328	0.00	Report	*
Device in Hand or Overridden - Chilled Water Pump	CHW P4	open	Chilled Water Pump Equipment	Holborn Bars	Jun 13th 2017 Aug 21st 2017	-\$639	-\$715	0.00	Report	~
Unresponsive Economizer Damper	A-R8-LG-10 VAV AHU	open	Air Handling Unit Equipment	Holborn Bars	Jul 6th 2017 Aug 21st 2017	~\$575	~\$988	0.00	Report	~
Unresponsive Economizer Damper	A-R9-LG-16 VAV AHU	open	Air Handling Unit Equipment	Holborn Bars	Jul 6th 2017 Aug 21st 2017	-\$354	-\$571	0.00	Report	~
Device in Hand or Overridden - Chilled Water Pump	CHW P3	open	Chilled Water Pump Equipment	Holborn Bars	Aug 3rd 2017 Aug 12th 2017	~\$83	~\$284	0.00	Report	*
