Online Condition Monitoring of a Remote Fan Provides Early Detection of Auto-Lubrication Failure, Prevents Catastrophic Shutdown

Remote condition monitoring system enables paper manufacturer to monitor a critical exhaust fan located facility's roof and prevent downtime when an auto-lubrication system fails, where a previous failure resulted in hundreds of thousands of dollars in downtime and repairs

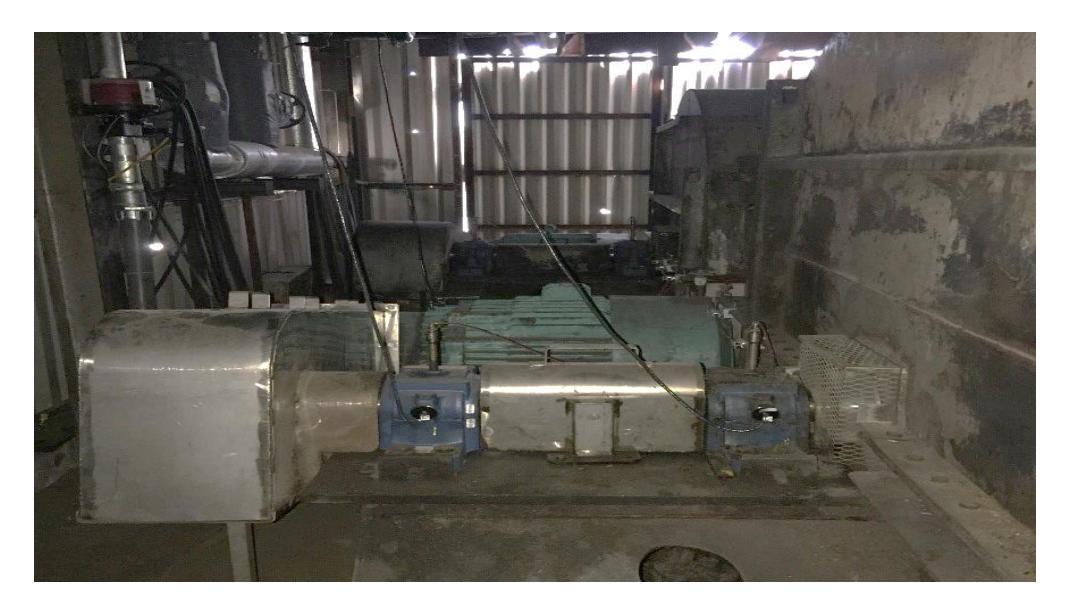
Figure 1: Exhaust fans located in a utility room on the roof where conditions included 70°C temperatures in the summer and snow and ice in the winter

The exhaust fans are driven by an AC induction motors with belt drives. Two taper-lock bearings (inboard and outboard) support the shaft. The fans act as overhung loads, which means that the bearing closest to the rotor of the motor (inboard) carries more load than the other bearing (outboard).

The motors were rated for 100,000 hour lifetimes (11+ years) but had previously failed after less than a year of operation. The cause was catastrophic failure of an inboard bearing. The stresses from that failure split the motor shaft torsionally. Given the location and size of the motor, repair required removing the motor from the roof by crane. The process took days and cost hundreds of thousands of dollars in lost productivity and cost of repairs.

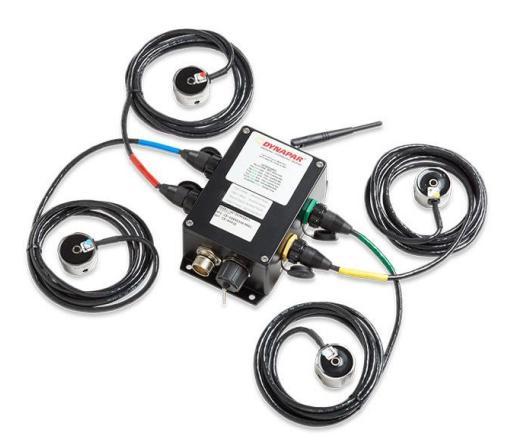
Figure 2: The Dynapar OnSite[™] Online Condition Monitoring System features four sensors, each with a triaxial accelerometer integrated temperature and the system features an optional encoder input for real time running speed.

The OnSite condition monitoring system was installed to monitor the motor and fan inboard and outboard bearings. It was configured to take temperature and vibration readings at routine intervals. The OnSite system captured data automatically and transmitted it via Wi-Fi. As a result, the service techs could gather the information they needed for analysis without putting themselves at risk.

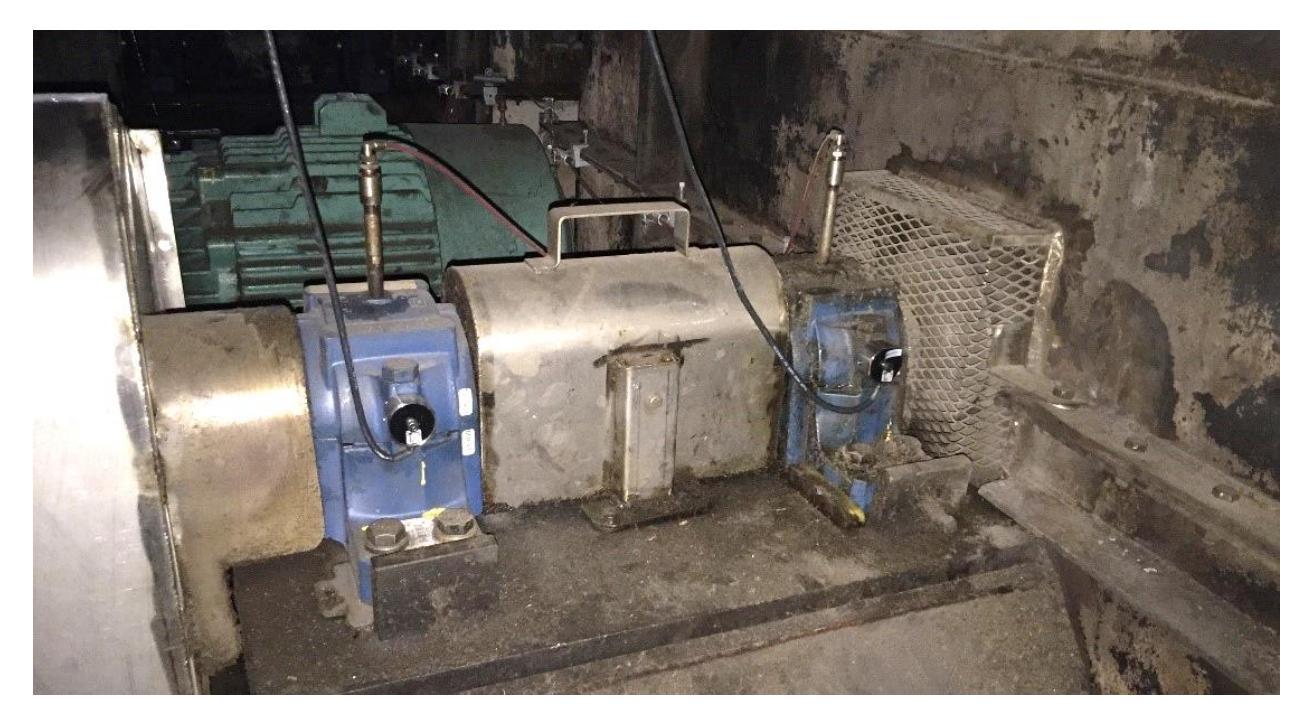
Figure 3: The Dynapar OnSite™ system shown with sensors mounted to both the inboard and outboard pillow-block bearing housings.

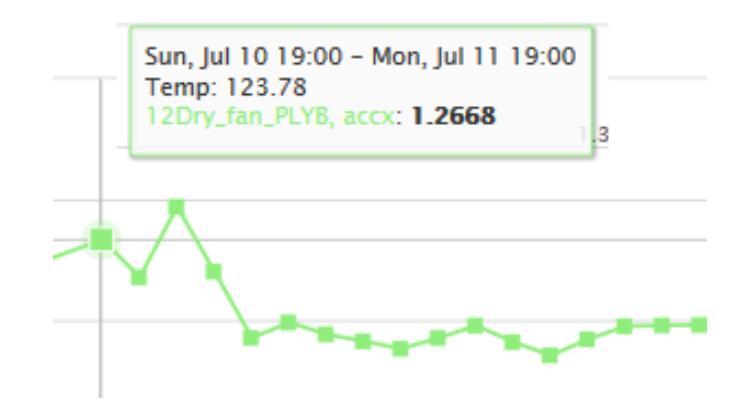
During normal operation, the bearing housings are heated to 70 °C. Instead, the reading captured by the OnSite sensor showed a temperature of 123°C. When the condition monitoring partner asked the maintenance group to investigate, the team discovered that the bearing lubrication machine was down. Early detection and enabled them to repair the problem before it triggered catastrophic failure in the bearing.

Figure 4: Temperature data from the OnSite system shows a reading of 123°C or more

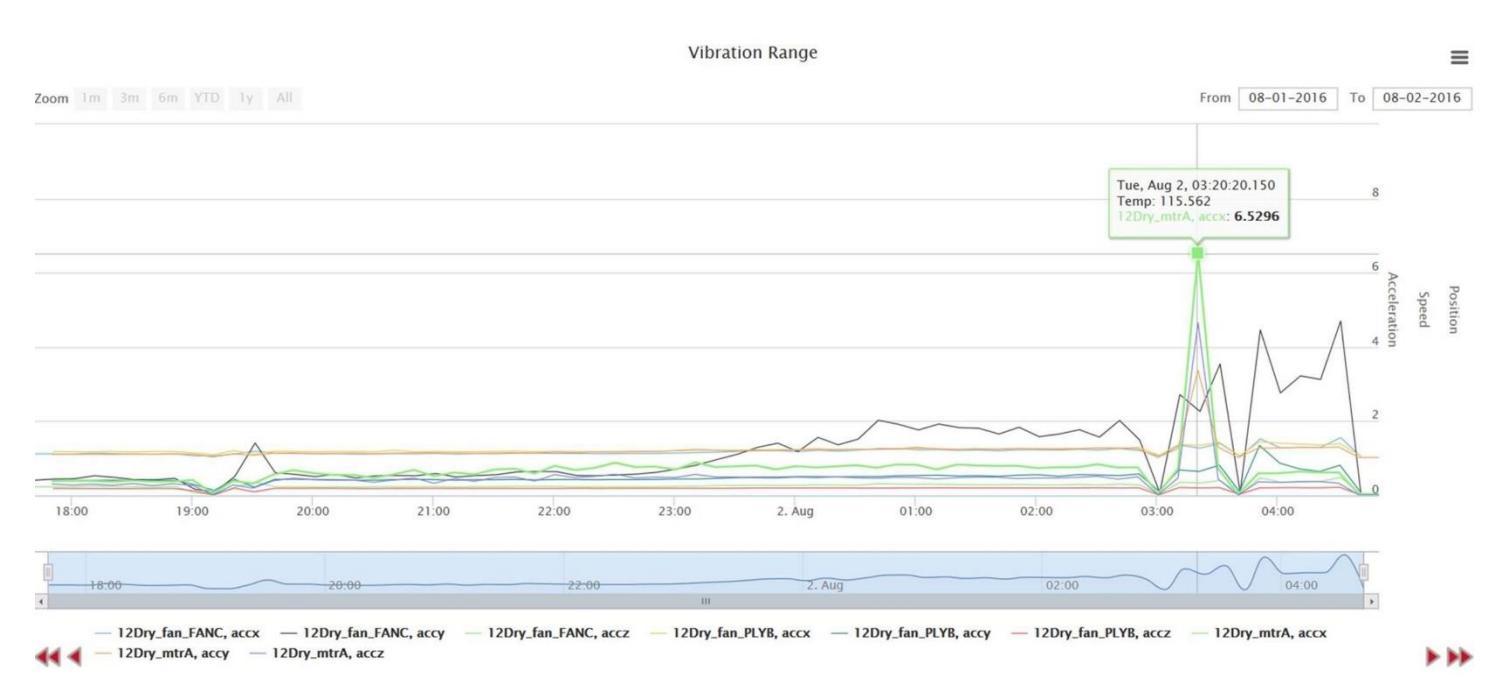
After the auto-lubrication system was replaced, the OnSite system monitored another temperature increase accompanied by severe vibration readings. The condition monitoring partner also alerted the maintenance group to the issue and they discovered the motor fan had also failed due to high temperature. A crew was able to replace the fan immediately before any permanent damage to the motor occurred.

Figure 5: A peak in both vibration and temperature can be seen in data from the OnSite system when the motor fan failed.
