### Case Study: UAV Photogrammetry Aids SR 503 Repair Plan

In mid-March of 2017, the Washington State Department of Transportation (WSDOT) contacted MacKay Sposito about an emergency response UAV flight to respond to a landslide on SR 503 near Speelyai Recreation Road. The call came on a Tuesday evening and we were able to review flight restrictions, plan our flights and necessary ground survey control, and mobilize for the flight within 48-hours, as determined by weather conditions.

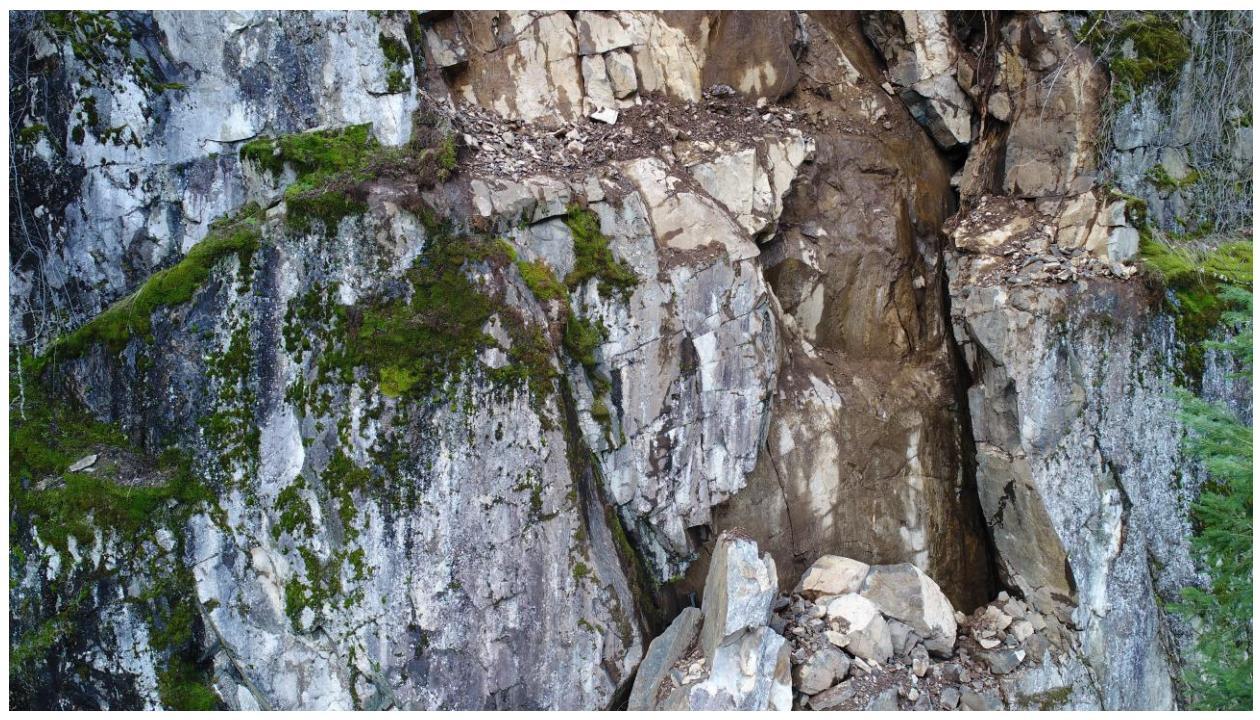
Close-up inspection of unstable area (photo)

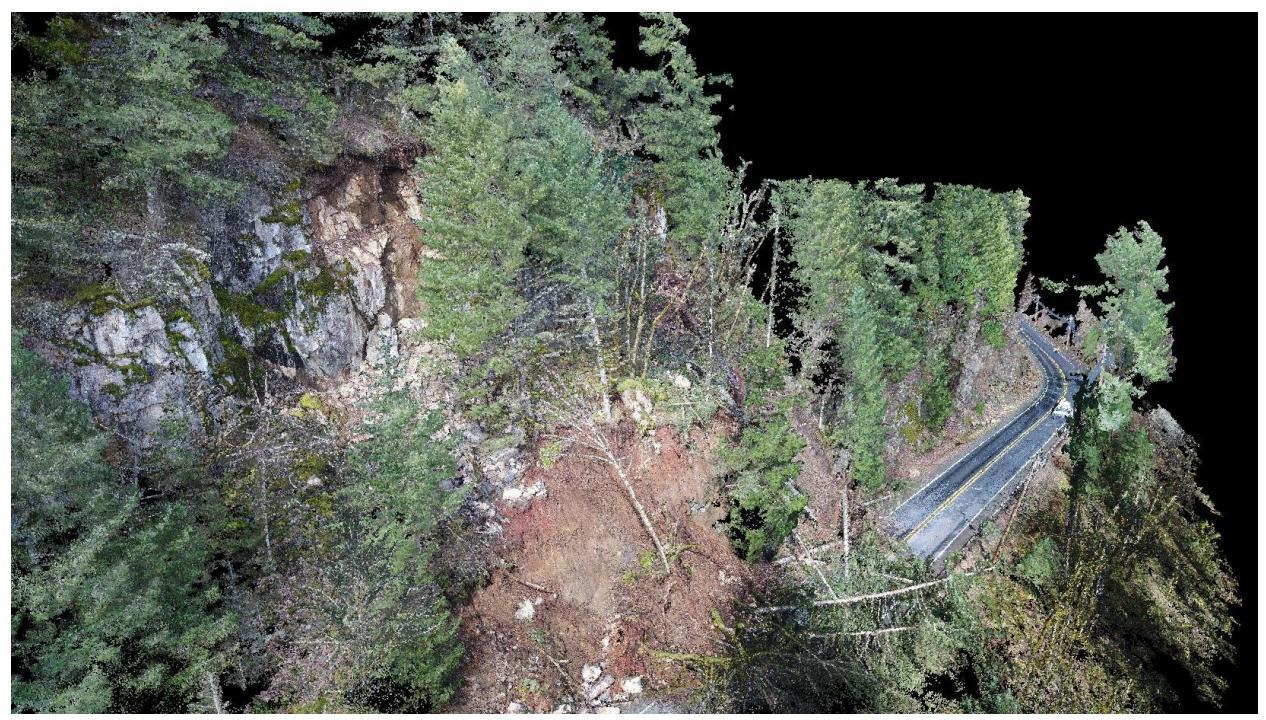
Point Cloud before vegetation removal

The point cloud processing took 3hrs 22m on the west side and 33m on the east; 30,618,838 3D densified points were generated on the west side and 9,007,801 on the east. Comparing the point cloud to conventional survey points (confidence points) the overall quality of the east side on the hard surface (road) was around 0.1ft. This confidence level exceeded some manufacture's stated accuracy level. The quality checks on the surrounding areas, including the slide area were within acceptable tolerances, typically 0.4ft. This is attributed to minimal control outside the roadway, which typically will cause the software to have a pull effect on the 3D point cloud data. The original point cloud was tiled into segments to allow for smaller file size.

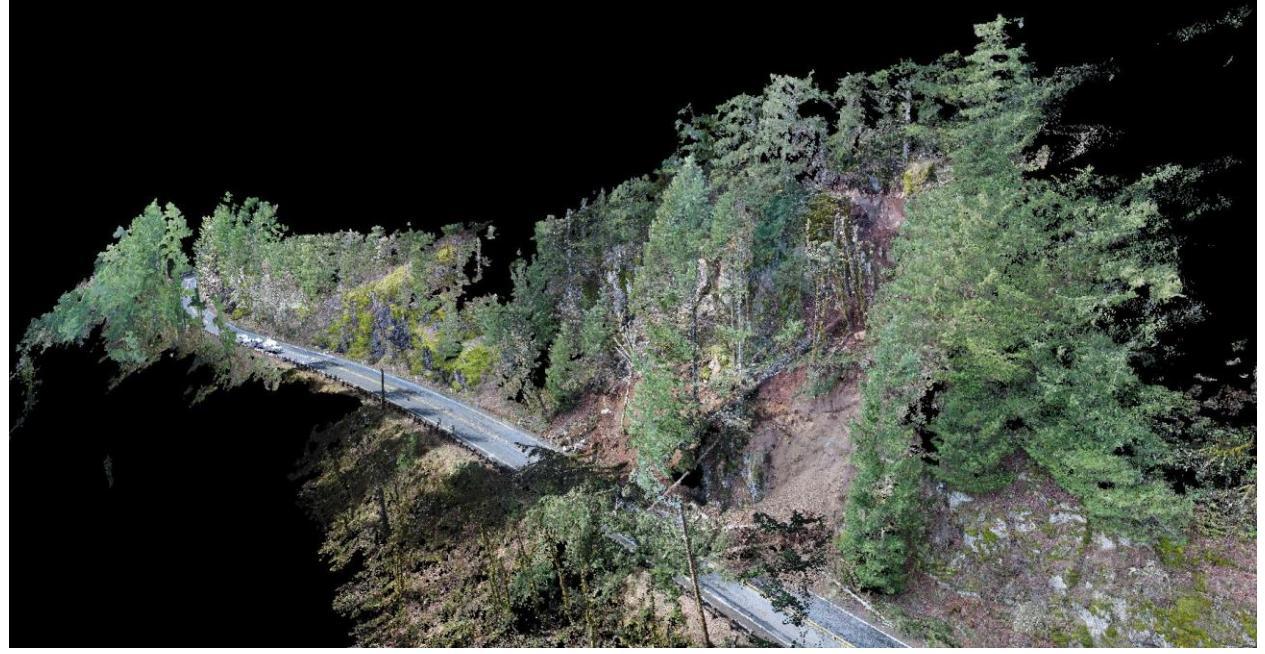
Point Cloud before vegetation removal

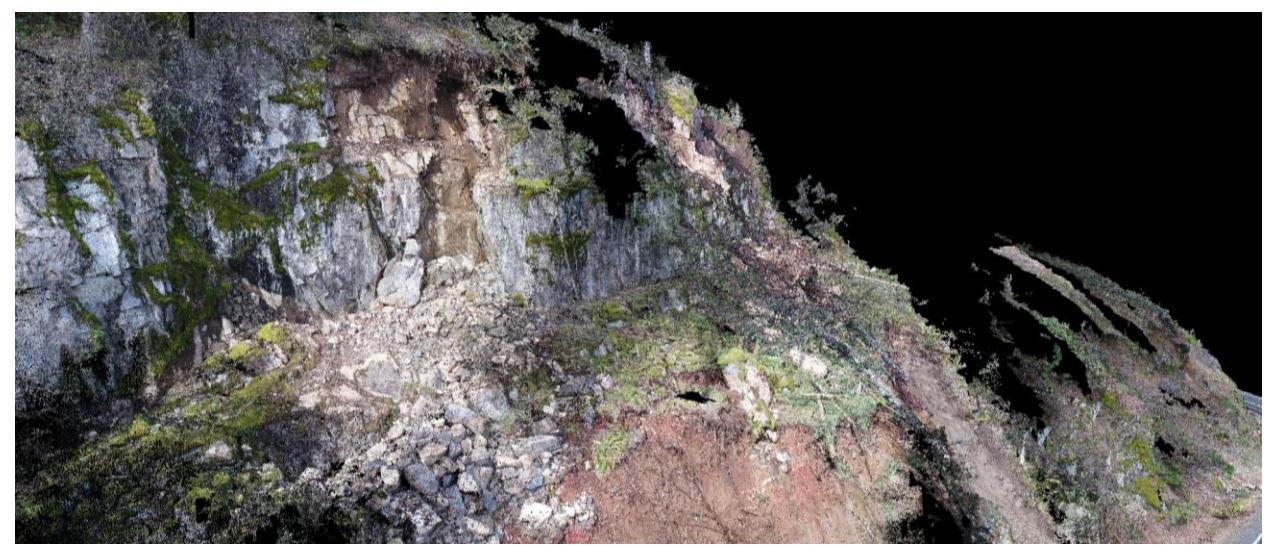
Point Cloud after vegetation removal

The East and West point clouds were merged together and prepared for vegetation removal. Due to the heavy vegetation and complexity of the terrain, this process is 40% automated and 60% manual. Generally the software will look at a small area within the point cloud and determine if any points fall outside or inside a given criteria. If they do, they will be classified as ground or non-ground points. From this classification, a detailed analysis can be made to further weed out the non-ground points. This final "ground" point cloud consisted of 26,557,715 3D points, which were used to generate a DTM. The final point cloud was tiled into segments to allow for small file size.

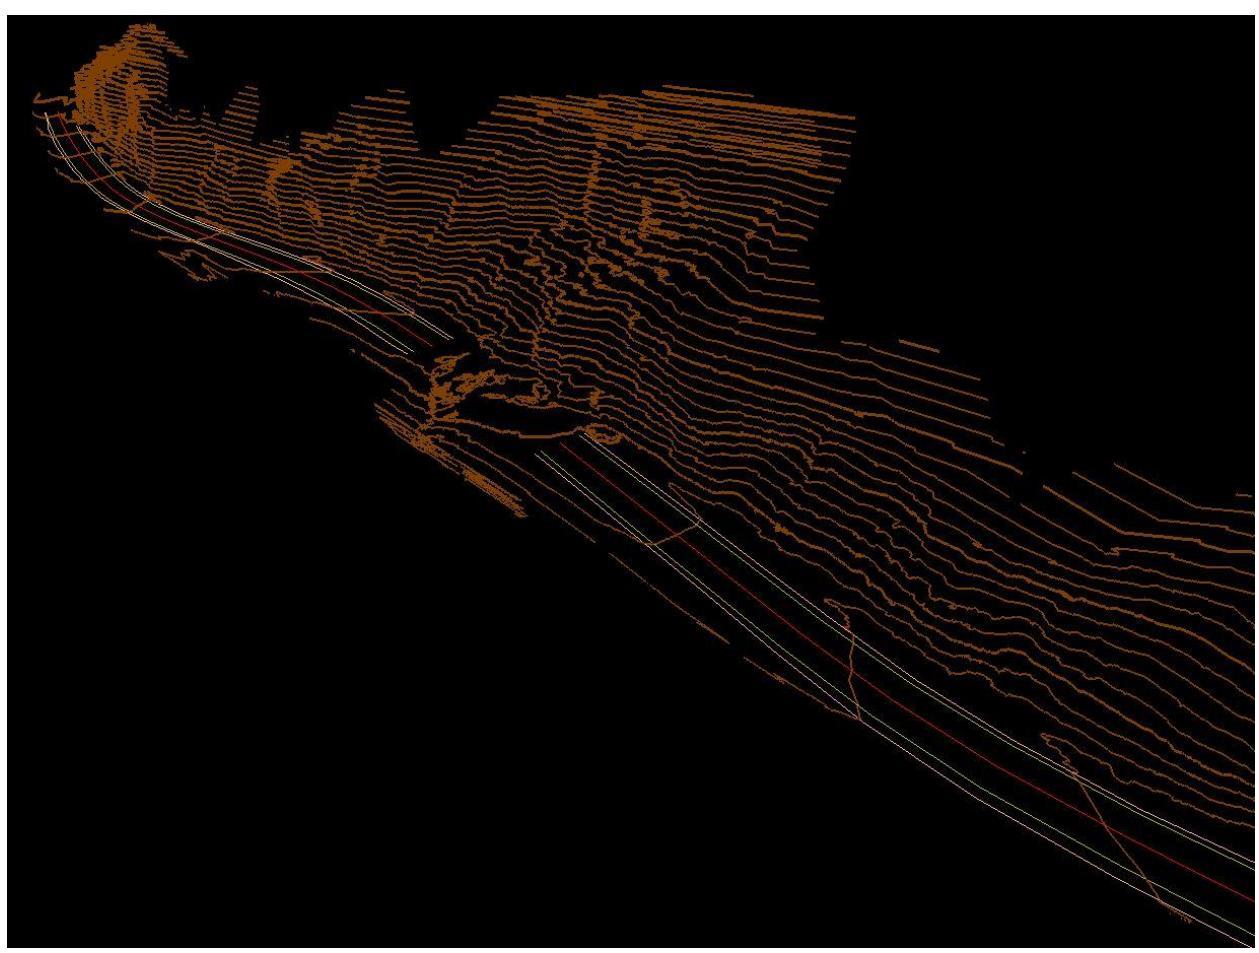
Digital Terrain Model (DTM) showing contours at 5' intervals

A Microstation DGN file was created showing 2 ft contour lines, roadway linework, and site control. A comparison was made between the orthophoto and the final DGN. The georeferenced image fit perfectly.
