Profile

Mozart Page Mill

Challenge *Aged BUR Substrate*

Solution *AcryPly® Roof Restoration System*

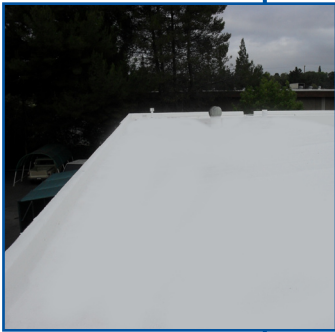
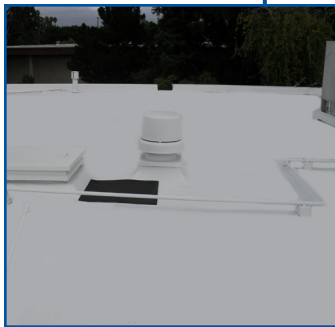
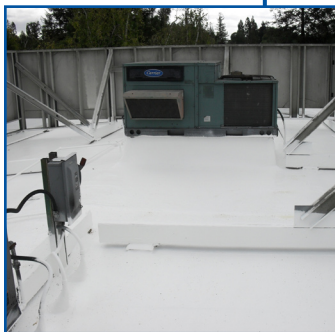
- Install a long-term roof system while the building remains occupied.
- Improve solar reflectivity with Title 24 compliant acrylic coatings.
- Create a sustainable system that will eliminate the need for a costly tear-off.

- 20 year system was installed using modified asphalt emulsion and high performance acrylic coating.
- System was able to be installed with no interruption to owners' tenants working inside.
- System is sustainable and can be re-coated to extend the life of the system indefinitely.
