Profile

California Lottery Commission

Challenge *Severely Deteriorating, Leaking Roof*

Solution *AcryPly® Restoration System*

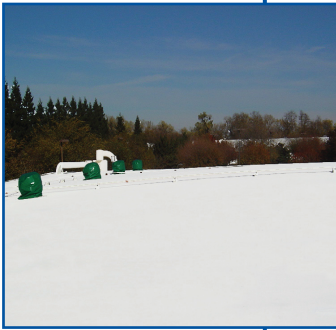
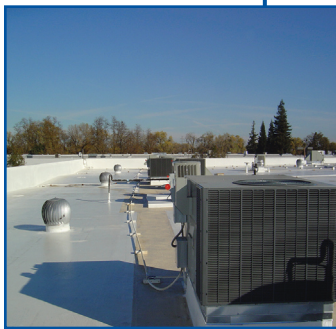
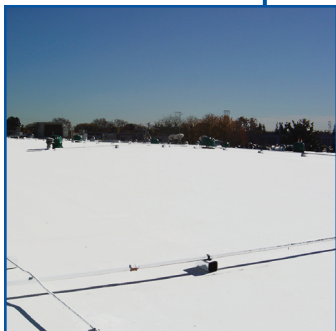
- 10 year old failing PVC membrane.
- Numerous cracks and badly crazed.
- Over 250 documented leaks.
- Provide a sustainable roofing system with excellent adhesion and resistance to plasticizer, (a key component in PVC roofing membranes that prevents cracking) migration.

- Seamless, energy efficient roofing system featuring a fully adhered, leak free 120 mil membrane.
- Evening installation and heavy dew that deposited on the roof during the night was solved with a unique AcryShield® "quick-set" roof coating.
- Costly recover or tear off was not required; repairs and coating were completed at only a fraction of the cost of a recover roof.
- Substantial energy savings.
