## Restoration Case Study

### Centennial Farm House

**Location:** Kawkawlin, MI

**Loss Event:** Water and Structural Damage from Fire

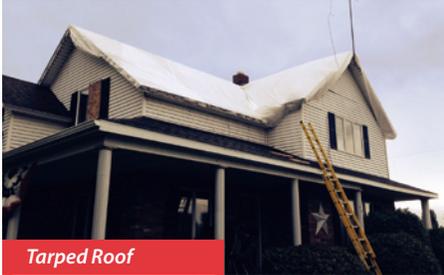
Tarped Roof

Our project manager met with the insurance adjuster and home owner and secured an emergency work authorization. Within a few hours, our crew had the entire roof system tarped off and the home boarded up to protect against further water damage from the storm.

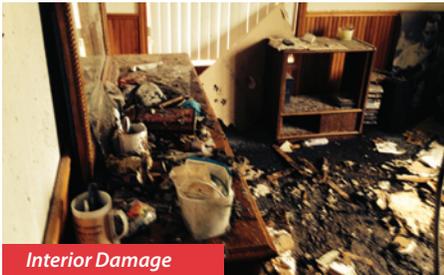
Interior Damage

Three quarters of the home suffered water damage from the prevailing rain storm and consequential flooding from the massive amounts of water required to extinguish the fire.

Our water mitigation and content recovery teams arrived early the next morning to assess the damage and implement the mitigation plan. Affected areas of the home were identified and contained. A drying envelope was created and air dryers were used to remove the moisture. The contents were evaluated, photographed, cataloged, and packed out within a few days. Once the contents were removed from the home, we immediately began demolition and mold remediation of the affected structure.

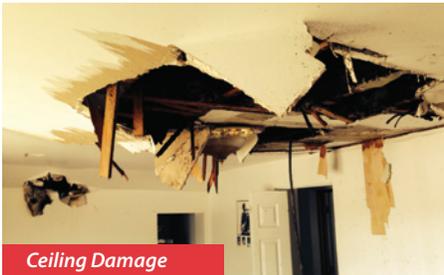
Ceiling Damage

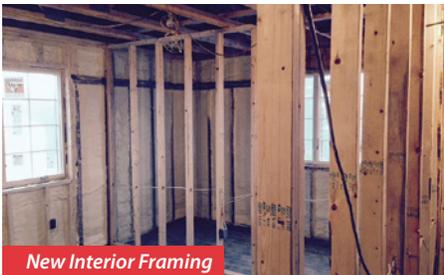
New Interior Framing

Due to the age of the home, the balloon framing, and multiple floor and ceiling levels presented a unique demolition and reconstruction challenge. Due to the severity of the fire, the entire roof structure had to be demolished and re-built with an engineered roof truss system. To the home owners delight, this allowed us to extend the second story, five foot knee walls to a full eight foot wall system, providing more usable living space.

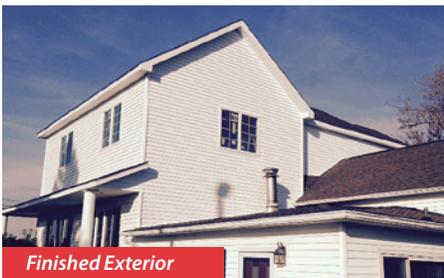
Finished Exterior

Every room in this home but one was affected by the fire or subsequent water damage. Our Fast Track process allowed us to complete the project in three and a half months. Our experienced reconstruction team was able to update the structure using modern construction techniques, while still maintaining the historical integrity and appearance of the home. We came in on schedule and on budget, and the customer was pleased with our quality workmanship and the exceptional care we took in restoring their home and belongings.
