Root Cause Determination of Excessive Hull Vibration On a First-In-Class Tugboat Design

Azima DLI was tasked to collect vibration data on a new tug being built in Seattle for use as a North Puget Sound escort tug. The tug's main duty is to escort tankers through the narrow channels through the San Juan Islands. A tug is designed to apply large forces to steer or brake the tanker in the event of an emergency. To meet these requirements, the 129'-6" long tug has a unique hull shape as shown in Figure 4. The vessel has a large skeg at the bow to provide lift, and a relatively wide and shallow hull. In indirect mode the hull acts similar to a kite, resulting in line pulls of over 150 tons at ten knots. This is double the static pull which the vessel's propulsion system can achieve. The vessel is propelled by a pair of Voith-Schneider cycloidal propellers, each driven by a 3,600 horsepower Caterpillar diesel. These propellers give precise control of both the thrust magnitude and direction.

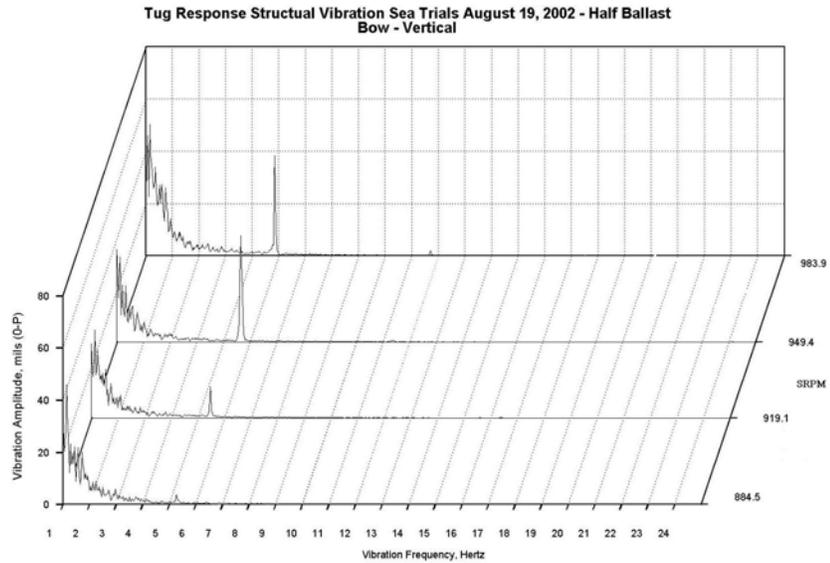
Figure 1

To quantify speed dependent displacement at different locations around the ship, a set of speed plots for point locations and ballast levels were created using MATLAB and an in-house program written by Azima DLI. The ranges of all the plots were kept constant for easy comparison between points and test conditions. See Figure 1.

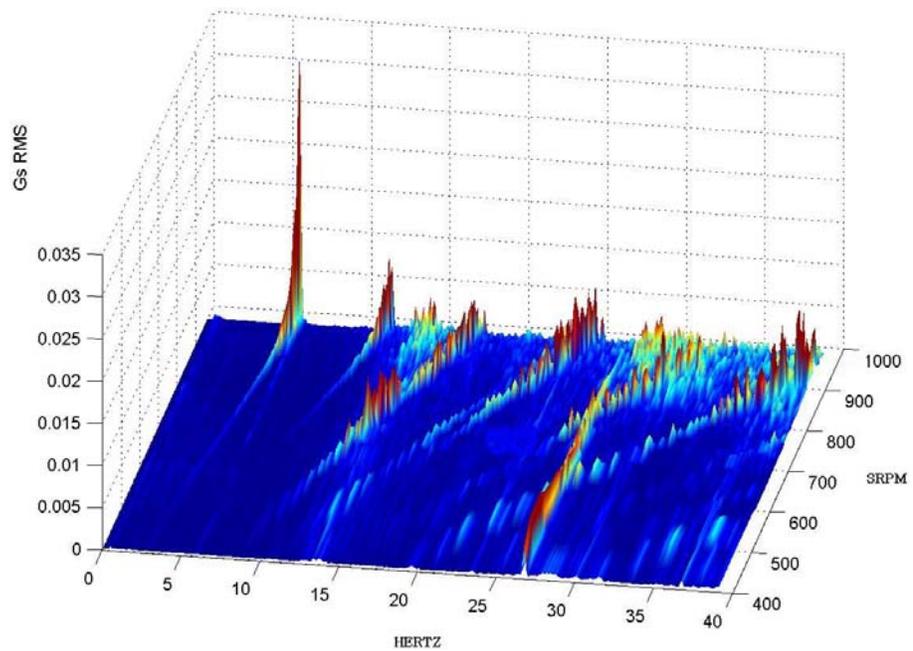
Figure 2

To identify forced as well as resonant responses at each point, MATLAB was also used to create 3D speed rundown plots. These plots clearly show the relationship of speed dependent energy inputs and their interaction with the natural frequency of the structure at each point. For example, the forced elements occur on the plot as diagonal stripes, whereas the natural frequencies appear as stripes parallel to the Z or Shaft RPM axis. When a forced input crosses a natural frequency, the resonant response can be seen on the Y axis of the plot. A good example of this occurs at ~5 Hz and ~1000 SRPM.

The height of the peak as well as its color denote the severity. In this case, the cycloidal drive blade rate crosses the fundamental natural frequency of the hull and the large red peak is the resonant response in Gs RMS. See Figure 2.

In all there were nine sets of distinct data taken during six separate sea trials. Each set of data contained several runs with different operating conditions including speed rundowns. Analysis of all graphical and animated data from all tests showed the resonance of the hull being excited by the blade pass frequency of the Voith cycloidal drive units.

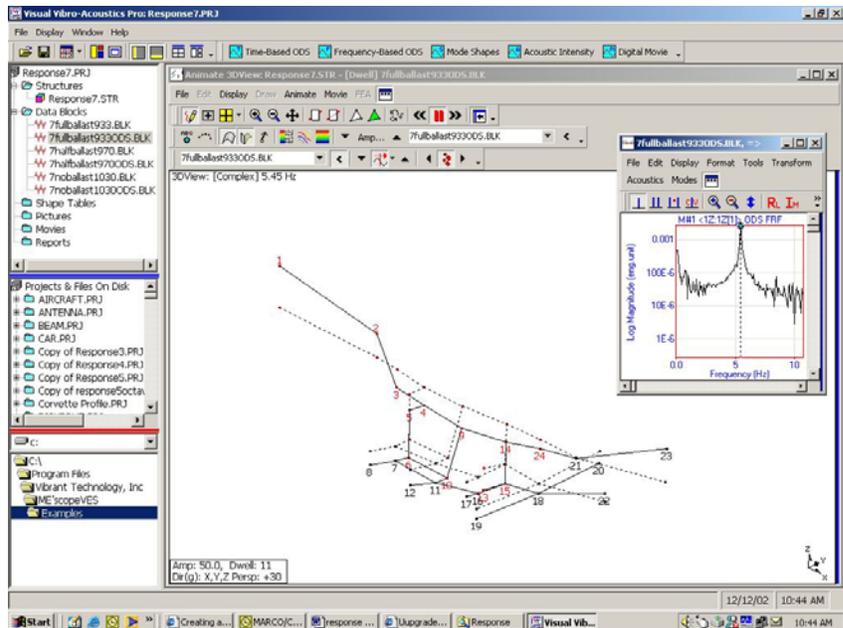
ME'scopeVES from Vibrant Technology, Inc. was used to create an animated three dimensional model of the structural points for each set of conditions. These animated models allowed us to view the movement of the points relative to each other at discreet frequencies. The most interesting frequency range was found to be at full power and excited by the Voith drive system. This frequency ranged between around 5.4-6.0 Hz depending on ballast conditions. For example, the animated structure shown in Figure 3 has the bow point (1) in the upper left corner. The other structural locations are labeled accordingly throughout the ship with the stern point (23) at the right. The dotted lines are the at-rest values and the solid lines represent the deviations as the structure moves through it's animation cycle. Notice the discreet animation frequency window in the upper right corner with the animation frequency set to resonance at 5.45 Hz.

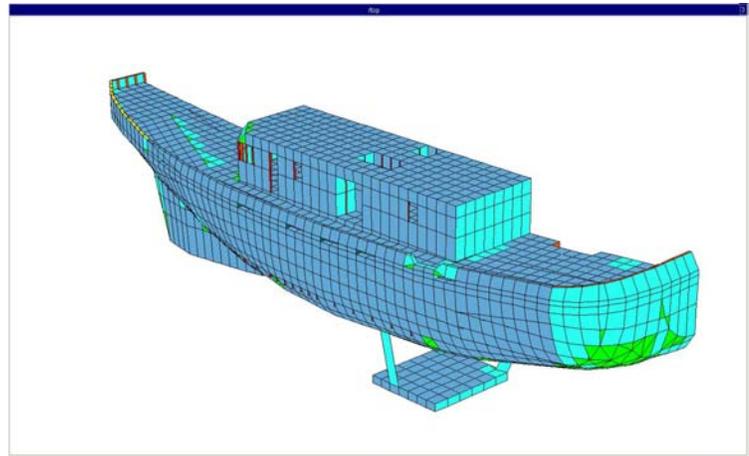
The first option was known to be very expensive and have a six-month lead-time. To check the viability of the structural changes, i.e. the second option, the project's naval architects contracted for a fine mesh finite element model of the ship. See figure 4. Once built, the model was tuned with the previously acquired empirical data. Different modification variants were then modeled and the natural frequency was evaluated. The modifications chosen were: the boxing-in of the bulwarks, the

addition of a heavy keel doubler, the addition of two stanchions in the engine room, and the addition of two stanchions in the generator room. This was an addition of 30 tons of steel. The model showed these modifications shifting the natural frequency of the hull higher by about 10% for the half ballast condition. In this case, the natural frequency would shift to 6.26 Hz from 5.66 Hz for the as built hull. At 6.26 Hz, the natural frequency is approximately 7% higher than the maximum Voith bladerate excitation frequency. Given the response curve measured in the tests, it was determined that this was sufficient to meet the vibration goals. These modifications were completed and the sea trials resumed.

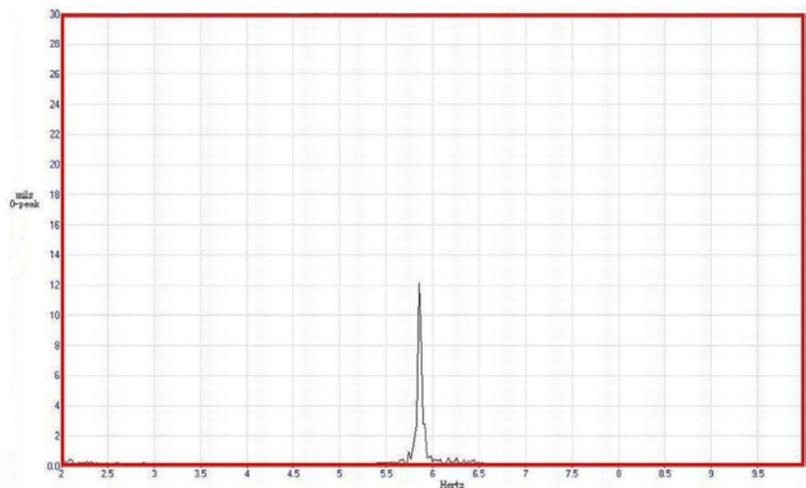
Figure 5

Tug Response Structural Vibration Sea Trials December 26, 2002 Half Ballast 980 SRPM
Bow - Vertical

The final vibration sea trial was conducted using an Azima DLI diagnostic data collector running Signal AQ and ME'scope software. Vibration levels were quantified at two previously measured locations, three different ballast conditions and three different operating speeds for each ballast condition. The modifications were successful. See Figure 5. This operational vibration level was acceptable to both the ship's builders and operators.
