## **BUILDING MAINTENANCE**

## **Challenge:**

## DFT® Model SCV® Check Valve Features:

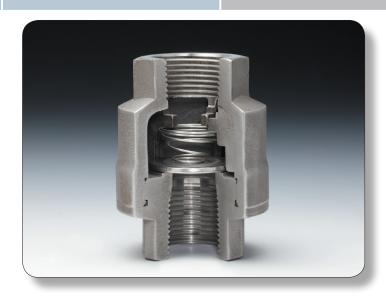
The DFT® model SCV® check valves were the answer to this problem. The University installed .75", .5", 1", 1.25", 1.5", and 2" sized SCV's 750 CWP, NPT ends. The SCV spring-assisted design improved longevity and provided tight shut-off due to proper disc/ seat alignment.

- 1/2" to 3" line size
- 750 & 3600 CWP
- FNPT or Socket Weld ends
- Stainless steel construction
- Inconel® X-750 spring
- Zelon® "O" ring body seal
- Edge-guided disc
- Spring assisted silent closing, non-slam
- Tight shutoff lapped disc & seat
- Horizontal or vertical installation
- Simplified 5-part construction
- Easy maintenance
- Versatile
