Profile

Google

Challenge *Failing BUR with Cap Sheet Roof*

Solution *AcryPly® 10-Year Roofing System*

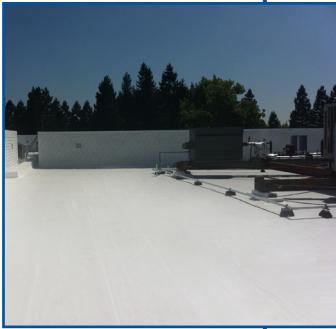
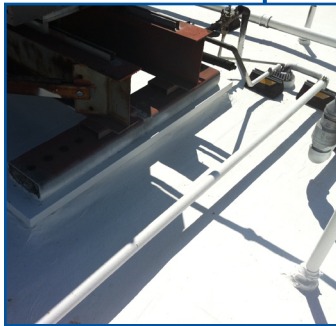
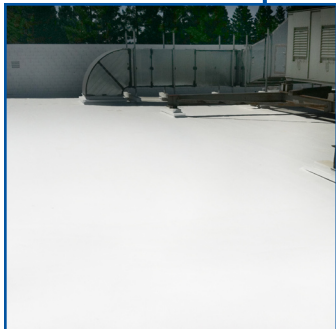
- AcryPly roofing system using both asphalt emulsion and AcryShield A-503 base coat with A-400 top coat.
- System was applied directly over existing cap sheet roof.

- Provide a cost effective system that provides a superior monolithic roofing membrane without the disruption of a tear-off and disposal.
