Profile

Hundley Hardware Co.

Challenge *Aging, Leaking Metal Roof*

Solution *AcryShield Restoration System*

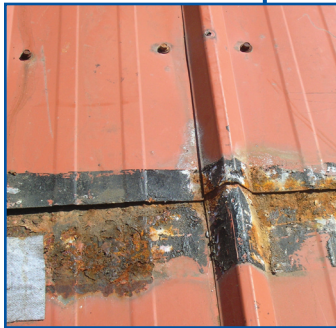
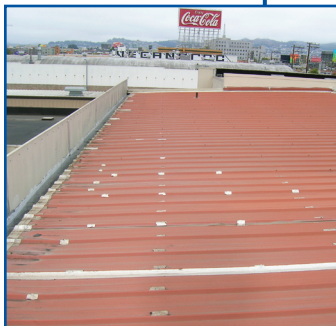
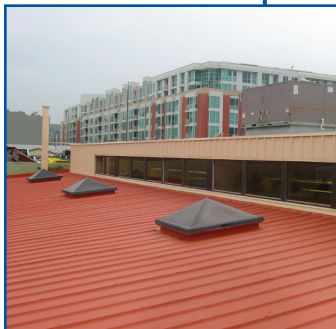
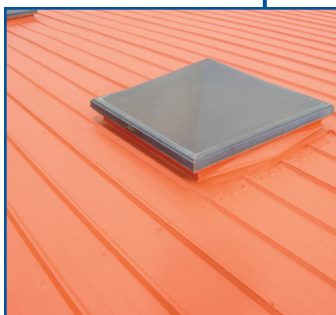
- Aged metal roof leaking
- Occupied business
- Custom colors needed
- Multiple roof levels

E.M. Hundley Hardware Company's building was an aging metal roof system, over twenty years old, that was revealing inconsistent nuisance leaks to the interior sales floor. IRC specified a National Coatings AcryShield® restoration coating system consisting of a localized, reinforced two-coat, 100% acrylic elastomeric custom color coating system with polyester fabric reinforcement at all metal panel end joints. "National Coatings makes this approach feasible not only with excellent coating products but also with the wide range of accessory products from rust-inhibitive primers to individual butyl caps to encapsulate the existing panel fasteners."

- Superior waterproofing and reinforced seams
- No business disruption
- Custom tinted coating matched existing building scheme
- Leak Free
