**NTN** corporation

# **Care and Maintenance of Bearings**

## Care and Maintenance of Bearings (Revised)

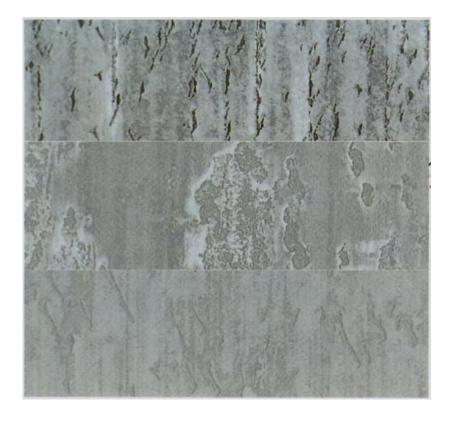
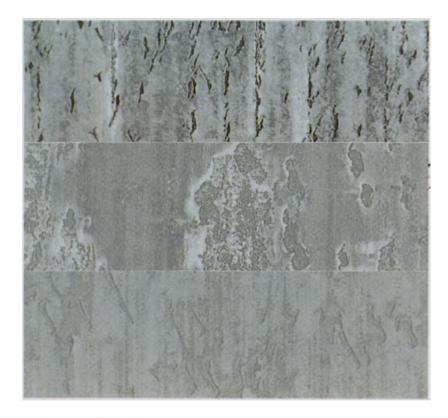
**Explanation of the Photos.** These are microscopic photographs of peeling damage generated on the surface of a ball/roller bearing. Peeling can occur when the surface roughness is high, or when the lubrication performance is poor. Peeling has a flat-colored appearance, and when observed under a microscope, shows minute flaking and cracks. The top photo shows an example of minute flaking interconnected with cracks. The photo in the middle shows an example of partial separation of the surface, occurring after a number of areas where minute flaking occurred have been connected. This is often seen when grease lubrication is used. The bottom photo shows an example in which a directionality is seen in the minute flaking. The example also shows cracks due to slippage.

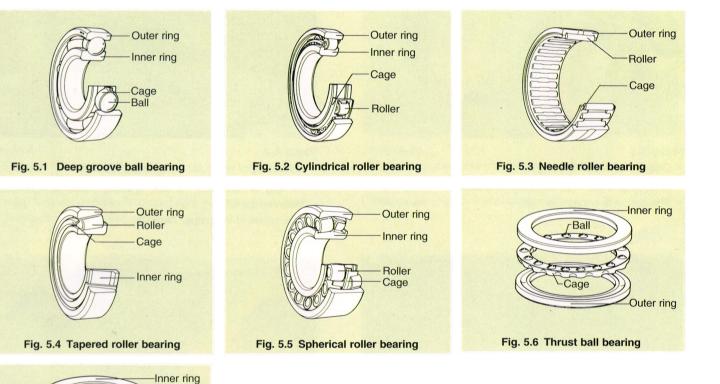
Figures 5.1 to 5.7 show the names of bearing parts referred to in the descriptions of the failure cases.

Cage

Outer ring

Roller
