## Evoqua Water Restored Metal Roof

<b>Size:</b>	16,000 square feet
<b>Location:</b>	Milpitas, California
<b>Products:</b>	AcryShield A510
<b>Contractor:</b>	Just Leaks, Inc.

PROJECT PROFILE

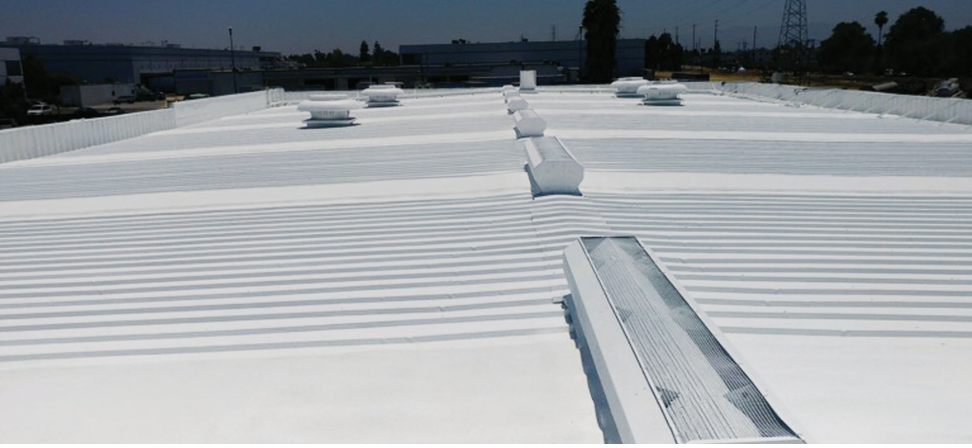
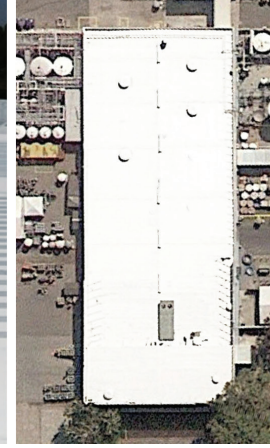
- › Old metal panel roof had numerous recurring leaks.
- › Built-in gutters had chronic leaks and fiberglass skylight were deteriorated and no longer usable.
- › Portions of the roof used a very thin gauge metal, prone to bending when stepped on.
- › Client had quotes from other roofers to replace metal panels at a cost that was prohibitive.

- › Sealed entire gutter system with one part urethane and polyester.
- › Framed in skylights and used SPF roof membrane over skylights and thin-metal panel areas.
- › AcryShield products created a watertight, monolithic membrane across the entire roof field.

*The client is very pleased with much cooler temperatures in the warehouse during the summer. Facility manager used to be afraid to walk on the thin metal panels, but now feels very comfortable as the SPF greatly stiffened and strengthened the roof panels. New SPF and AcryShield roof with urethane and polyester gutters was less than half the cost of replacing the panels and gutters with no disruption to building operations.*
