Field Failure Early Warning System

Gregg Kittlesen

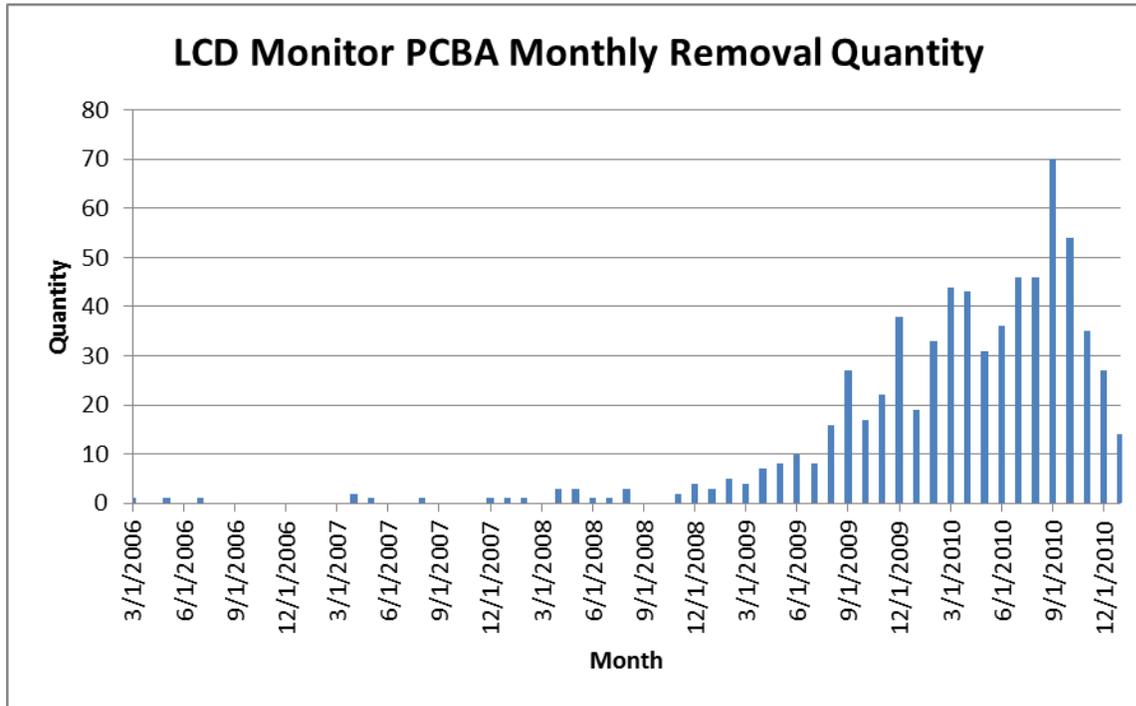
Three reliability charts were provided on experience with an in-flight entertainment system over several years. Monthly quantities of liquid crystal display (LCD) monitor removals (2 to 75) and mean time between unscheduled replacement (~170,000 to ~10,000 hours) were presented for a three year period. Monthly quantities of LCD monitor printed circuit board assembly (PCBA) removals (0 to 70) were presented for a five year period, see Figure 1. Additionally, a “time since installation” (0 to 21,000 hours) failure distribution was presented. Over 90% of the failures were reported to have occurred after 14,000 to 21,000 hours since install. Over 68% of the failures were reported to have occurred after 17,000 to 21,000 hours since install. The carrier had been engaged with the avionics equipment supplier on this early wear-out issue for a period of time. The avionics equipment supplier was investigating the issue root cause to provide a corrective action.

Actual LCD monitor PCBA removed quantities by month were listed in the AMC agenda. The total number of LCD monitor PCBA in use, 2508, was calculated from publically available information. All monitors entered into service within a period of less than 2 years. For the purposes of this study comparing various issue detection threshold processes and in the absence of more detailed time to failure/suspension data, all monitors were considered to be placed in service in June 2004. This study does not have sufficient information to support conclusions regarding the significant decrease in LCD monitor PCBA removals during the most recent period of Nov. 2010 through Jan. 2011. However, the carrier reported their highest LCD monitor removal quantities uniformly during the most recent reported period of Sep. through Dec. 2010.

The monthly LCD PCBA removal quantities presented in Figure 1 were used to calculate rolling yearly removals in Figure 2.

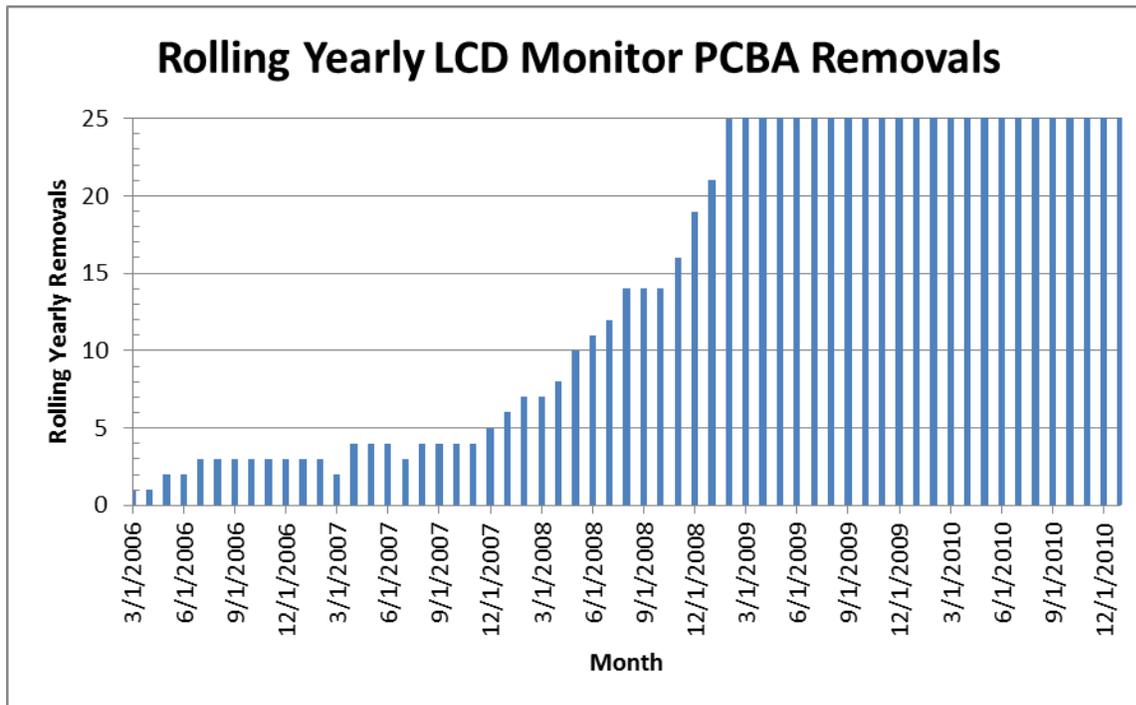
Figure 2

For this relatively small PCBA and limited deployment, removal of 1 unit in a month exceeds the expected upper limit calculation of 0.35% removals/year. Beginning in May 2006, there were no 12 month historical periods with fewer than the lower estimate of 2 PCBA removals. Beginning in May 2008, there were no 12 month historical periods with fewer than the upper estimate of 9 PCBA removals. Generally, removals of replaceable units are caused by a variety of issues.

However, if a series of long runtime units are removed due to a problem with one component, an emerging component wear-out issue may exist. It is suggested that a risk assessment be initiated when the observed replaceable unit removal rate exceeds 50% of the predicted removal rate. If the LCD Monitor PCBA predicted failure rate is 250 FIT (midpoint of the estimate 100 to 400 FIT), then the 50% threshold would be 2.7 PCBA removals per year. At such a low number of removals per year, this case study of a moderate population of an assembly with a low predicted failure rate illustrates the challenge of selecting an appropriate threshold to escalate actions. User organizations may choose to vary the threshold percentage at which to initiate a risk assessment based on factors such as population size, technology, median deployment time, and risk exposure. The risk assessment should review historical records regarding problems identified and formalize a tracking procedure to capture problems encountered on future removals. The greatest benefit of this process is early detection of an emerging component wear-out issue.
