Contaminated Aircraft Simulated Takeoff Tests for the 1999-2000 Winter: Preparation and Procedures

August 2000

Final Version 1.0

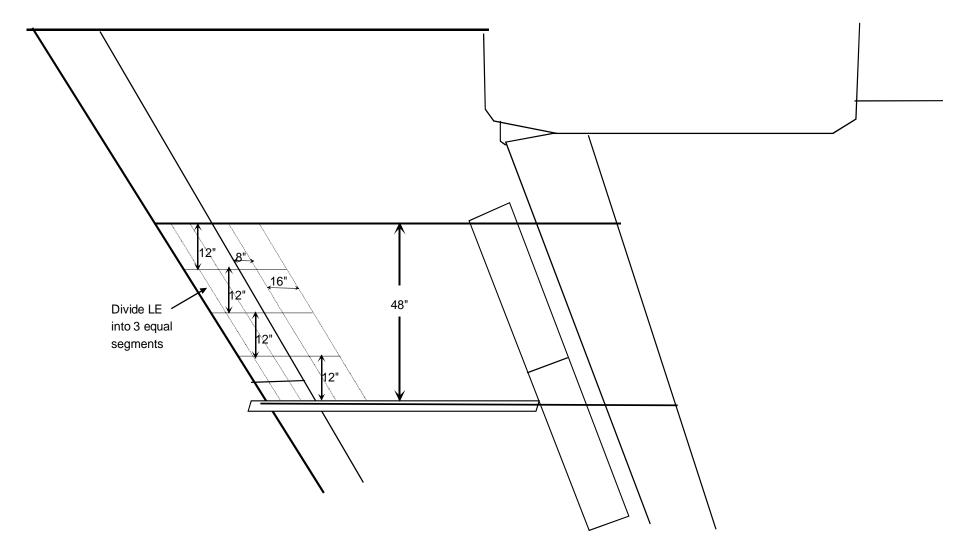
Figure 2.3 Reference Grid for Falcon 20 Wing

Chord 1 (Unslatted LE)
