Aircraft Full-Scale Test Program for the 1999-2000 Winter

Evaluation of the Positioning of Surface-Mounted Ice Detection Sensors on the Bombardier CL-65 Aircraft

December 2000

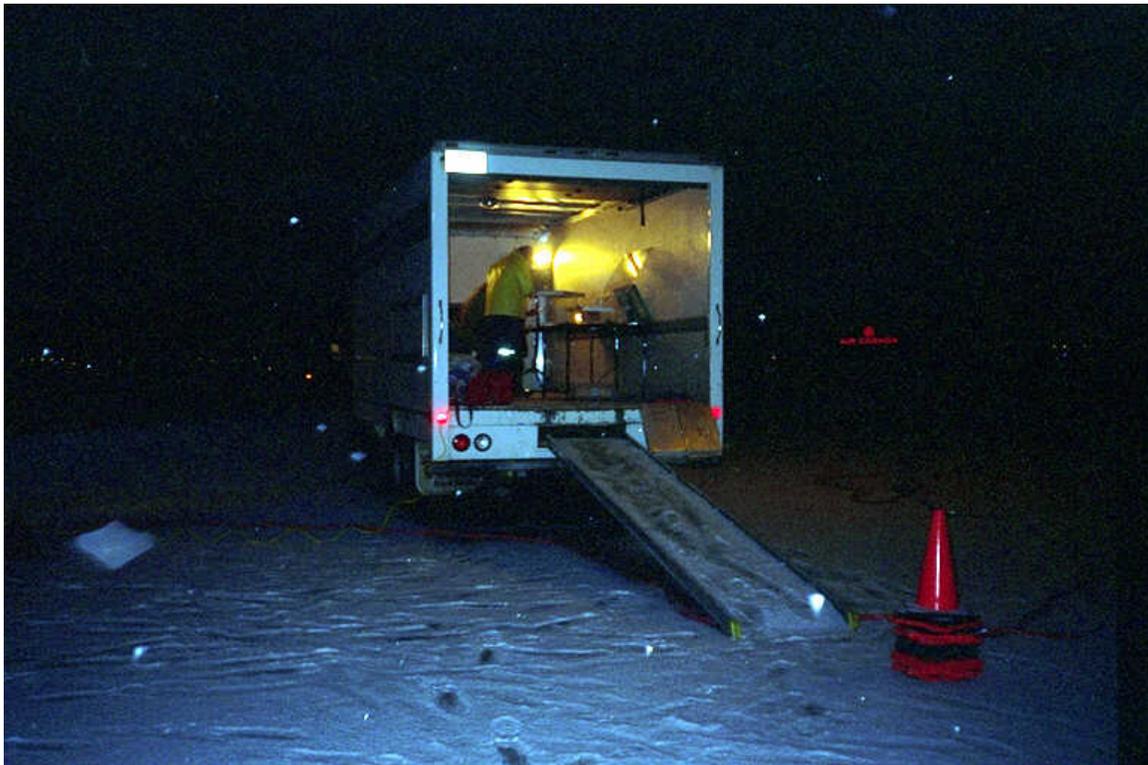
Photo 2.2
Field Lab for Full-Scale Tests

An electronic balance, shielded with plexiglass to reduce wind effects, was used to weigh the precipitation pans. The rate station was positioned on a table in the cube van. The van was positioned adjacent to the test stand. Photo 2.2 shows the truck used during the full-scale tests. The space in the van was also used for debriefing the test team between tests.

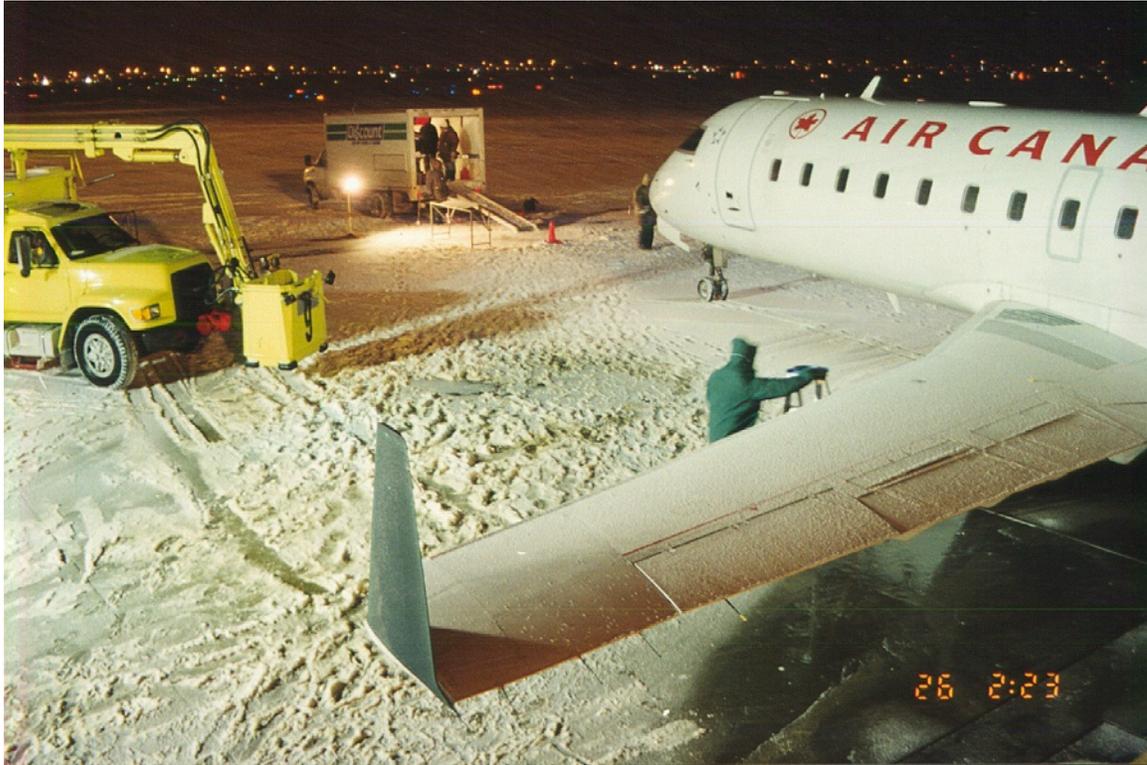
Photo 2.3
Set-Up of Full-Scale Aircraft Trials

Rolling staircases and several stepladders (see Photo 2.3) were positioned around each aircraft wing. Mobile mast-light units supplied wing illumination. Each unit consisted of four 1 000 W floodlights. A 6 kW diesel generator (an integral component of each unit) was also used to supply current for the lights and for other electrical requirements.

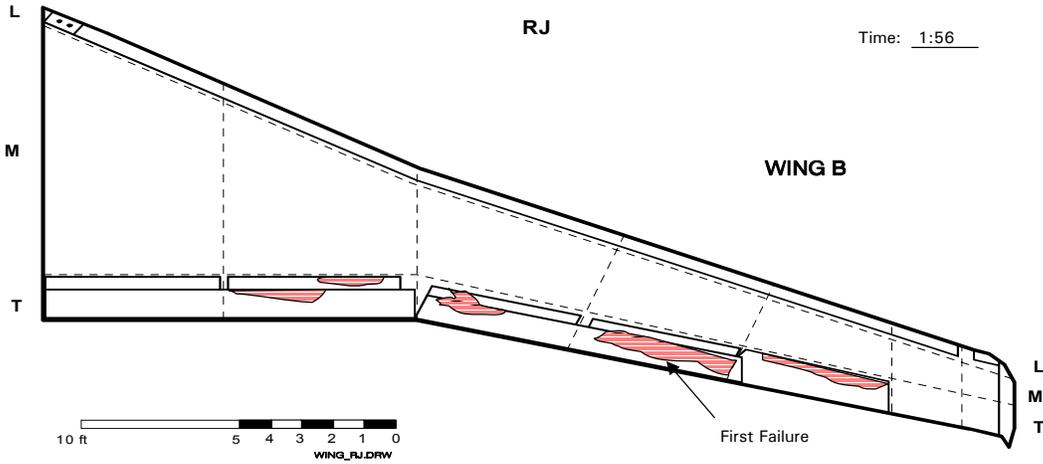
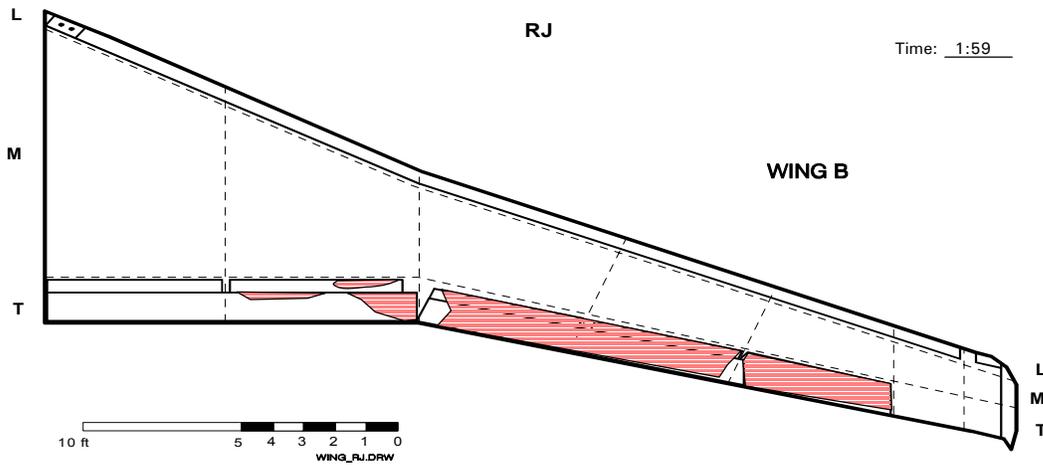
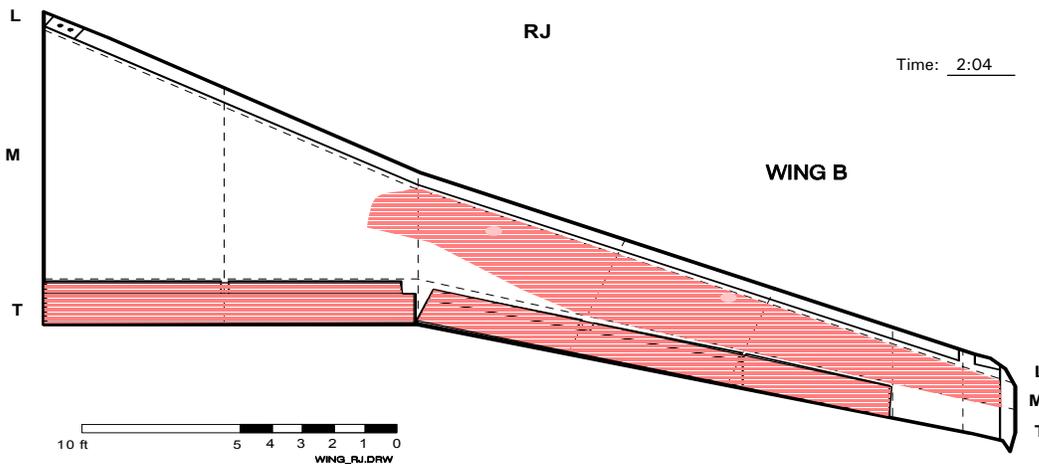
FIGURE 3.3
LOCALIZED FORM FOR AIRCRAFT WING

DRAW FAILURE CONTOURS (hr:min) ACCORDING TO THE PROCEDURE

The *Localized Aircraft Wing Form* (see Appendix B, Figure B-8) shows the form used for fluid failure tests at sensor head locations on the CL-65 RJ. A form was created for each of the port and starboard wings. Wing observers were assigned to identify fluid failures and draw failure contours on specific parts of the wing diagrams.

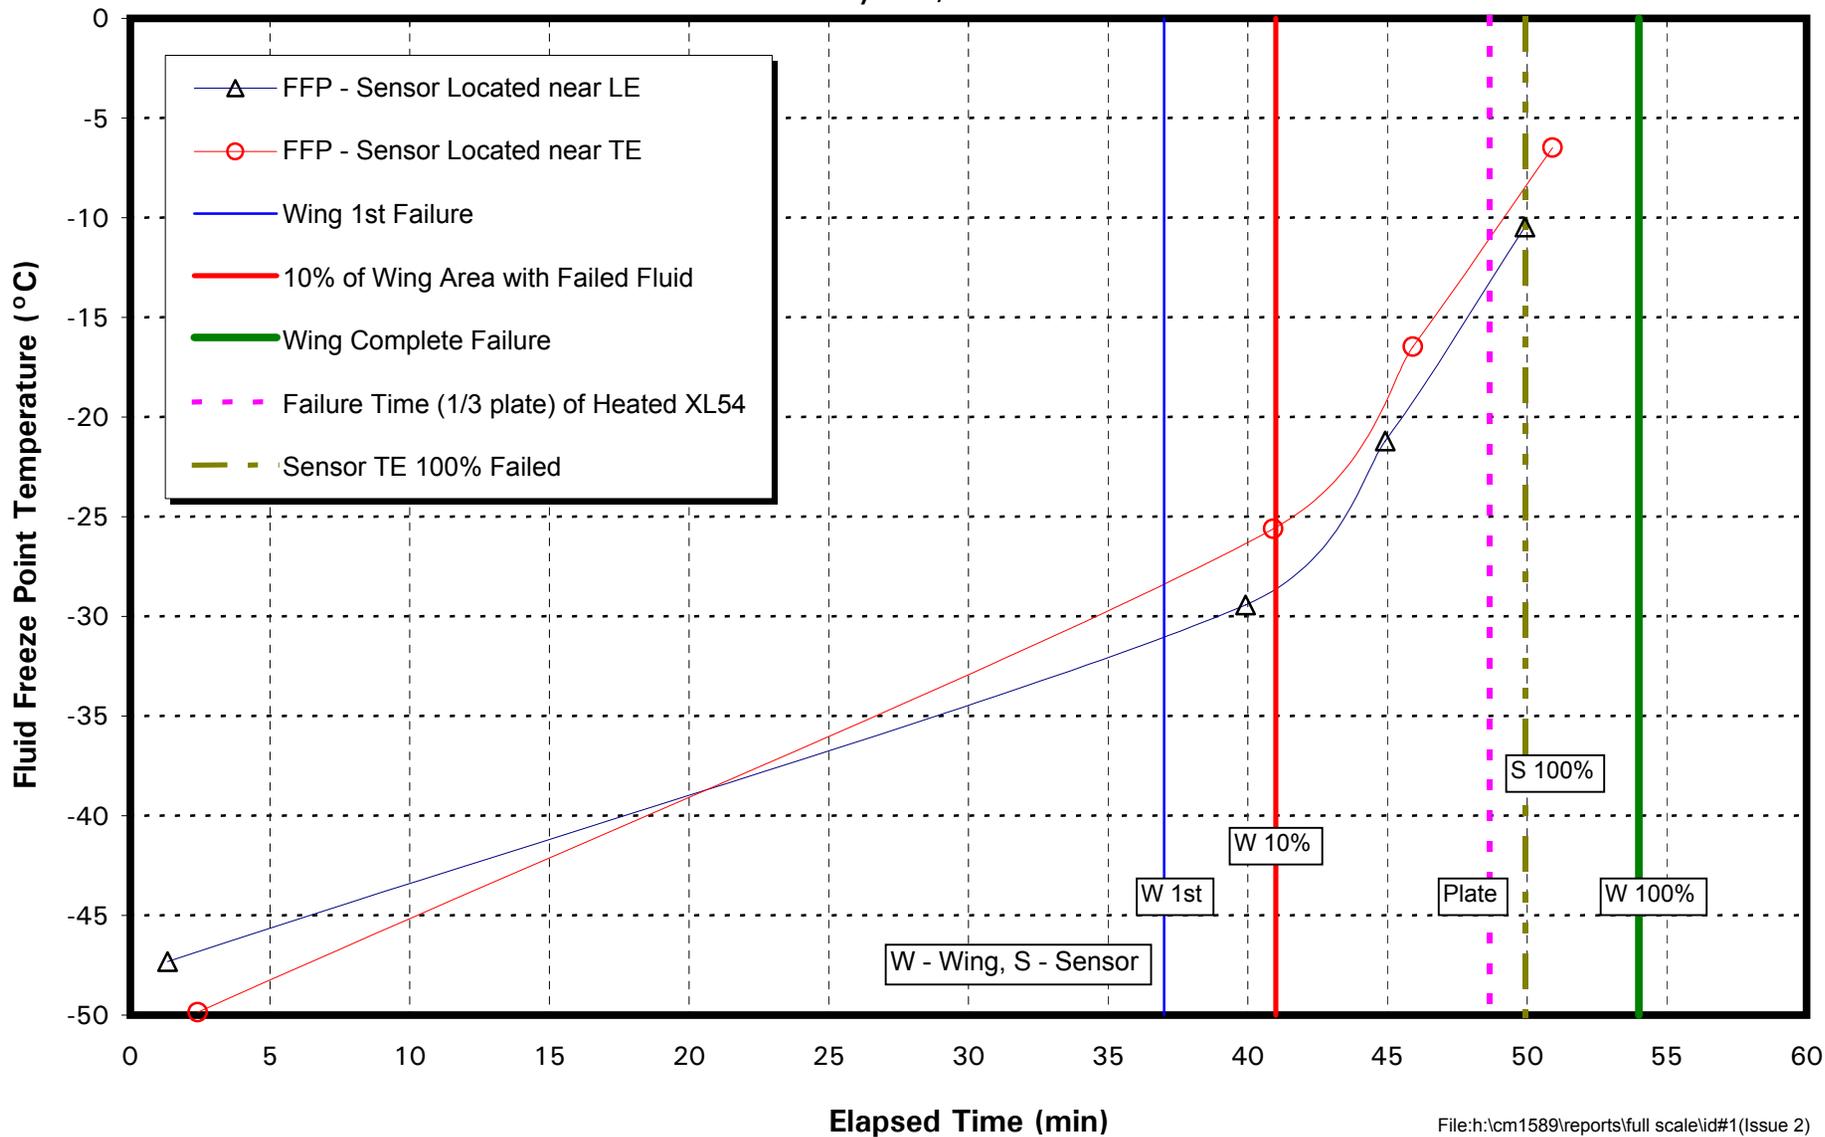
January 26, 2000 - ID # 1

UCAR XL54, OAT = -7°C, 3.0 g/dm²/h, 23 kph

Figure 4.1 and the related figures for the remaining tests contained in Appendix E show that the freeze point of the fluid measured near the proposed sensor positions ranges from about -10°C to -30°C when 10 percent of the fluid on the wing had failed. Ideally, sensor placement on the RJ should be on the trailing edge control surfaces, as these are the areas that display consistent failure. As this is not practical, an algorithm for the sensor could be developed to predict the condition of the fluid on the wing based on the condition of the fluid over the sensor head; however, it is not known whether the results would be of reasonable quality.

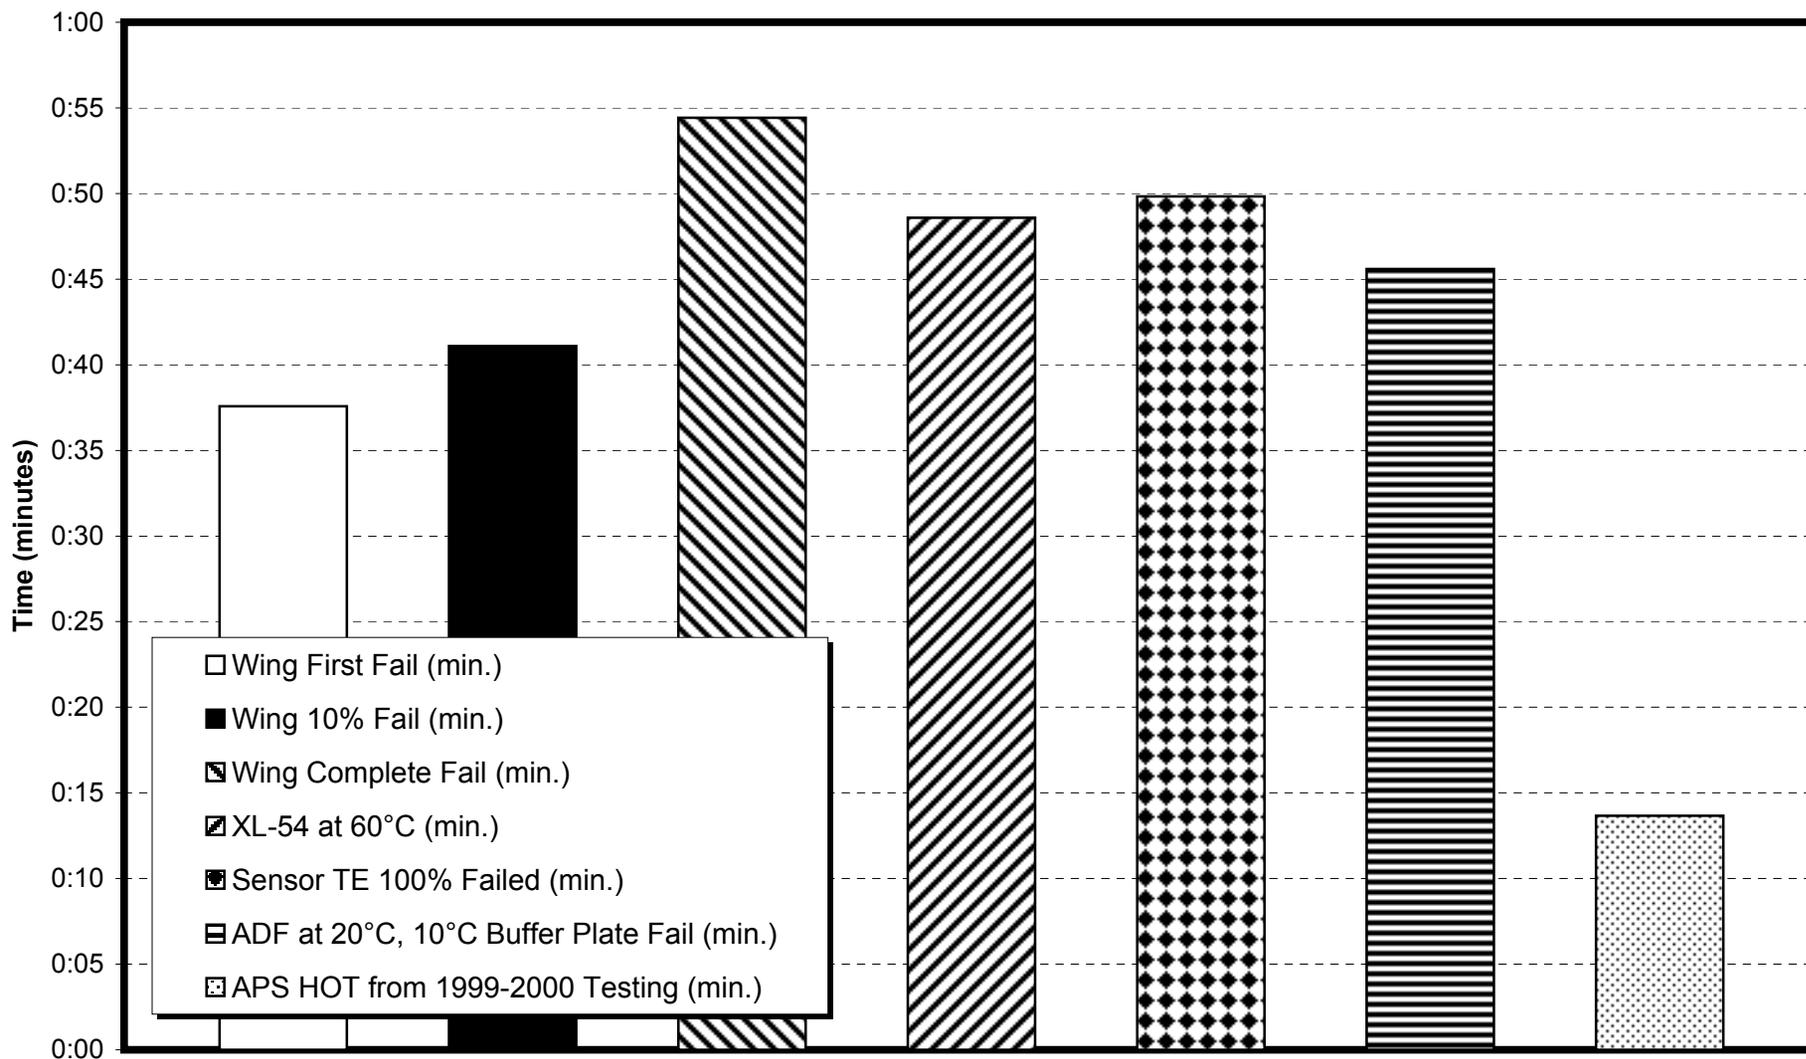
PLATE AND WING FAILURE TIMES FOR RUN 1

XL54 Fluid, OAT = -6.6°C, Rate = 3.0 g/dm²/h, Crosswind, Upwind Wing

Note: Current SAE Type I HOT is 6 to 15 minutes

It can be observed from Table 3.1 that the standard plate failure times did not coincide with the same wing failure level during each test. This was also observed during the similar full-scale tests that were completed previously on different aircraft and documented in Transport Canada report TP 13130E *Aircraft Full-Scale Test Program for the 1996/97 Winter*.

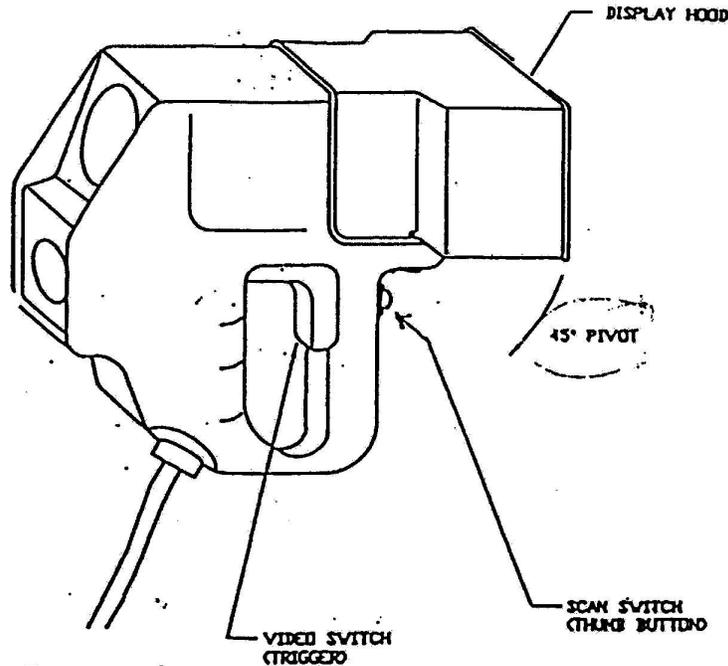
Figure B-2 ID-1H SENSOR MODULE A HAND-HELD VIDEO SCANNING UNIT.

Sensor Module Components:

- Video Switch (trigger)
- Scan Switch
- Adjustable Display Screen and Hood

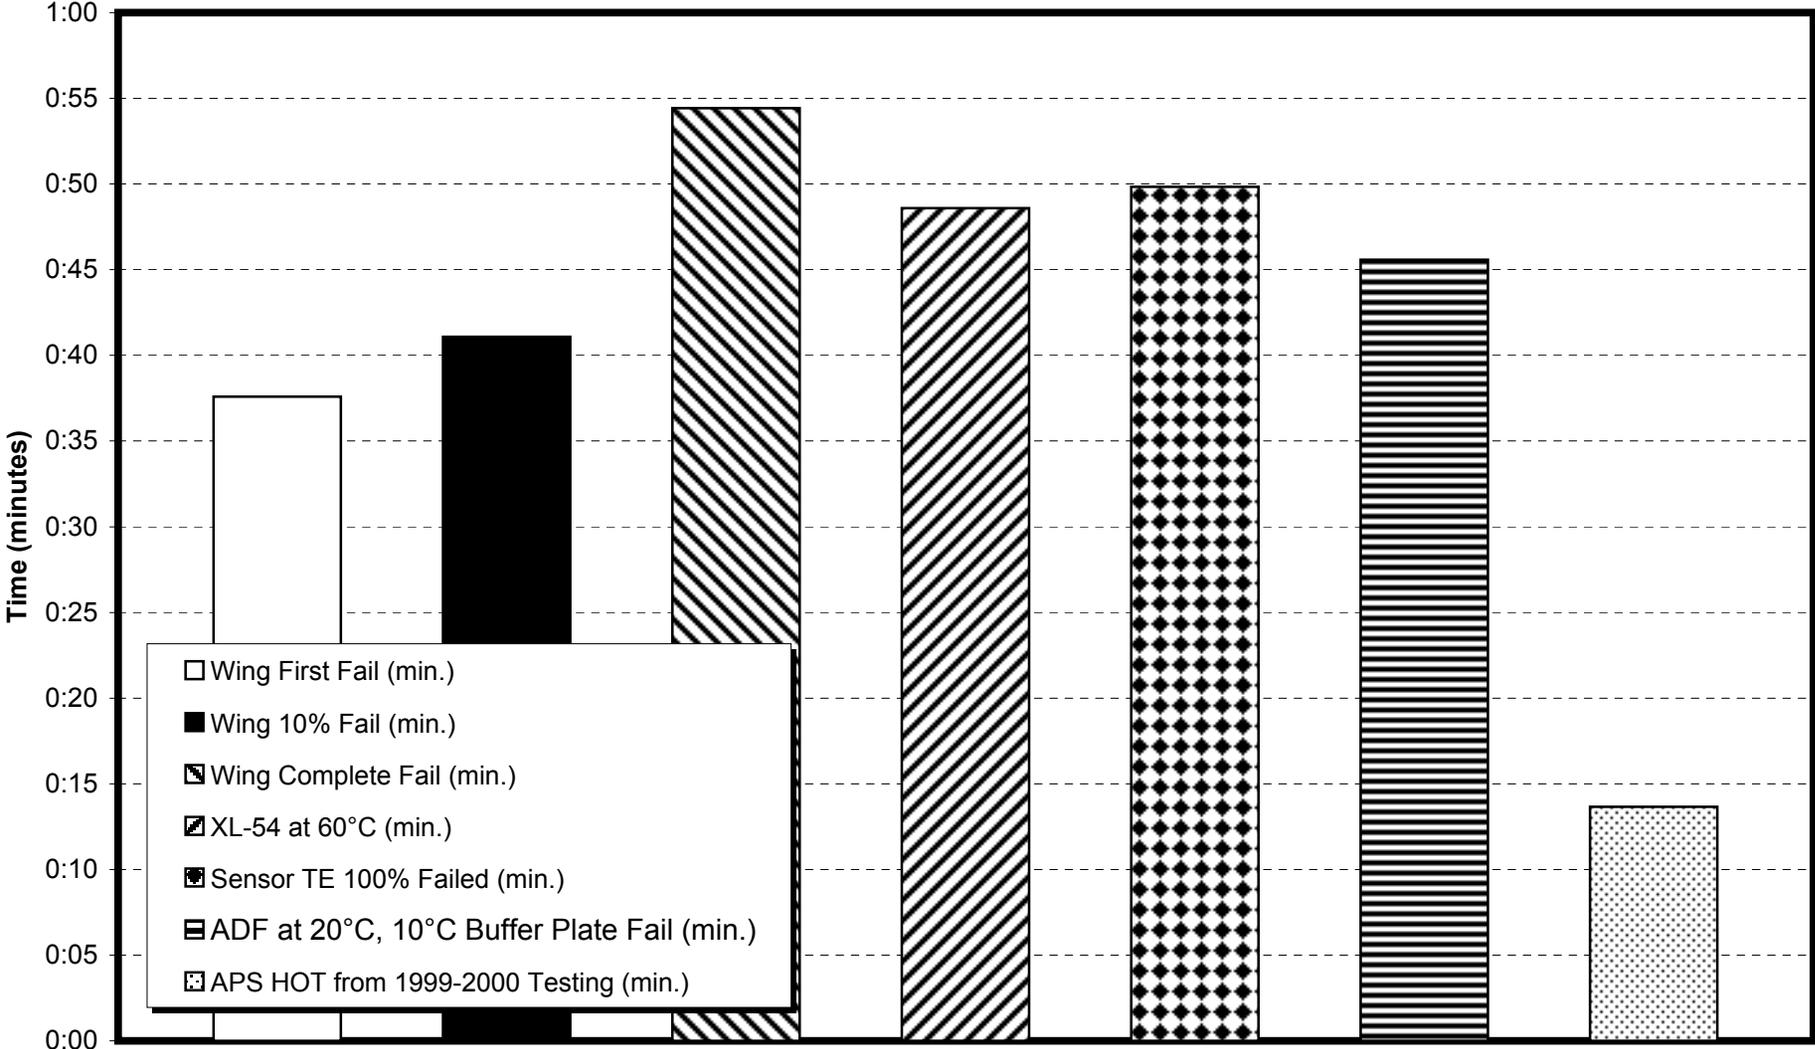
Plate and Wing Failure Times for Run 1

XL54 Fluid, OAT = -6.6°C, Rate = 3.0 g/dm²/h, Cross Wind 23 kph, Upwind Wing

Note: Current SAE Type I HOT is 6 to 15 minutes

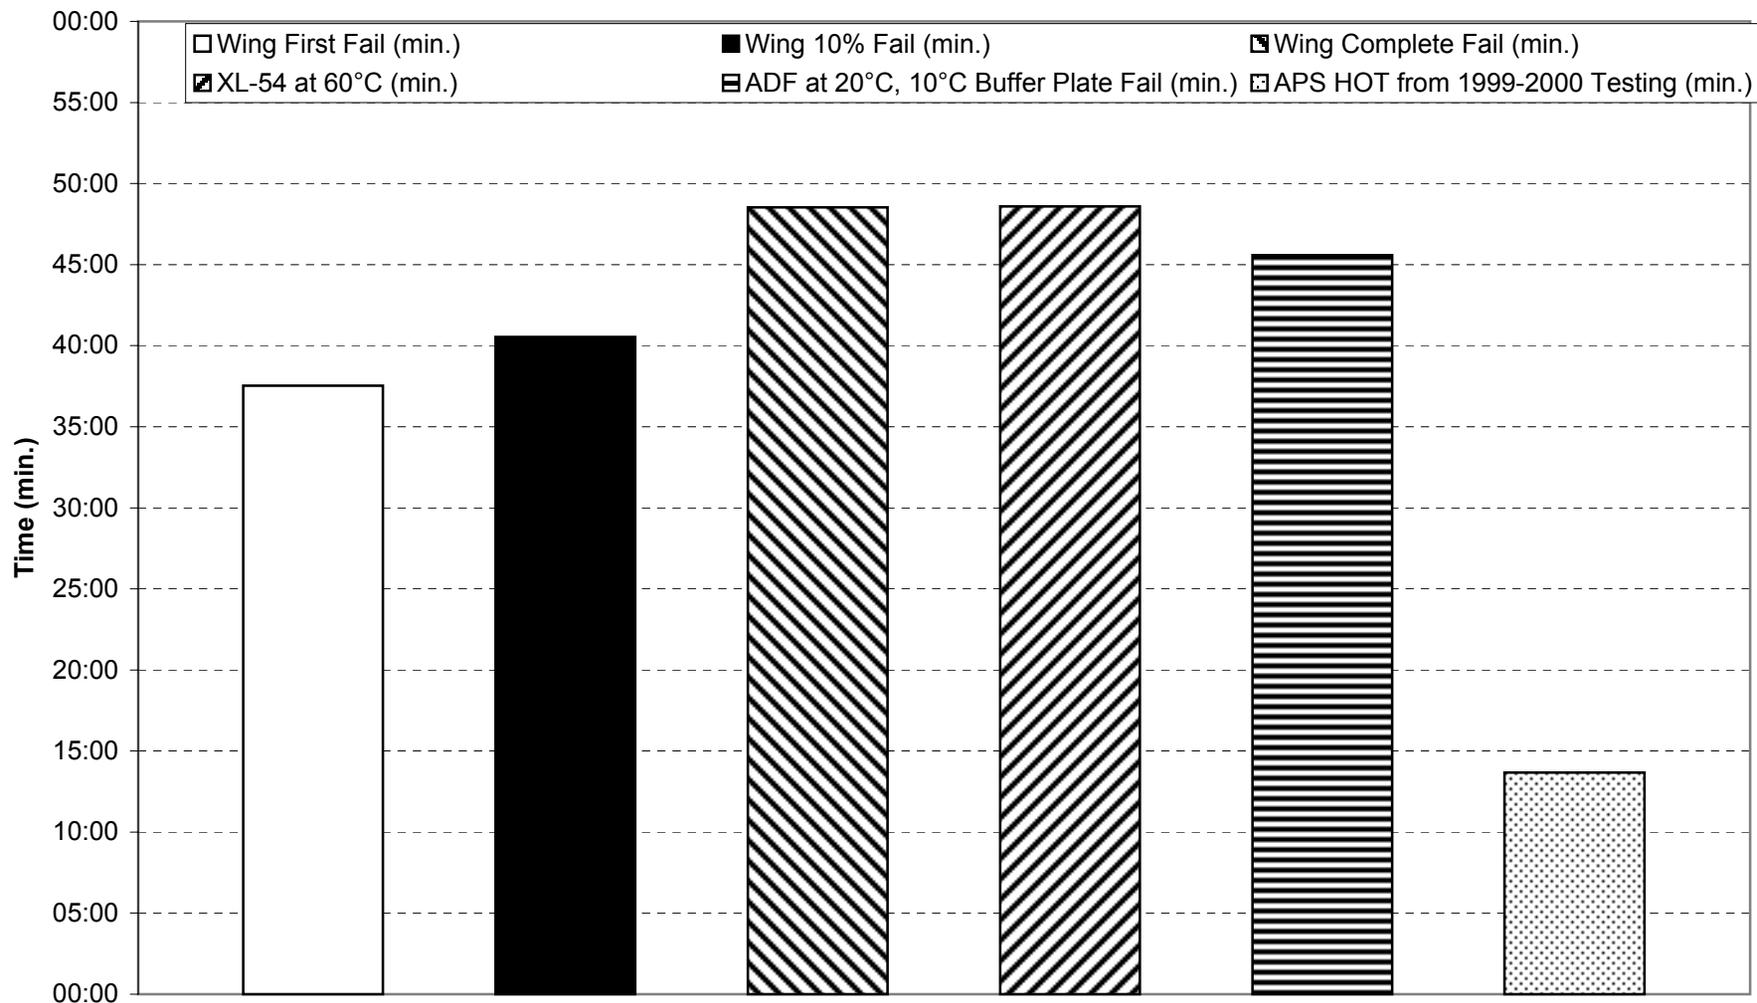
Plate and Wing Failure Times for Run 2

XL54 Fluid, OAT = -6.6°C, Rate = 3.0 g/dm²/hr, Crosswind 22 km/h, Downwind Wing

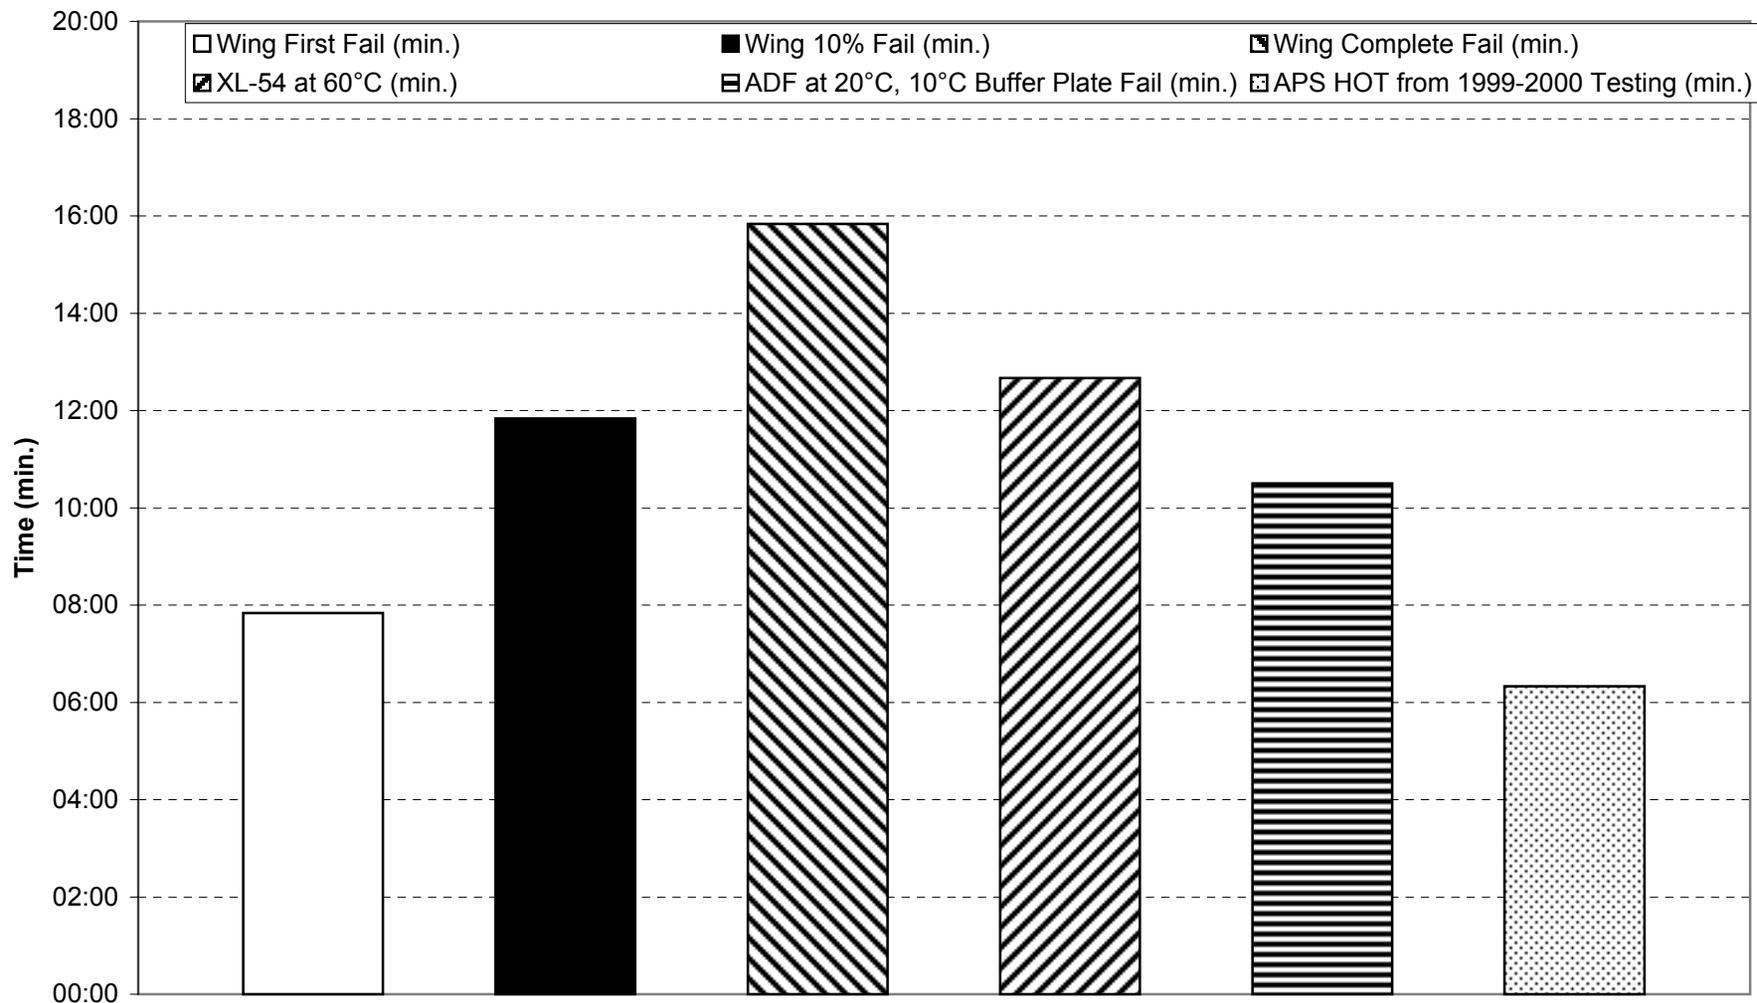
Plate and Wing Failure Times for Run 3

XL54 Fluid, OAT = -6.6°C, Rate = 9.1 g/dm²/hr, Crosswind 22 km/h, Upwind Wing

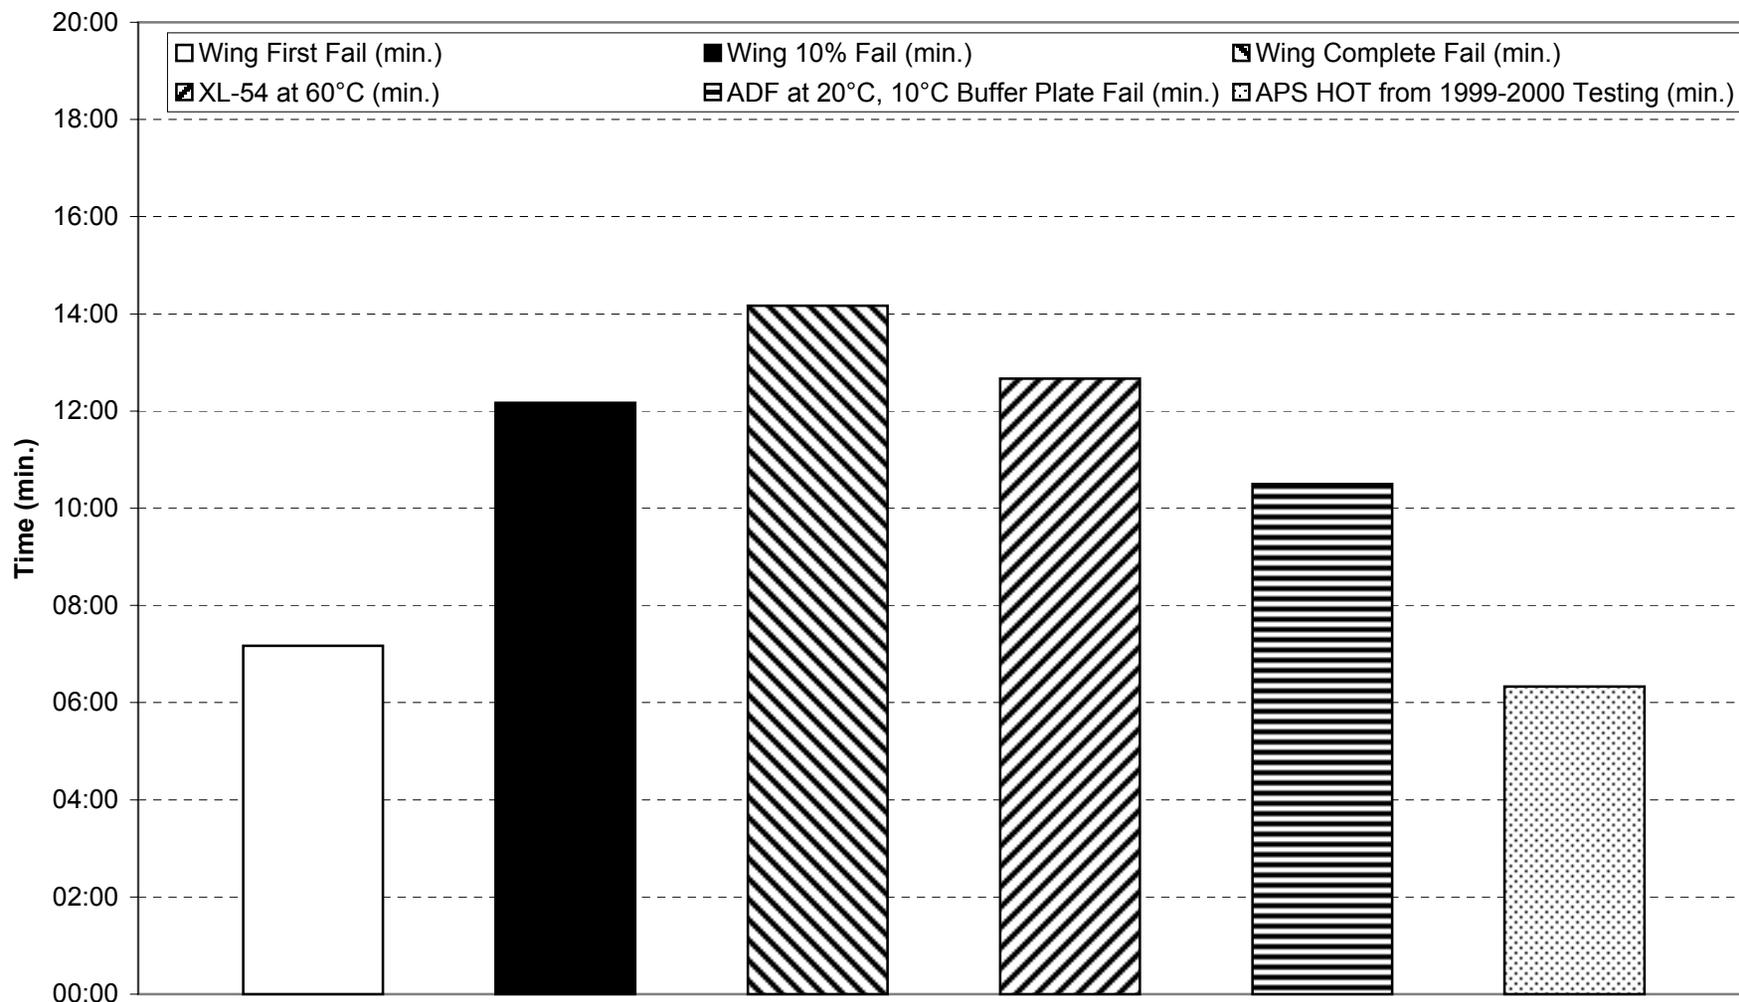
Plate and Wing Failure Times for Run 4

XL54 Fluid, OAT = -6.6°C, Rate = 9.1 g/dm²/hr, Crosswind 21 km/h, Downwind Wing

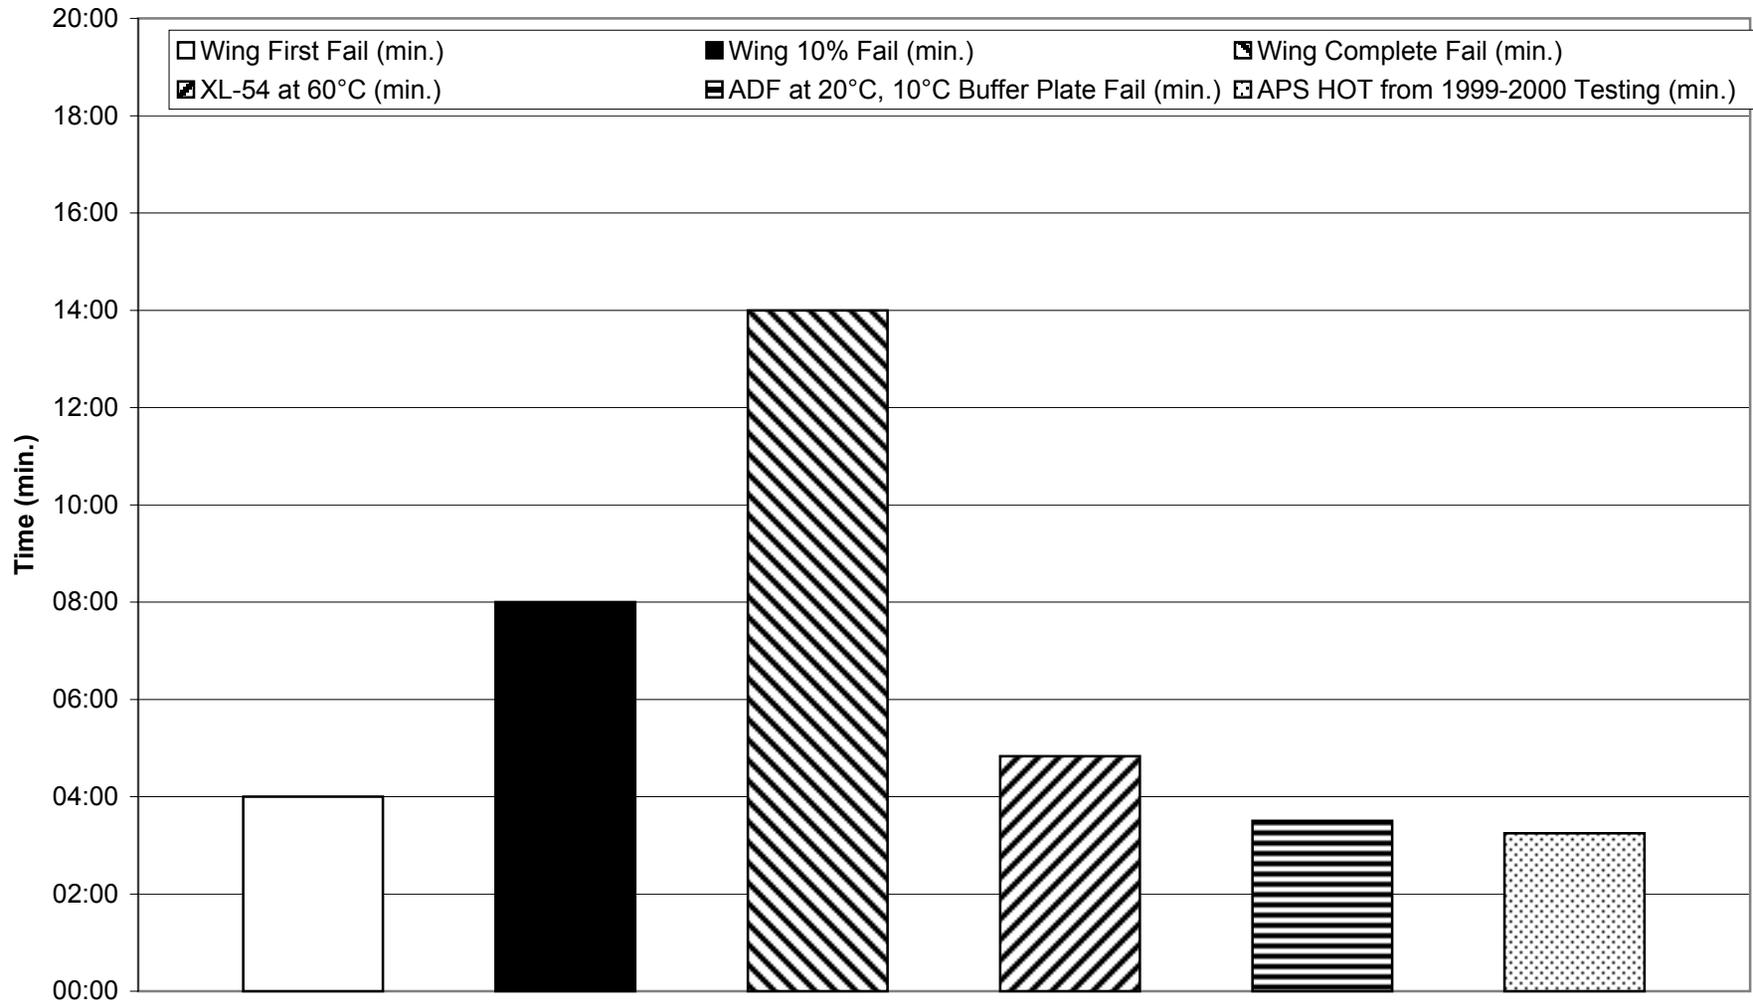
Plate and Wing Failure Times for Run 5

XL54 Fluid, OAT = -6.8°C, Rate = 24.0 g/dm²/hr, Tailwind 18 km/h

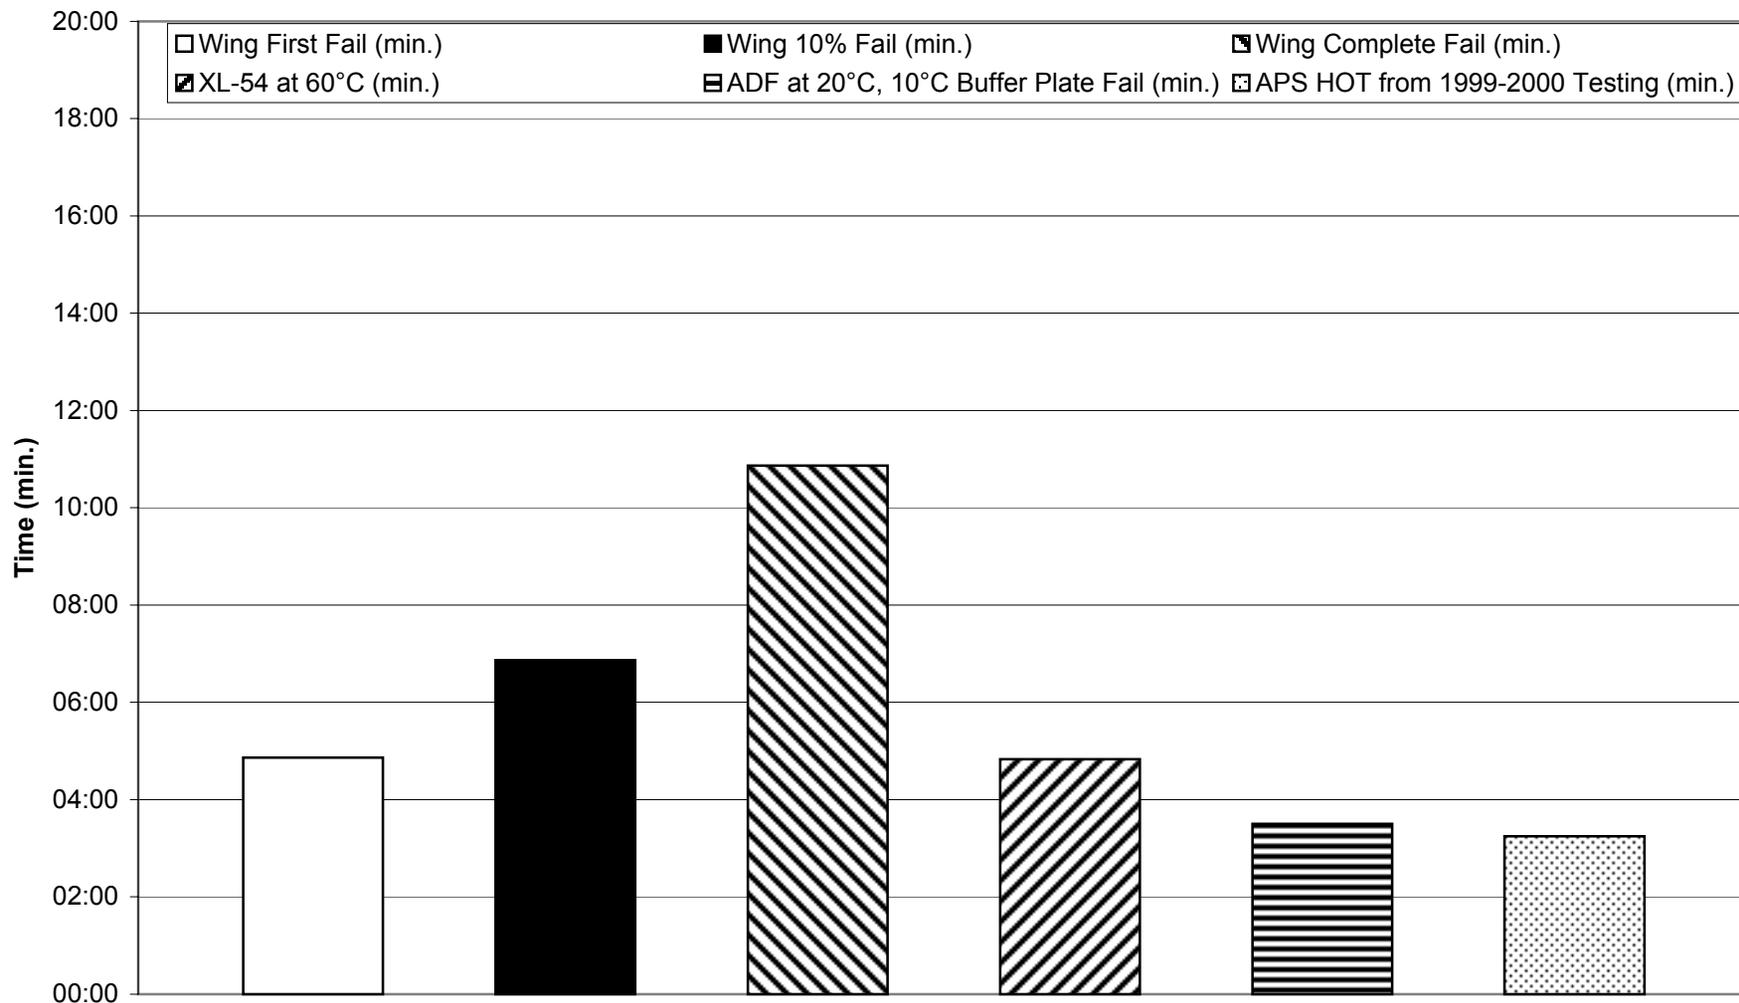
Plate and Wing Failure Times for Run 6

XL54 Fluid, OAT = -6.8°C, Rate = 24.0 g/dm²/hr, Tailwind 17 km/h

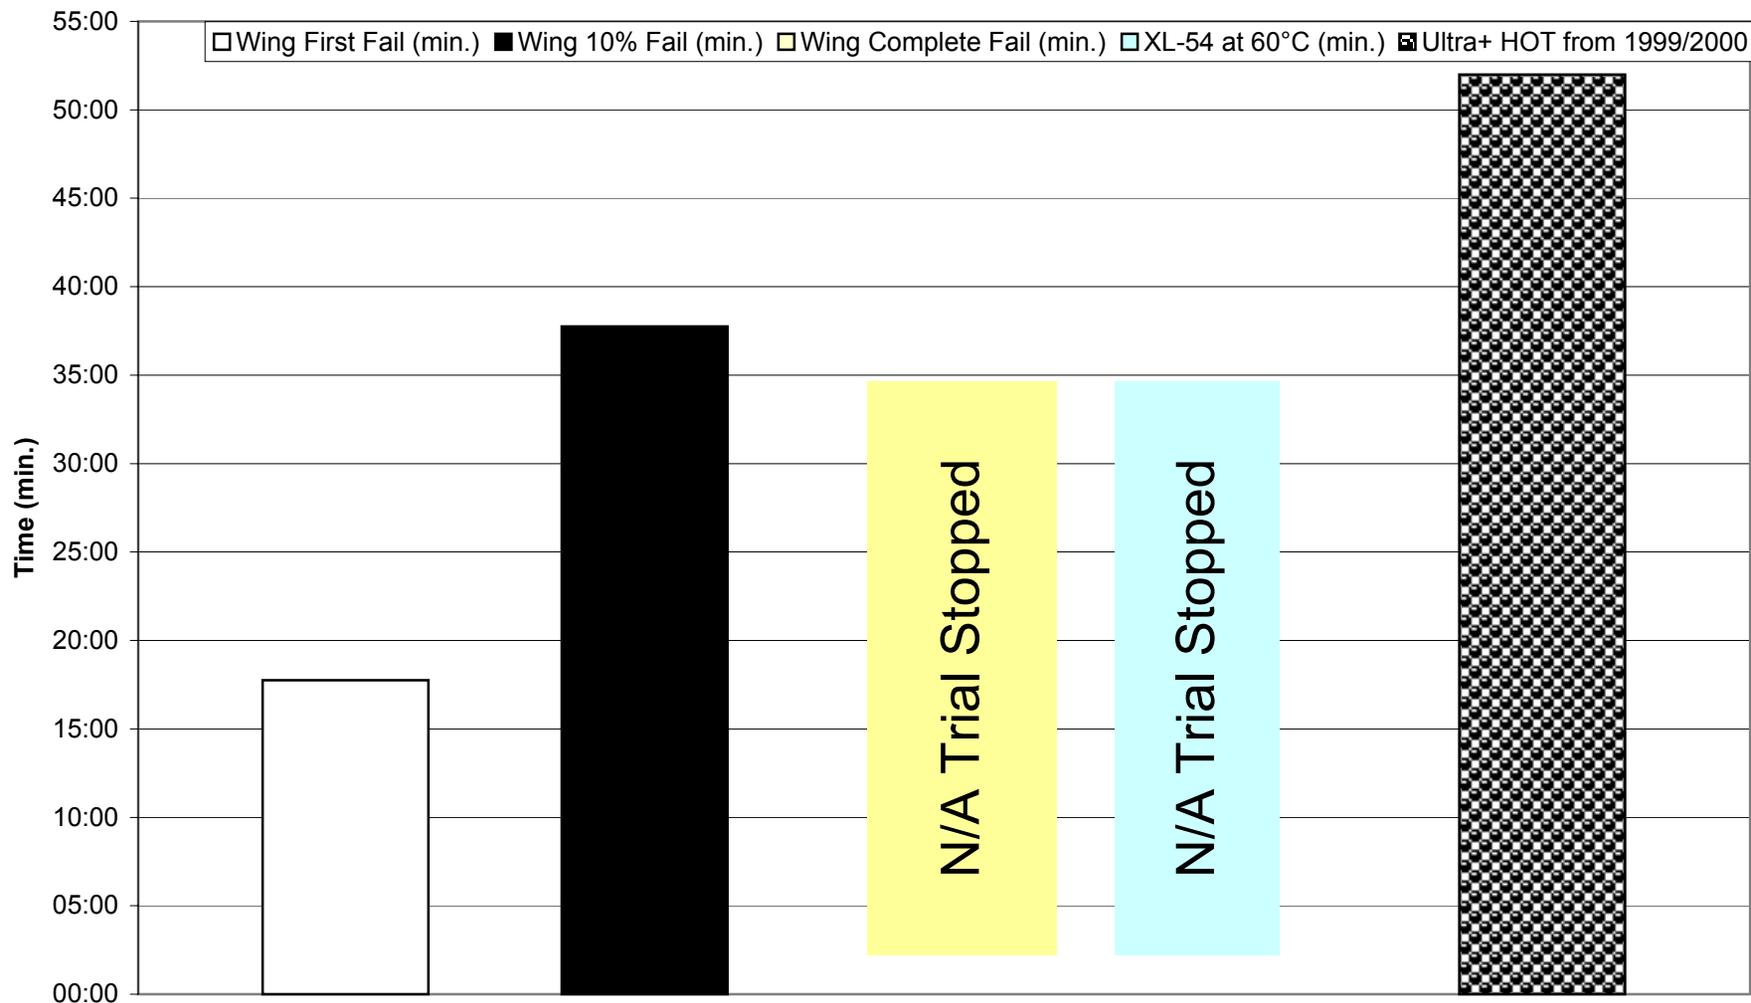
Plate and Wing Failure Times for Run 7

XL54/Ultra+ Fluids, OAT = -7.0°C, Rate = 14.0 g/dm²/hr, Headwind 15 km/h

Note: When the trial was stopped, the test plates were approaching three inch line failures.

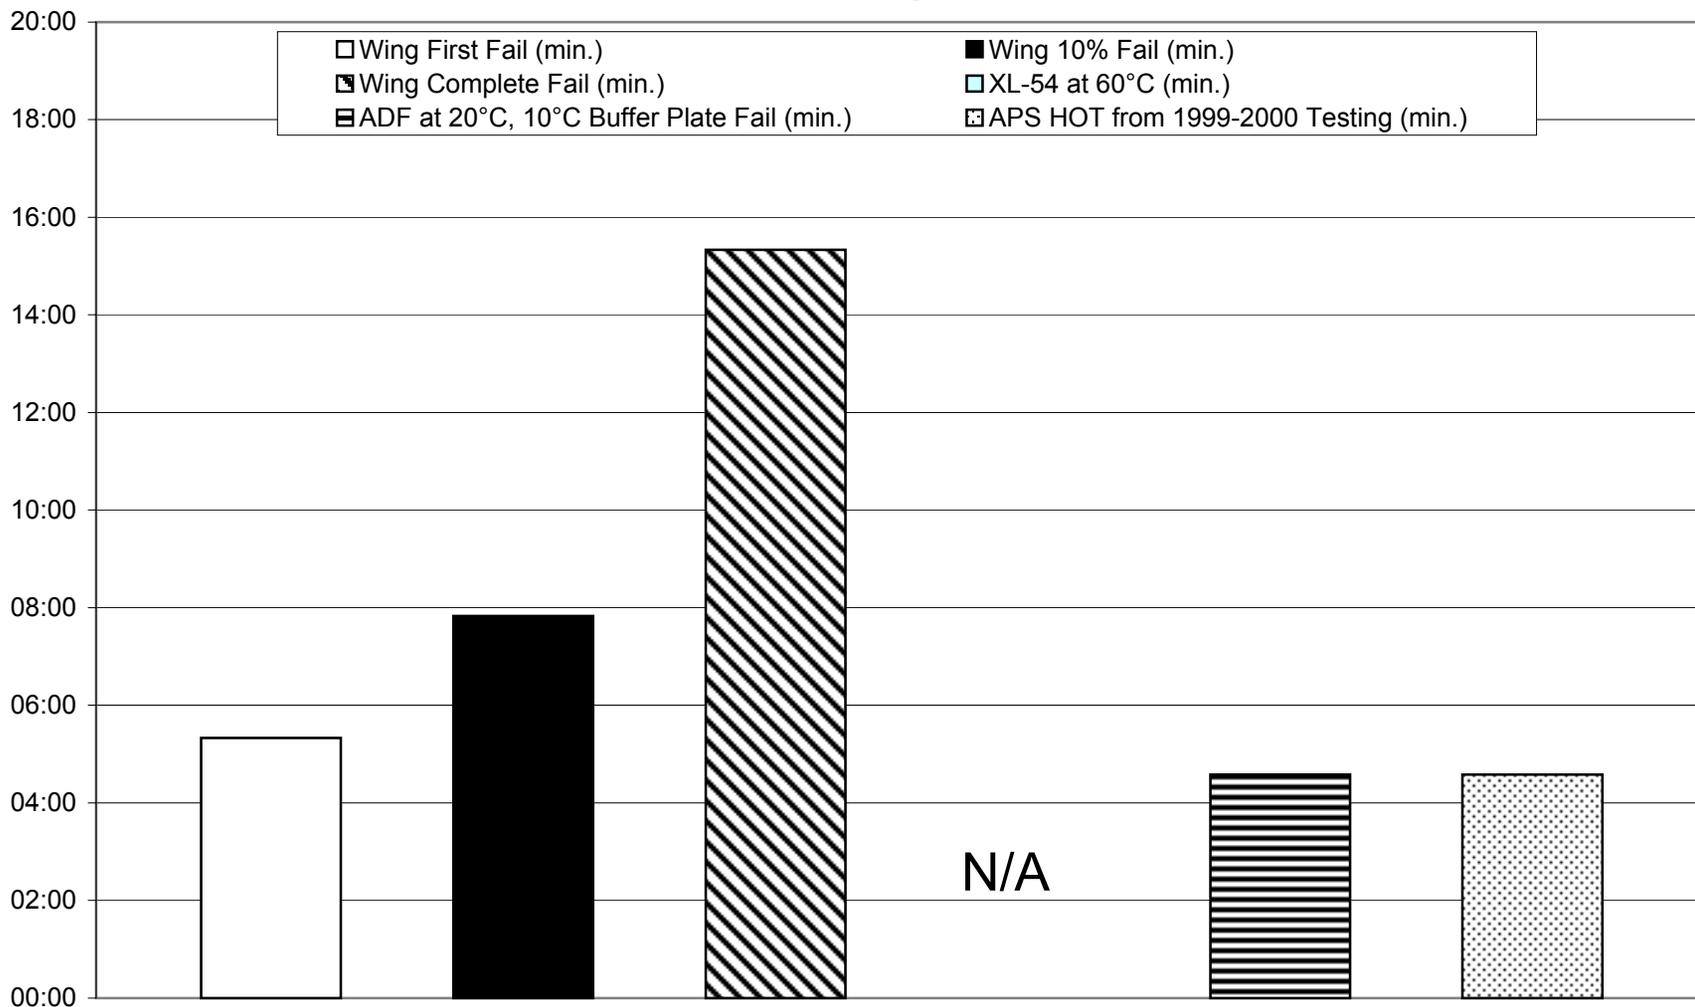
Plate and Wing Failure Times for Run 8

XL54 Fluid, OAT = -6.9°C, Rate = 14.0 g/dm²/hr, Headwind 15 km/h
