Case Study

ICORENE® 1060 (ESF)

Enhanced Surface Finish

Design and outdoor furniture

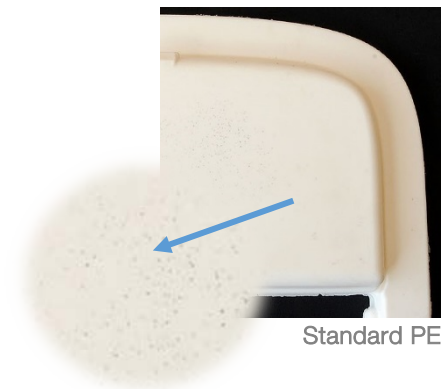
Standard PE

Outdoor furniture is exposed to weathering, dirt and abuse. Rotomoulded PE shows up some imperfections of surface pinholing which traps the dirt and is very hard to remove.

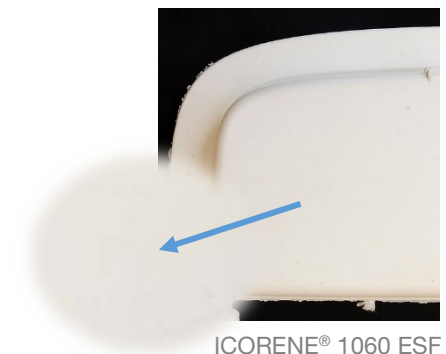
ICORENE® 1060 ESF is specially formulated grade containing an additive that eliminates surface pinholing. When the furniture becomes dirty, the product can be easily cleaned with detergents and water, without leaving dirt particles trapped on the surface.

An enhanced surface finish improves the looks and quality of the moulded furniture for many years.
