Proper BI Placement During VHP Decontamination Cycles

The Packaged BI (HMT-091 series)

The Unpackaged Ribbon BI (SBC-327 series)

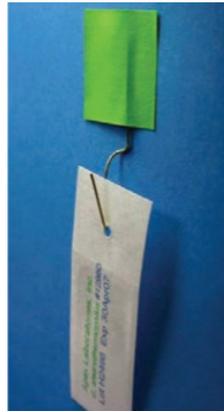
Figure 1. Examples of proper BI configurations when using the hole in the envelope to hang the BI

A hole has been provided in the envelope so the BI can be hung from a fixture on the wall, ceiling or other structure. BI units can be hung individually or in multiples as demonstrated in figure 1. A recent Spore News on the advantages of using replicate BIs at a single location can be found on the Mesa website or by using the following link: <https://biologicalindicators.mesalabs.com/wp-content/uploads/sites/31/2014/07/Spore-News-Vol-9-No4.pdf>

Plastic spacers have been placed on the wire hanger between each BI to ensure proper vapor flow around each BI unit.

When positioning the BIs in the isolator, the printed side should always face towards the vapor flow, and at no time should it be obstructed. Ideally the BI should be positioned so that the flow of vapor can pass by both sides of the envelope.

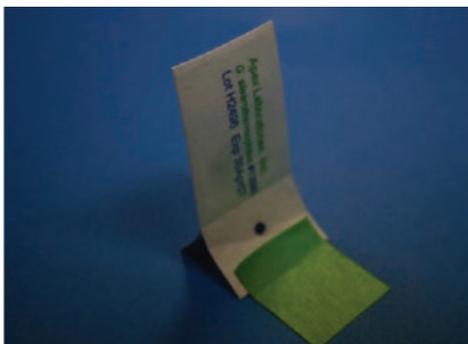
Figure 2. Examples of proper BI configurations when using adhesive tape to position the BI

An adhesive tape can also be used to fix BIs into place. The best practice here is to place the tape on the peel flaps of the envelope and then secure it to the surface being monitored, as illustrated in figure 2. Care must be taken not to cover the pocket of the envelope with the tape which would obstruct the vapor flow, as illustrated in figure 3.

Note: Not all adhesive tapes are equal. Tape that absorbs or catalyzes hydrogen peroxide should not be used. Additionally, tape that leaves a residual behind once it is removed should be avoided.

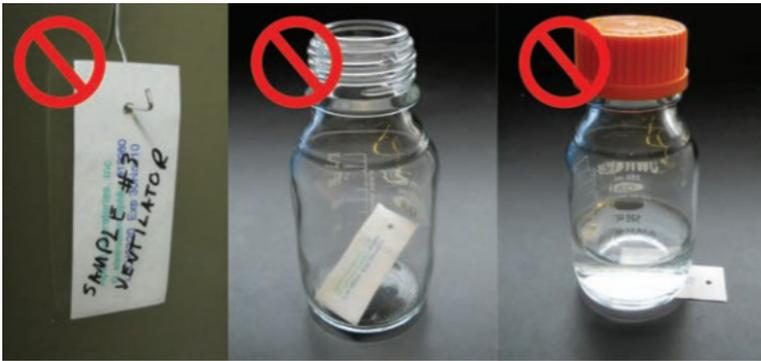
Figure 4. Examples of IMPROPER BI use: writing on the face of the package, and placing BI into or underneath a container.

Another common practice, especially when using a large number BIs, is to write identifying marks on each BI. These marks help identify the location in which the BI was placed as demonstrated in the first photograph in figure 4. As is the case with the tape, placing marks on the pocket of the envelope should be avoided. Certain types of ink may also catalyze hydrogen peroxide and should be avoided completely. Due to poor vapor flow, placing BIs into or underneath bottles (figure 4) or other containers is not recommended.

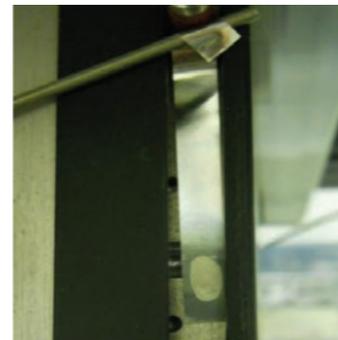
Figure 6. Examples of ribbon BIs in dead leg (left photograph) and hanging on isolator fixture (right photograph)

Dead legs in an isolator are certainly areas of concern and should be eliminated or minimized. The ribbon can be useful in these cases in identifying the gas penetration down dead legs. The inoculated area can be placed into the area of concern, and if sufficient vapor flow occurs through this restriction, the spores on the BI will be inactivated. However, if the result after culturing the BI is “growth”, then it is fair to assume that inadequate vapor flow is occurring and the area is a true dead leg. See Figure 6.

An advantage of this BI is that the inoculated area of the ribbon can be placed into locations where the disc BI cannot physically fit, including restricted areas where the vapor penetration may be in question.
