# PDI-750BS

## Hospital Grade Individual Power Supply

MODEL NUMBER: <b>PDI-750BS</b>	Document Number: PD196-054R3
	SERVICE MANUAL	Page 4 of 4

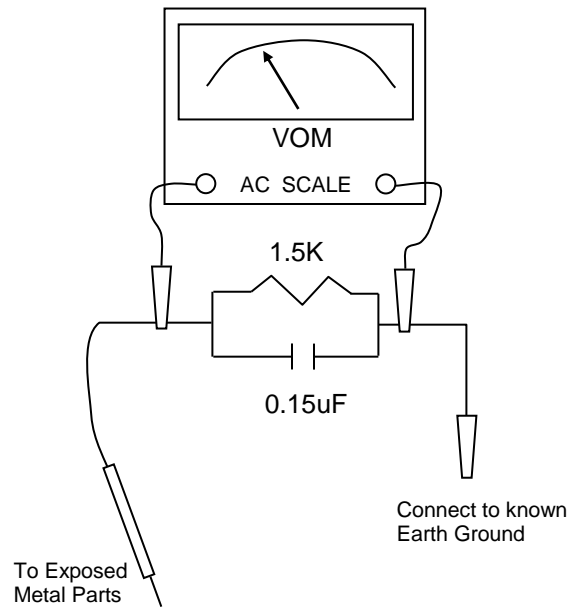
6. After re-assembly of the power supply, always perform AC leakage current tests on all exposed metallic parts and the cabinet. Do not make any connection to the "RF IN" connector. Do not use a line isolation transformer during this test. Place a ground adapter on the power supply's AC plug, but leave the adapter ground floating (ungrounded). Use an AC voltmeter, having 5000 ohms per volt or more sensitivity, in the following manner: connect a 1500 ohm 10 watt resistor, paralleled by a 0.15mfd, 150VAC type capacitor between a known good earth ground (water pipe, conduit, etc.) and the exposed metallic parts, one at a time. Measure the AC voltage across the combination of a 1500 ohm resistor and 0.15mfd capacitor. Reverse the power supply AC adapter plug and repeat AC voltage measurements for each exposed metallic part. Voltage measurements must not exceed 0.15 volts RMS. This corresponds to 0.100 milliamps of AC current. Any value exceeding this limit constitutes a potential shock hazard and must be corrected immediately before returning the power supply to service.
