PDI-E42LEDA
Modular High Definition
Healthcare-grade LED Television

Document Number: PD196-278R3

Service Manual

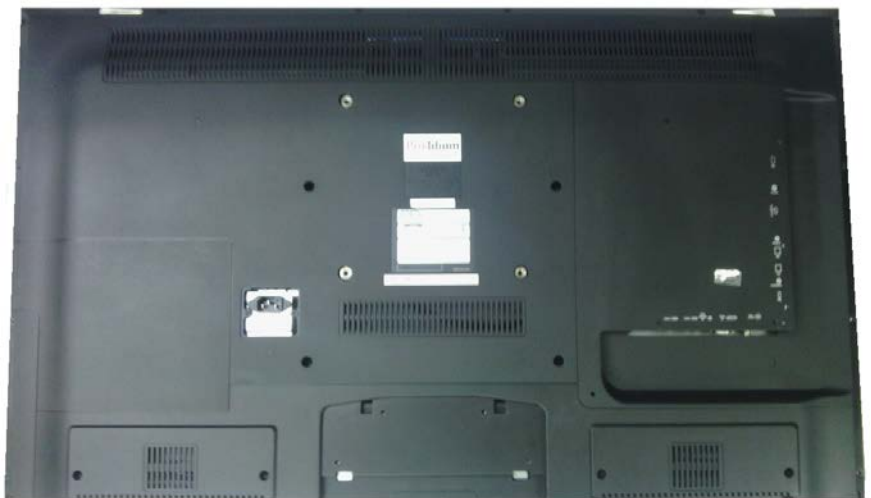
Back Cover

1. Remove 27 screws from the back cover.
2. Lift back cover and remove, being careful of tabs and cable connections.
