API 653 good practices for insulated storage tanks

NISTM
National Institute For Storage Tank Management

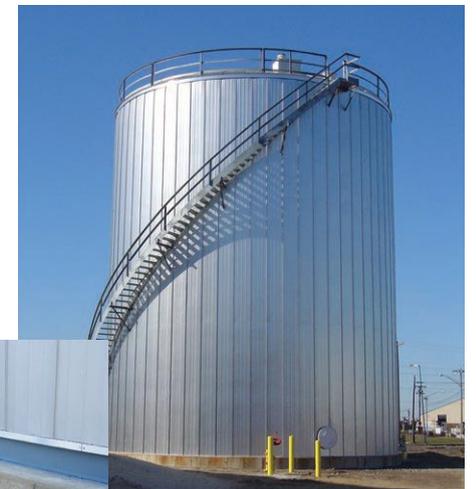
Insulation support system.

Insulation support systems are available that will provide a solid foundation for the insulation panels to rest upon. Support systems can be adapted to go around the tank's apertures and will be wide enough to accommodate the current thickness of the existing insulation panels. The solution is provided by a simple weld procedure that attaches angle clips to the tank. Care must be taken because the support system is rigid and will not allow flex or sag. Issues have arisen when this system was installed utilizing flat steel that flexed and crushed the shell jacketing due to the down forces and weight of the insulation.

work permit that allows hand or electric tool utilization for cutting the existing shell panels. The support system is then bolted together as it is installed around the tank base. It is fast, simple and no welding is required.

A nonwelding version of the insulation support system that enables the tank to stay in service is also available. Installation of this system can be completed with a low-risk hot
