2017 Audi A3/ A3 E-Tron/S3/RS3

Weak Key Fob - Failure to Recognize

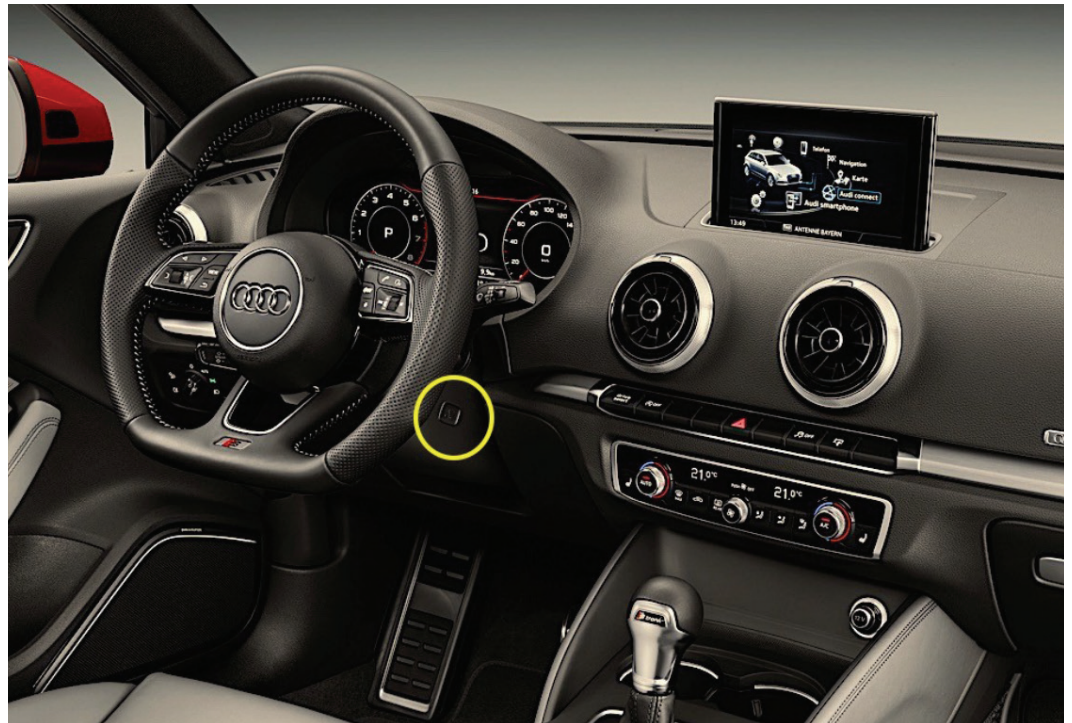
When an Audi proximity key fob battery becomes weak, the vehicle may have difficulty acknowledging its presence and not start.

Holding the fob near the designated area will aid in starting the vehicle.

The designated area in this model is on the right side of the steering column.

Immediately replace the weak key fob battery.

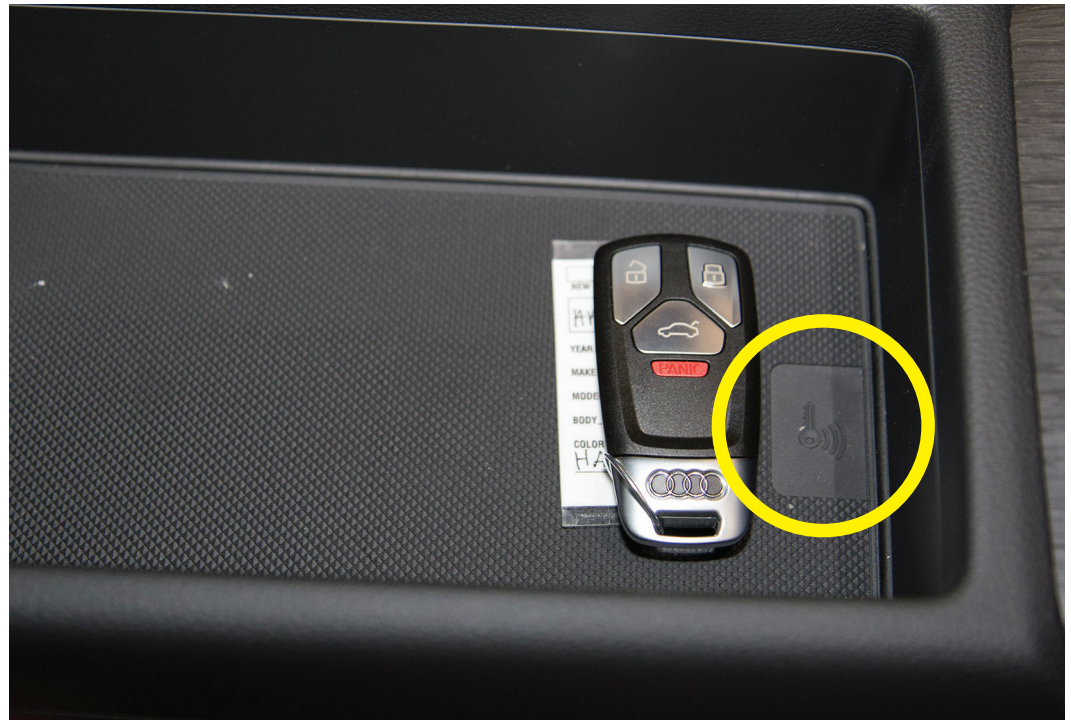
2017 Audi A4/S4/ A4 Allroad

When an Audi proximity key fob battery becomes weak, the vehicle may have difficulty acknowledging its presence and not start.

Holding the fob near the designated area will aid in starting the vehicle.

The designated area in this model is in the center console.

Immediately replace the weak key fob battery.

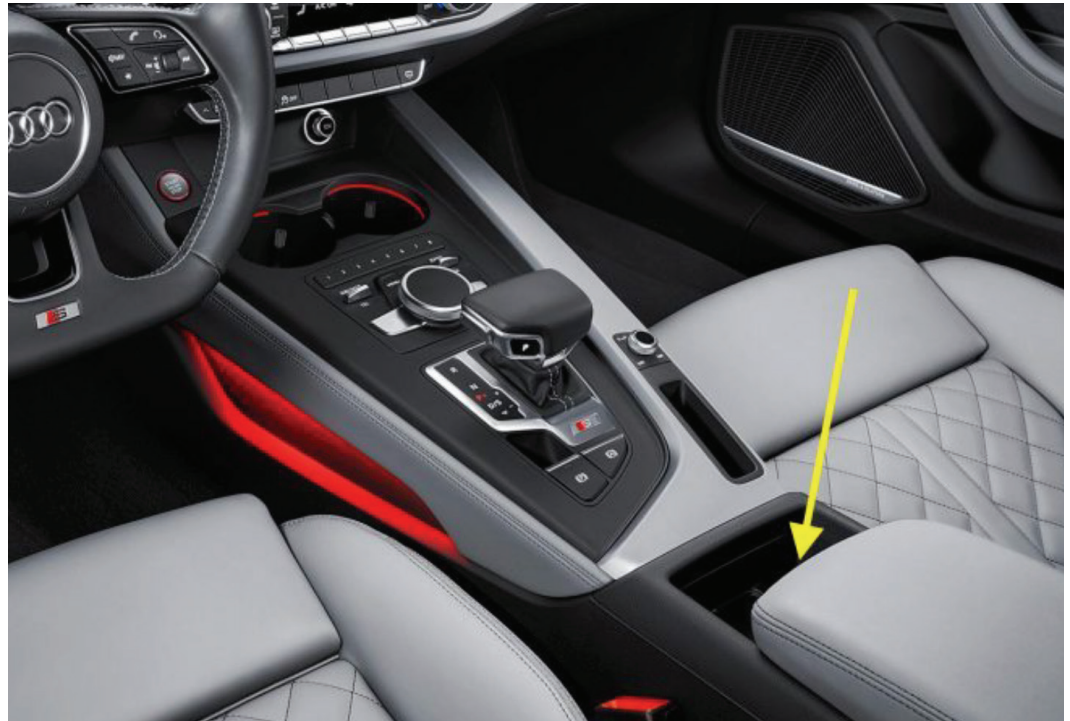
2017 Audi A5/S5

When an Audi proximity key fob battery becomes weak, the vehicle may have difficulty acknowledging its presence and not start.

Holding the fob near the designated area will aid in starting the vehicle.

The designated area in this model is in the cup holder.

Immediately replace the weak key fob battery.

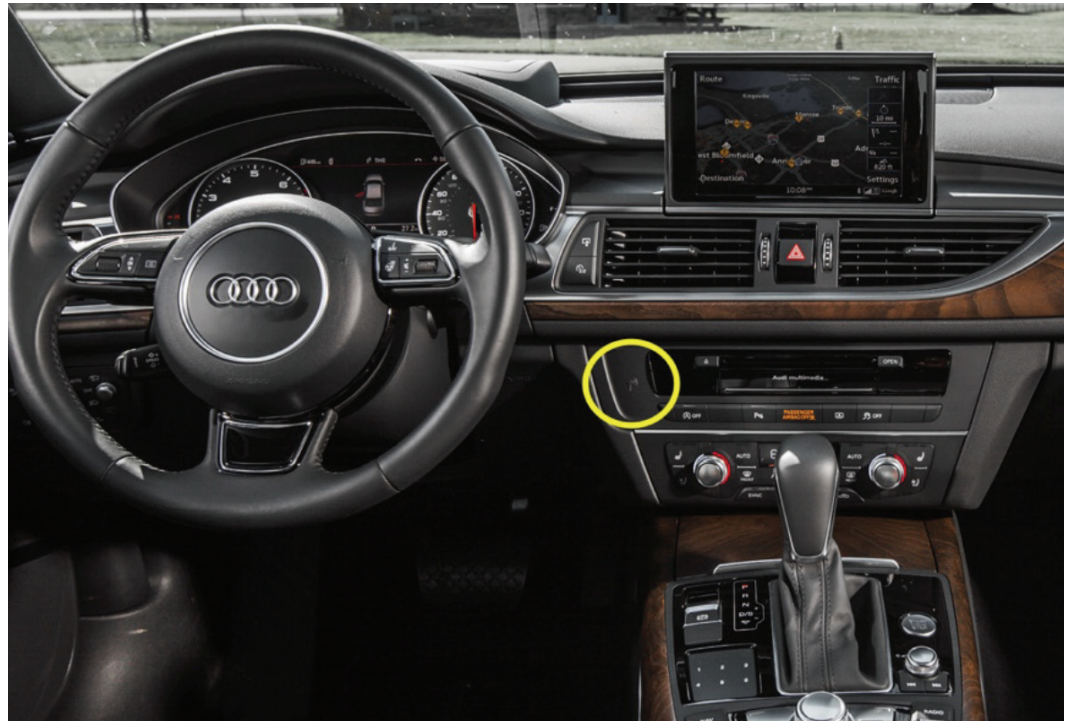
2017 Audi A6/S6

When an Audi proximity key fob battery becomes weak, the vehicle may have difficulty acknowledging its presence and not start.

Holding the fob near the designated area will aid in starting the vehicle.

The designated area in this model is on the dash next to the multimedia player.

Immediately replace the weak key fob battery.

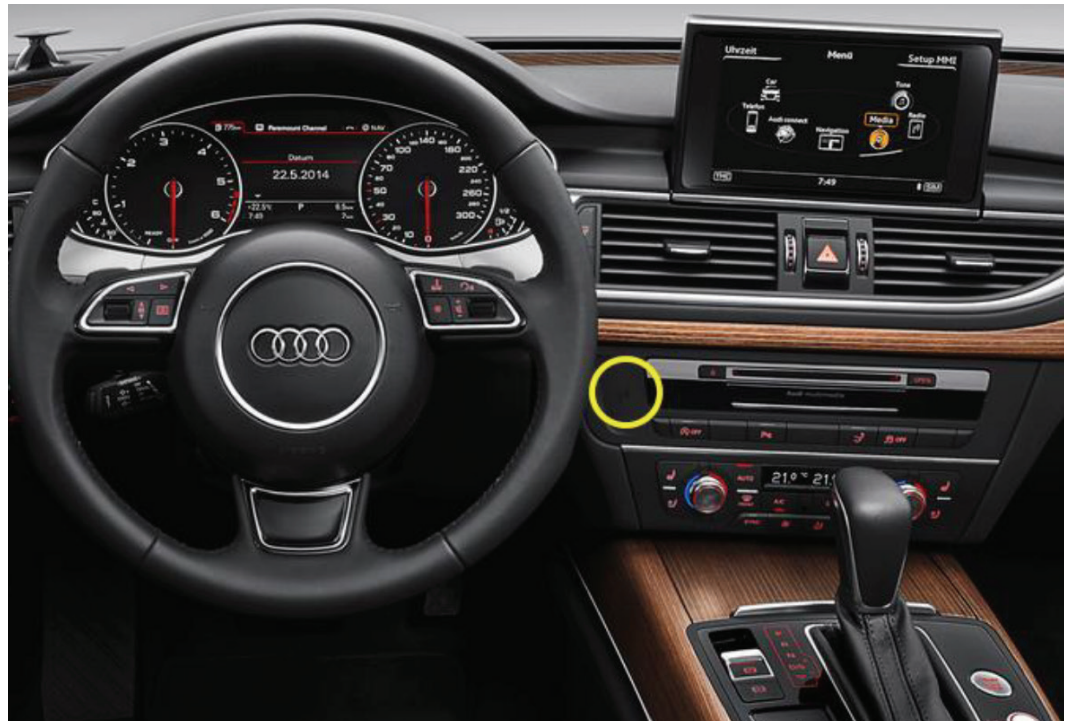
2017 Audi A7/S7/RS7

When an Audi proximity key fob battery becomes weak, the vehicle may have difficulty acknowledging its presence and not start.

Holding the fob near the designated area will aid in starting the vehicle.

The designated area in this model is on the dash next to the multimedia player.

Immediately replace the weak key fob battery.

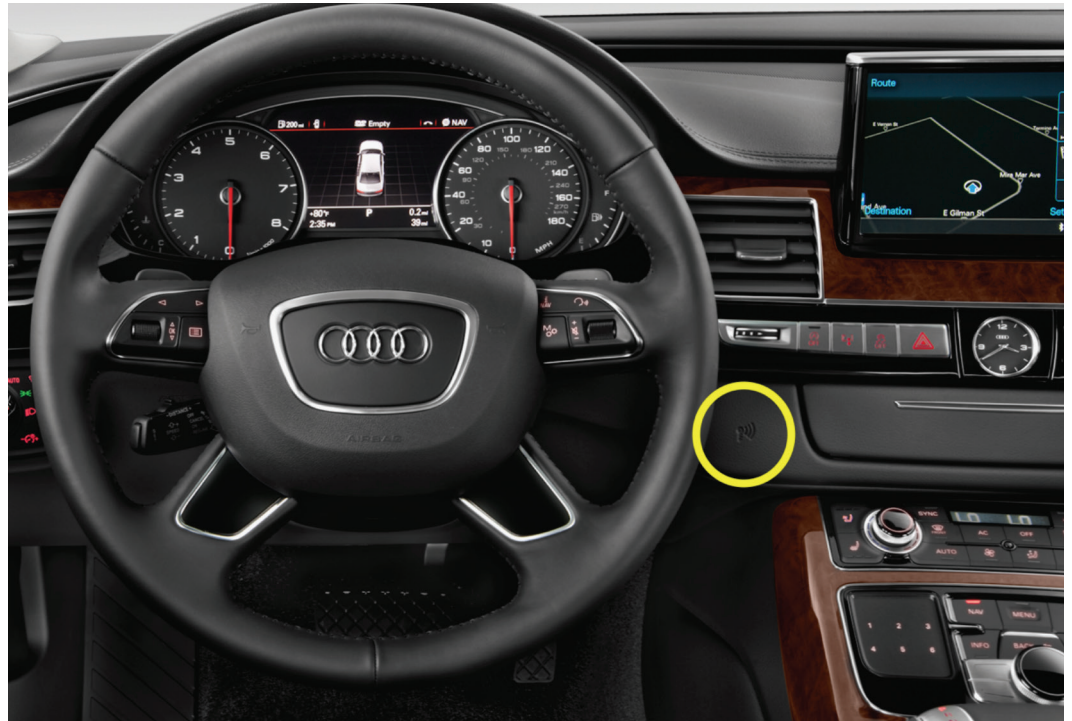
2017 Audi A8/S8

When an Audi proximity key fob battery becomes weak, the vehicle may have difficulty acknowledging its presence and not start.

Holding the fob near the designated area will aid in starting the vehicle.

The designated area in this model is on the dash.

Immediately replace the weak key fob battery.

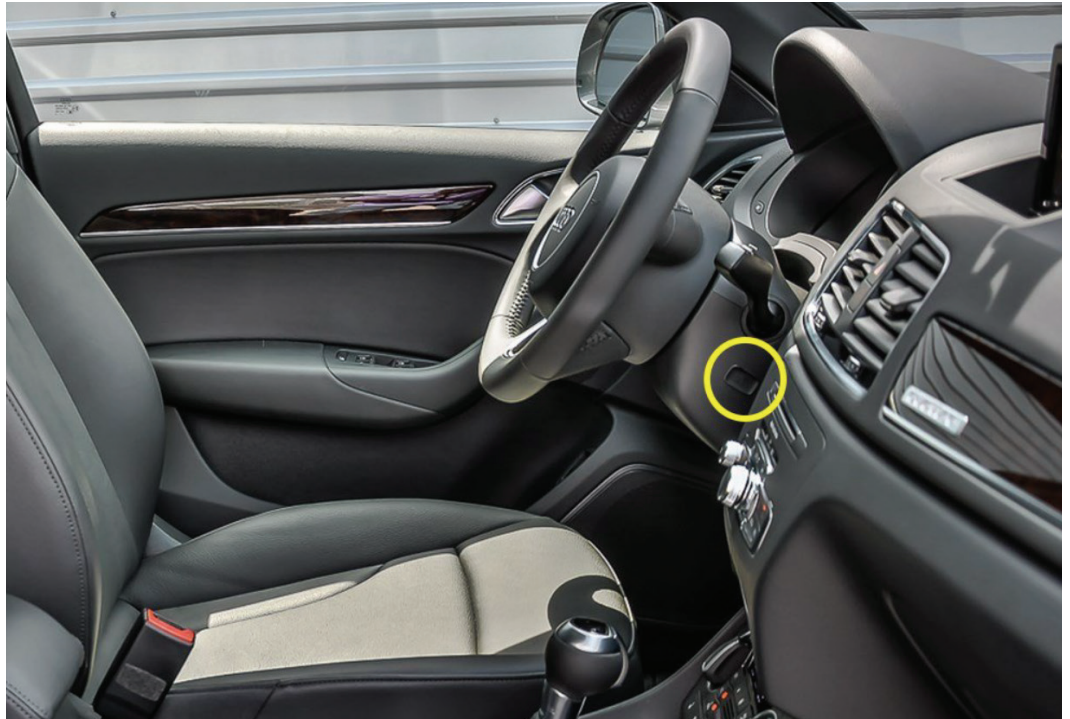
2017 Audi Q3

When an Audi proximity key fob battery becomes weak, the vehicle may have difficulty acknowledging its presence and not start.

Holding the fob near the designated area will aid in starting the vehicle.

The designated area in this model is on the right side of the steering column.

Immediately replace the weak key fob battery.

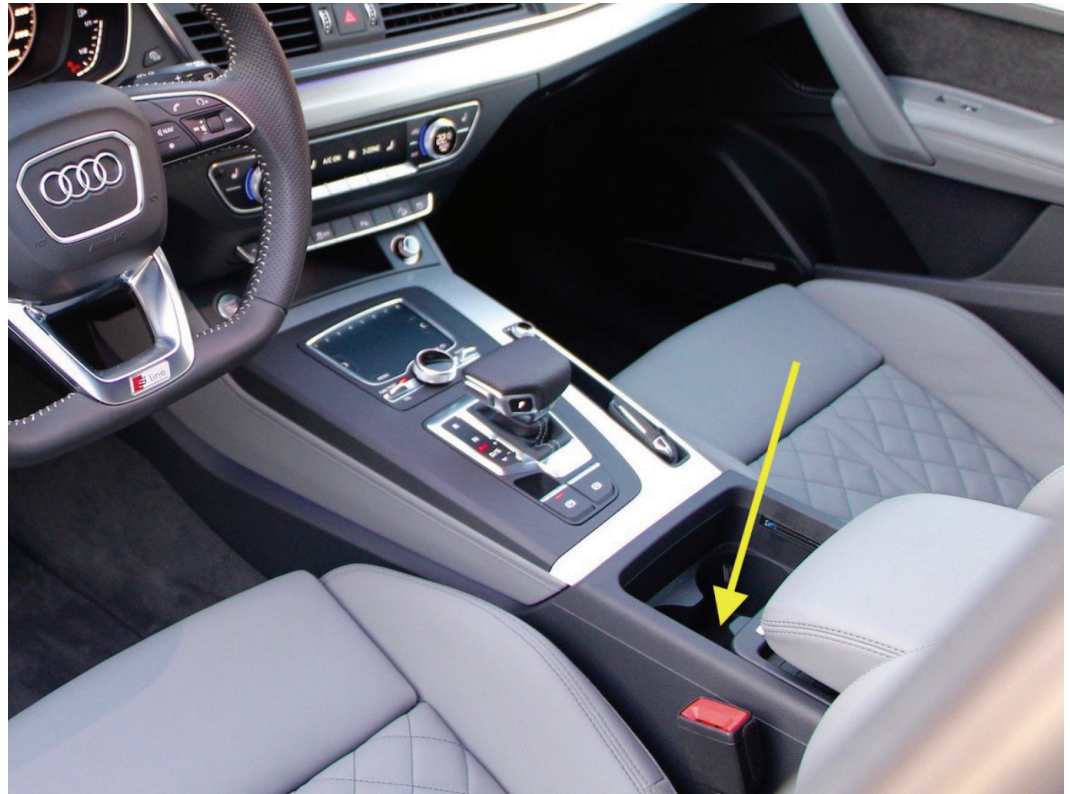
2017 Audi Q5

When an Audi proximity key fob battery becomes weak, the vehicle may have difficulty acknowledging its presence and not start.

Holding the fob near the designated area will aid in starting the vehicle.

The designated area in this model is in the cup holder.

Immediately replace the weak key fob battery.

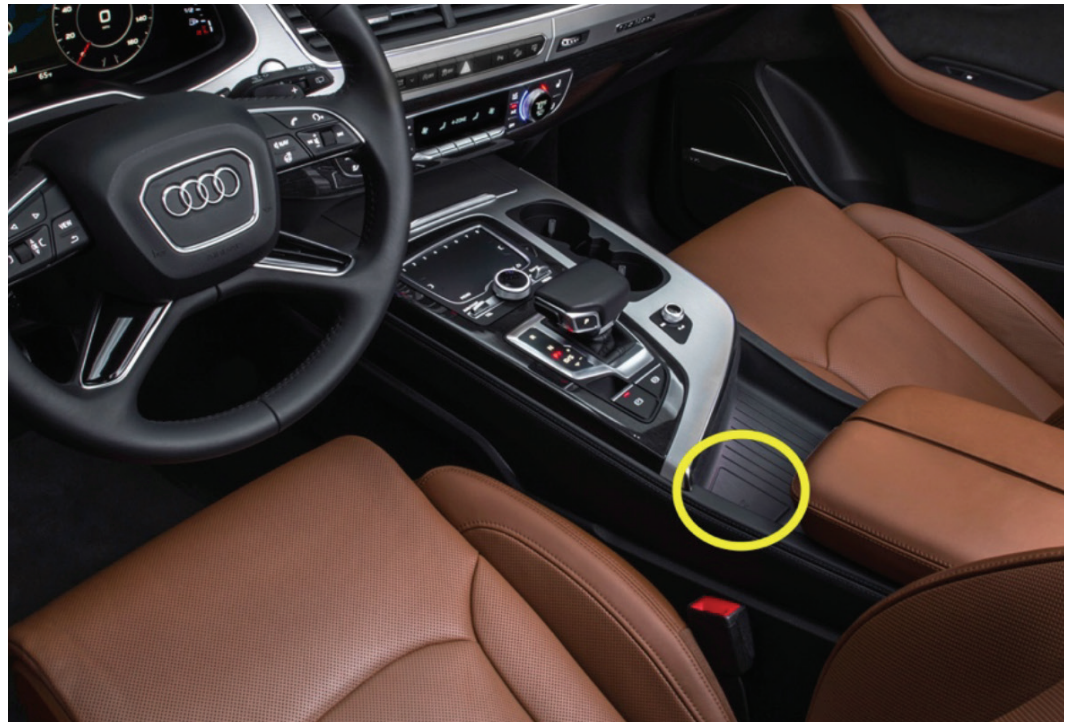
2017 Audi Q7

When an Audi proximity key fob battery becomes weak, the vehicle may have difficulty acknowledging its presence and not start.

Holding the fob near the designated area will aid in starting the vehicle.

The designated area in this model is in the center console.

Immediately replace the weak key fob battery.

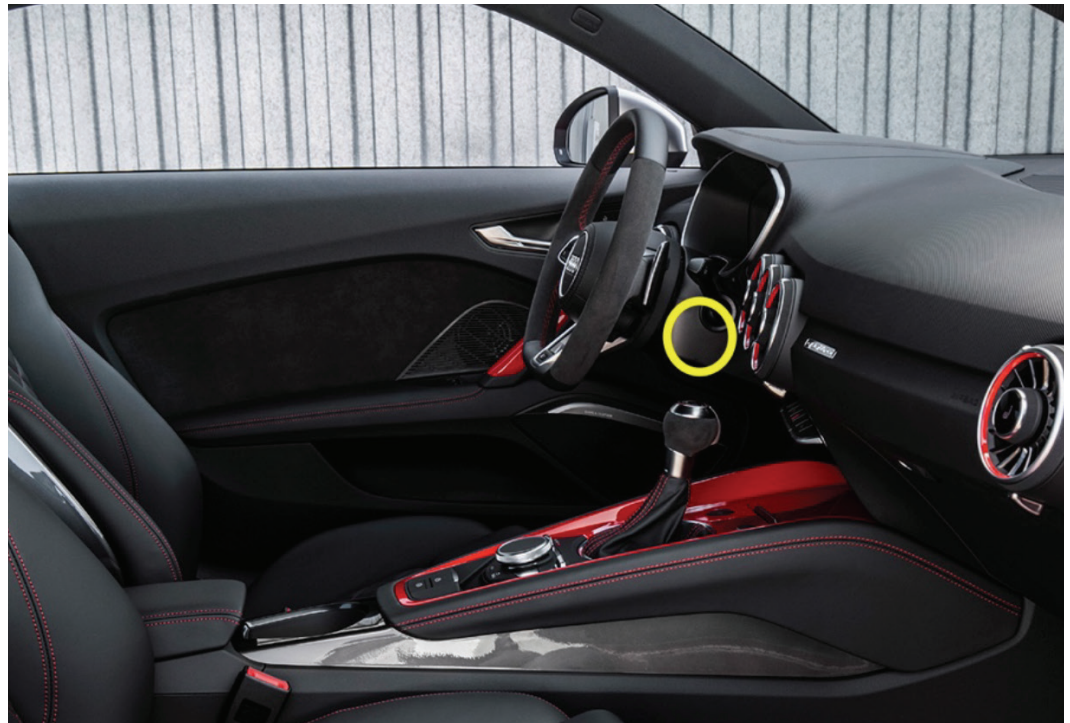
2017 Audi TT - All Variants

When an Audi proximity key fob battery becomes weak, the vehicle may have difficulty acknowledging its presence and not start.

Holding the fob near the designated area will aid in starting the vehicle.

The designated area in this model is on the right side of the steering column.

Immediately replace the weak key fob battery.
