ClearView Imaging's Label Inspection System

CASE STUDY
Food and Beverage Production | Label Inspection

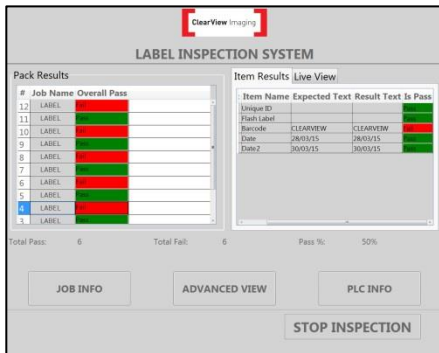
Figure 1: Screenshot of the inspection system working in real time

The Vision System is integrated into the production line. As a pack moves into the camera's field of view (FOV), this triggers the system to capture an image of the pack. Our system uses a Line Scan camera, which is particularly useful in an application such as this as it allows the system to easily accommodate various sizes of packages. A rotary encoder also allows the system to automatically compensate for varying conveyor speeds. This is essential for any single production line which processes multiple packs.

Signals are then sent to a PLC (programmable logic computer) to indicate either a 'pass' or a 'fail'. Defective goods are then sent to the reject bin by way of the PLC.

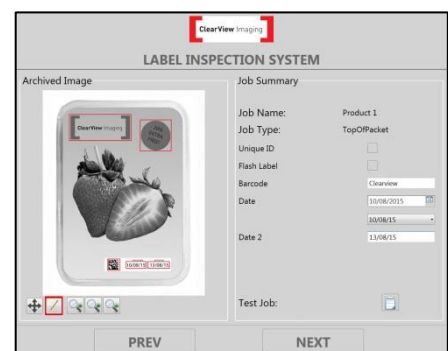
Figure 2: The wizard based software makes it easy to alter and add job variables

The system's Graphical User Interface (GUI) is particularly intuitive and easy to use. Users can write their own recipes (jobs) using a wizard based approach, making it easy to select different job variables and then later edit these variables on an existing set up. Many variables can be implemented, allowing for the users changing needs. Supported variables include items such as date, price, bar code and label placement, with many more also available.
