Repairs Summary

List of All Repairs

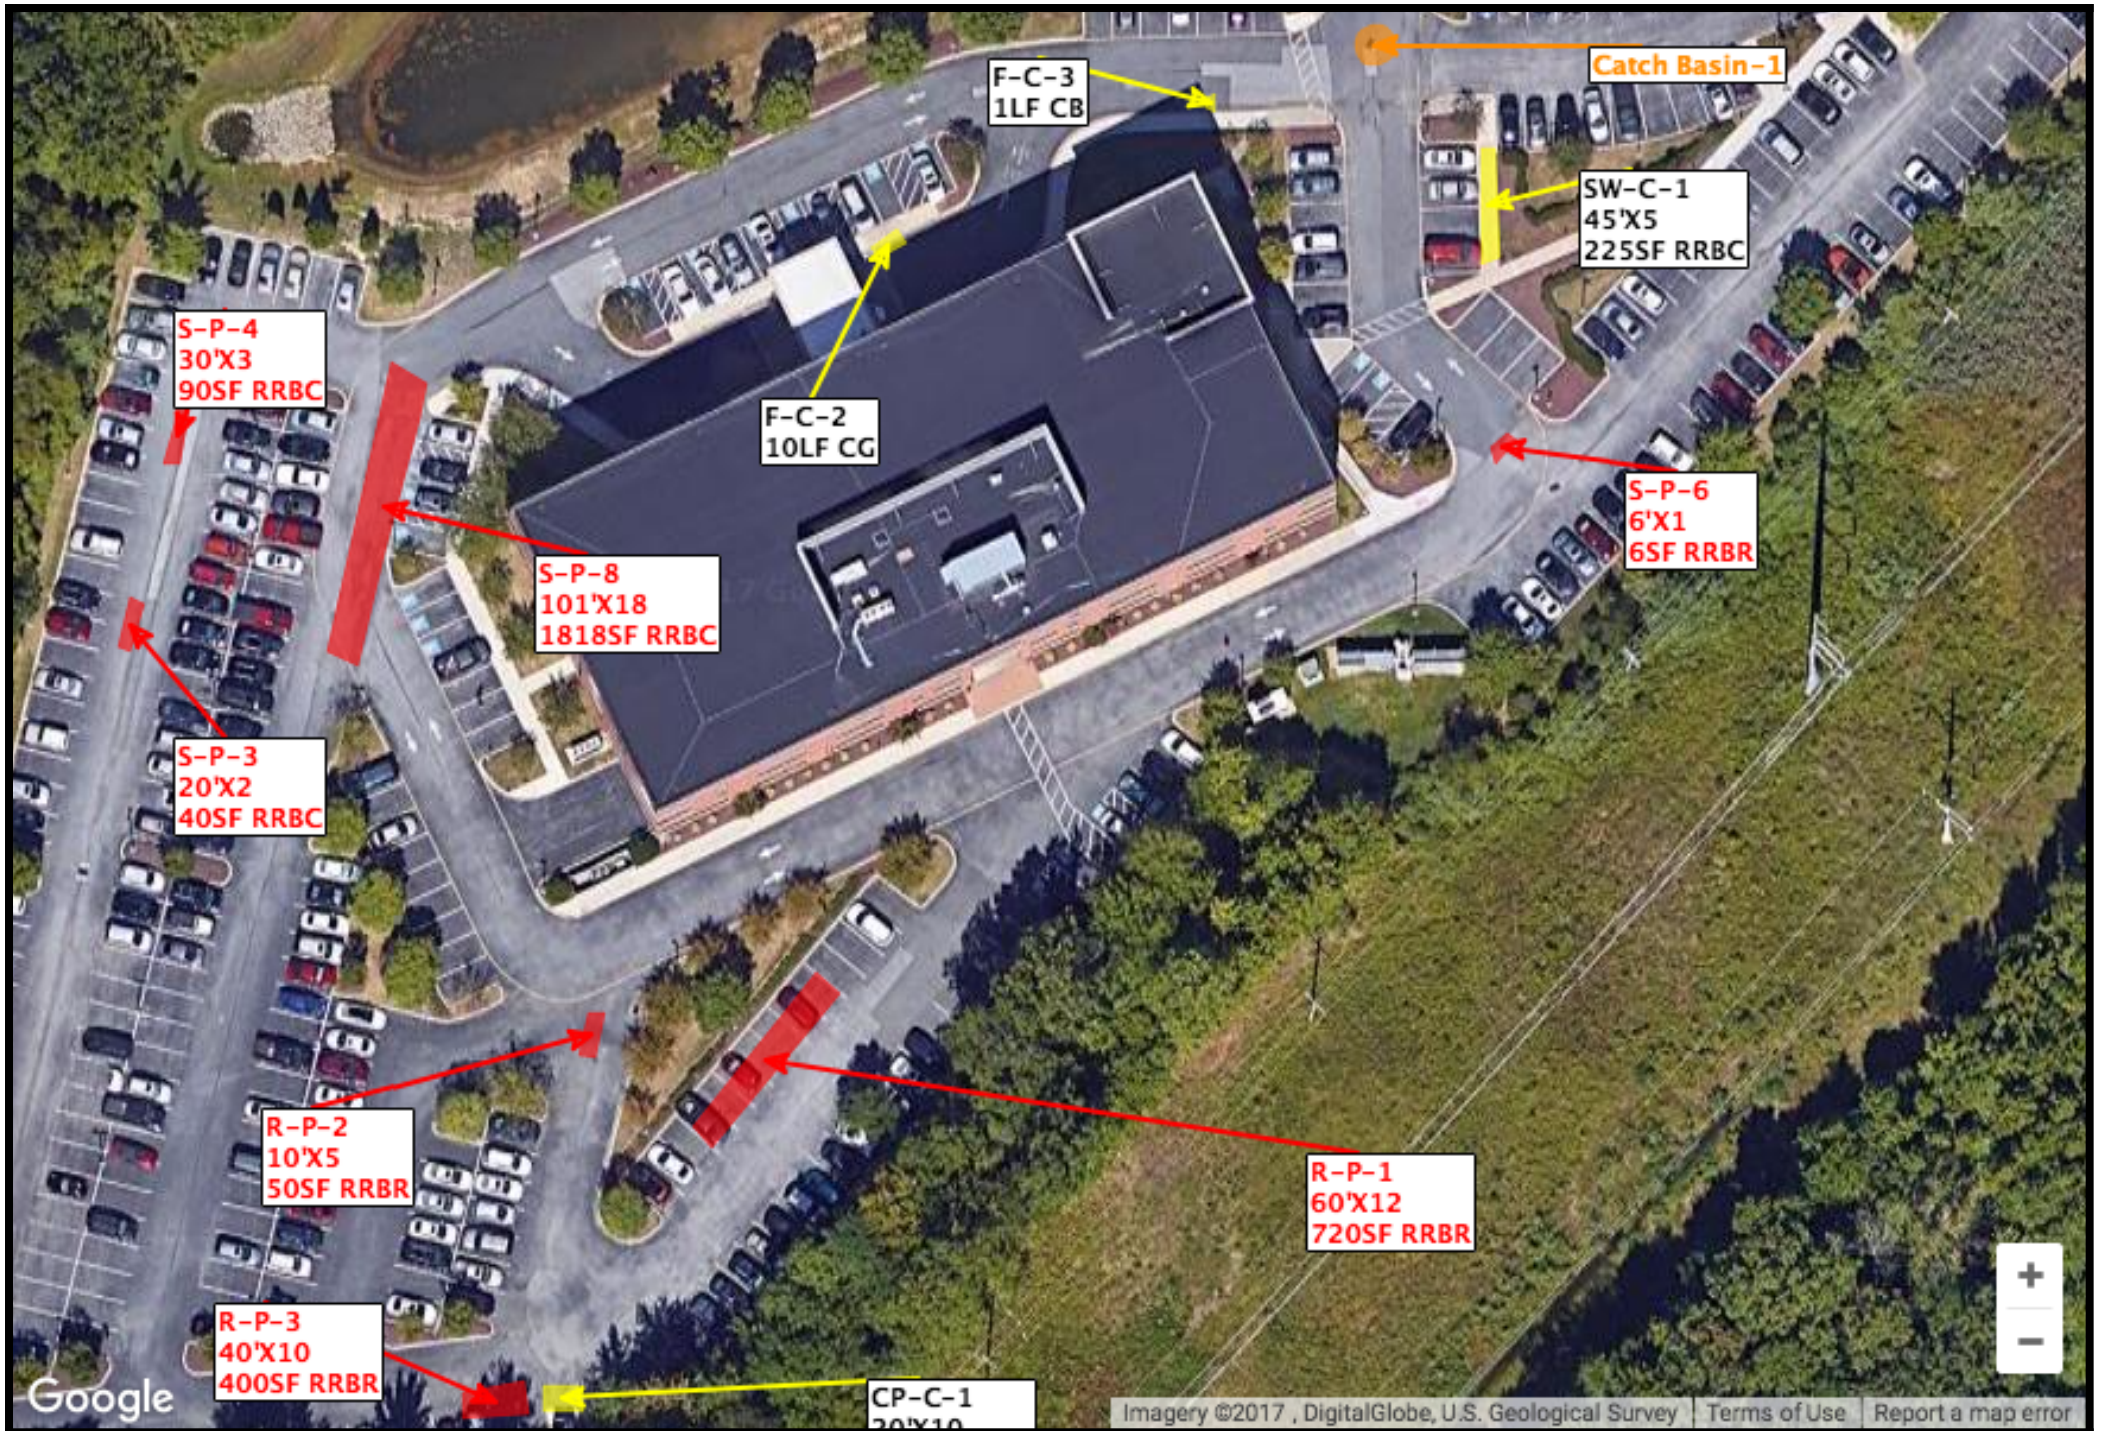
S-P-4
30'X3
90SF RRBC

S-P-3
20'X2
40SF RRBC

S-P-8
101'X18
1818SF RRBC

R-P-2
10'X5
50SF RRBR

R-P-3
40'X10
400SF RRBR

F-C-3
1LF CB

F-C-2
10LF CG

CP-C-1
20'X10

Catch Basin-1

SW-C-1
45'X5
225SF RRBC

S-P-6
6'X1
6SF RRBR

R-P-1
60'X12
720SF RRBR

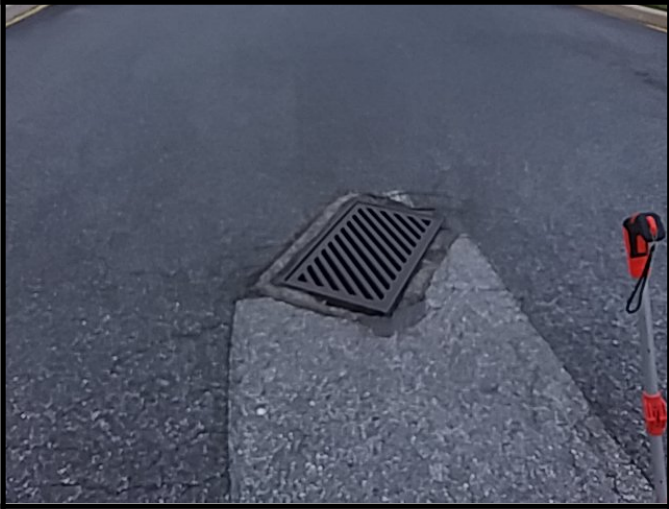
REPAIR# Catch Basin-1

Measurement: 1 Unit

Notes: Deteriorated catch basin

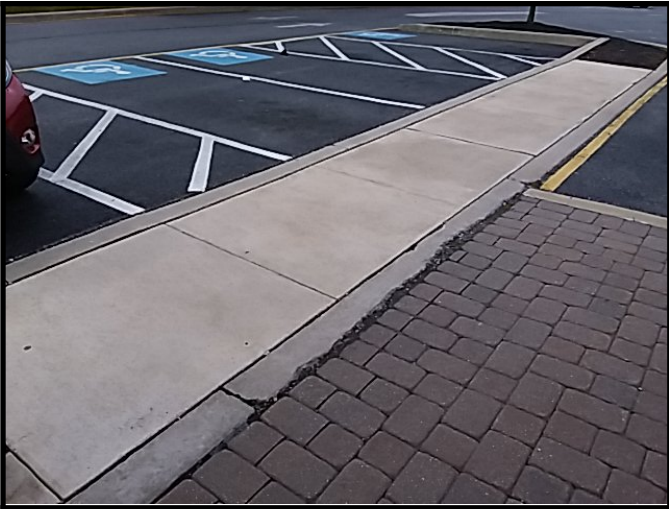
REPAIR# F-C-2

Notes: ADA violation. Path of travel has tripping hazard

Location: F-Front Drive, Material: C-Concrete, Type: CG-Curb & Gutter
Measurement: 10 Linear Ft.

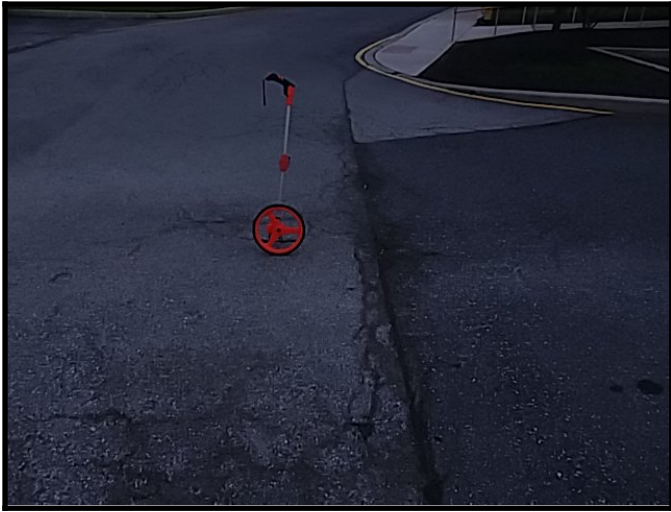
REPAIR# S-P-6

Measurement: 6 Square Ft.

Length: 6', Width: 1'

Location: S-Side Lot, Material: P-Asphalt, Type: RRBR-Remove & Replace with Base Replacement
