MOONEY AIRCRAFT INC

~~SERVICE BULLETIN NO. 20-5~~
SERVICE BULLETIN M 20-5

SUBJECT: Relief Of Brake Pedals

MODELS AFFECTED: M-20 Serial No. 1002 thru 1020

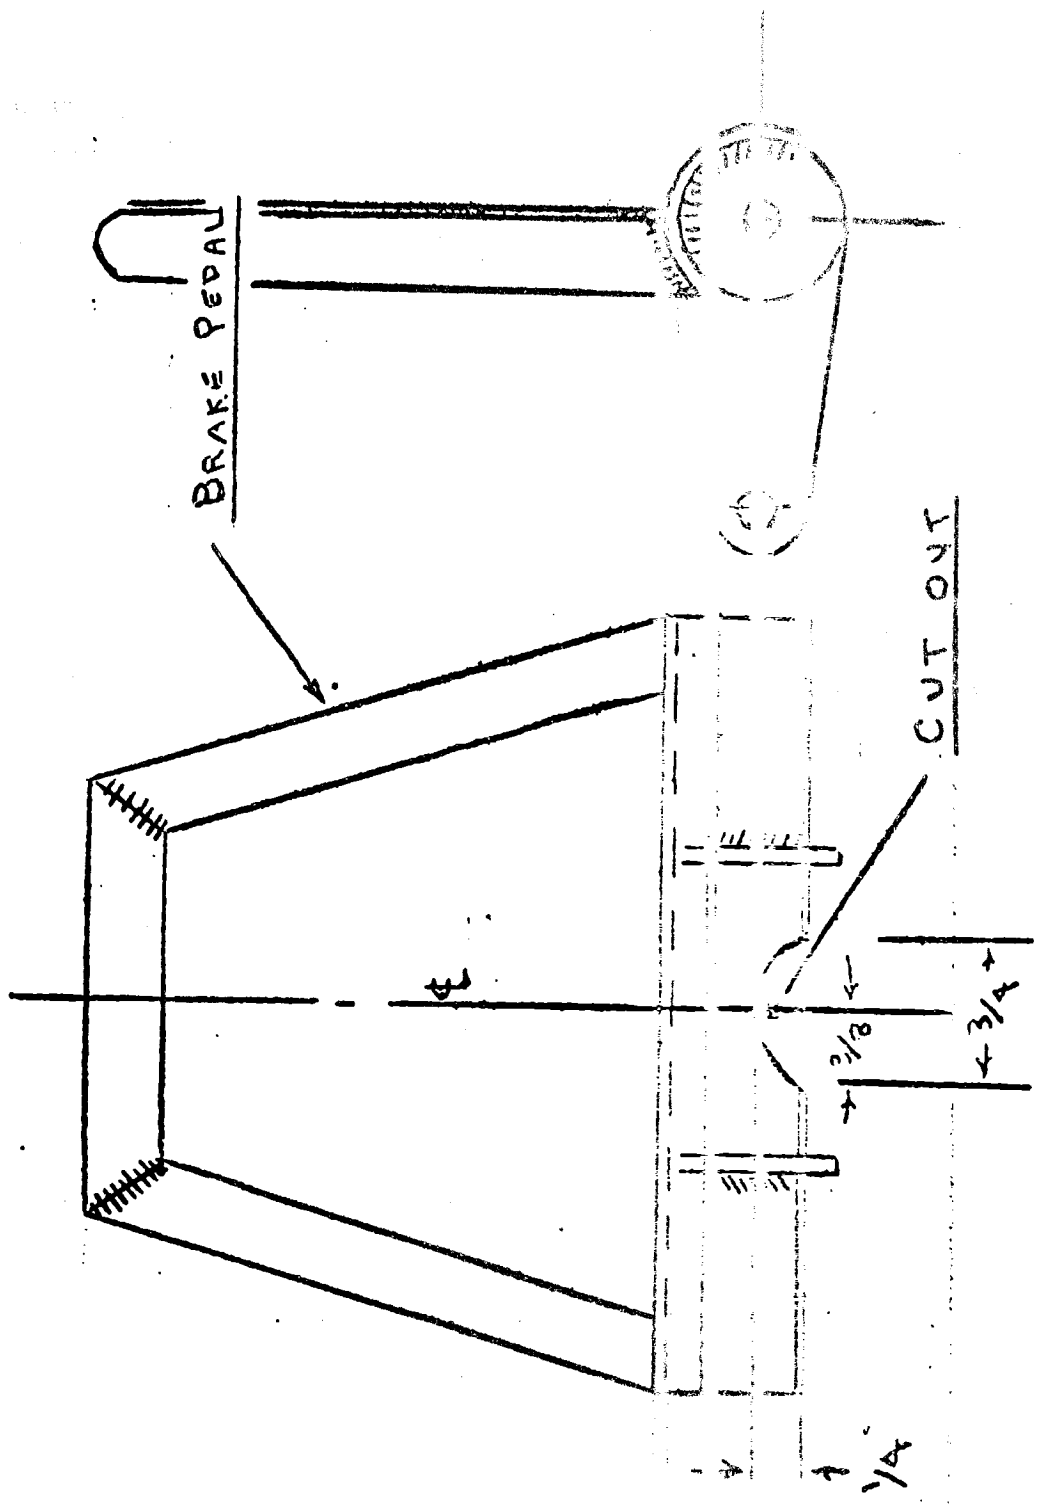
FIG 1

On the models affect it has been found that in some cases upon application of full left or right rudder the brake, on the side where the rudder is applied, will lock. This situation will be eliminated if a relief cut out is made in the lower part of the brake pedals as shown in figure 1.
