SUBJECT: Retrofit - Indicator Visual Fuel Level

MODELS AFFECTED: M20F, S/N 670001-670073

SERVICE BULLETIN M20-156

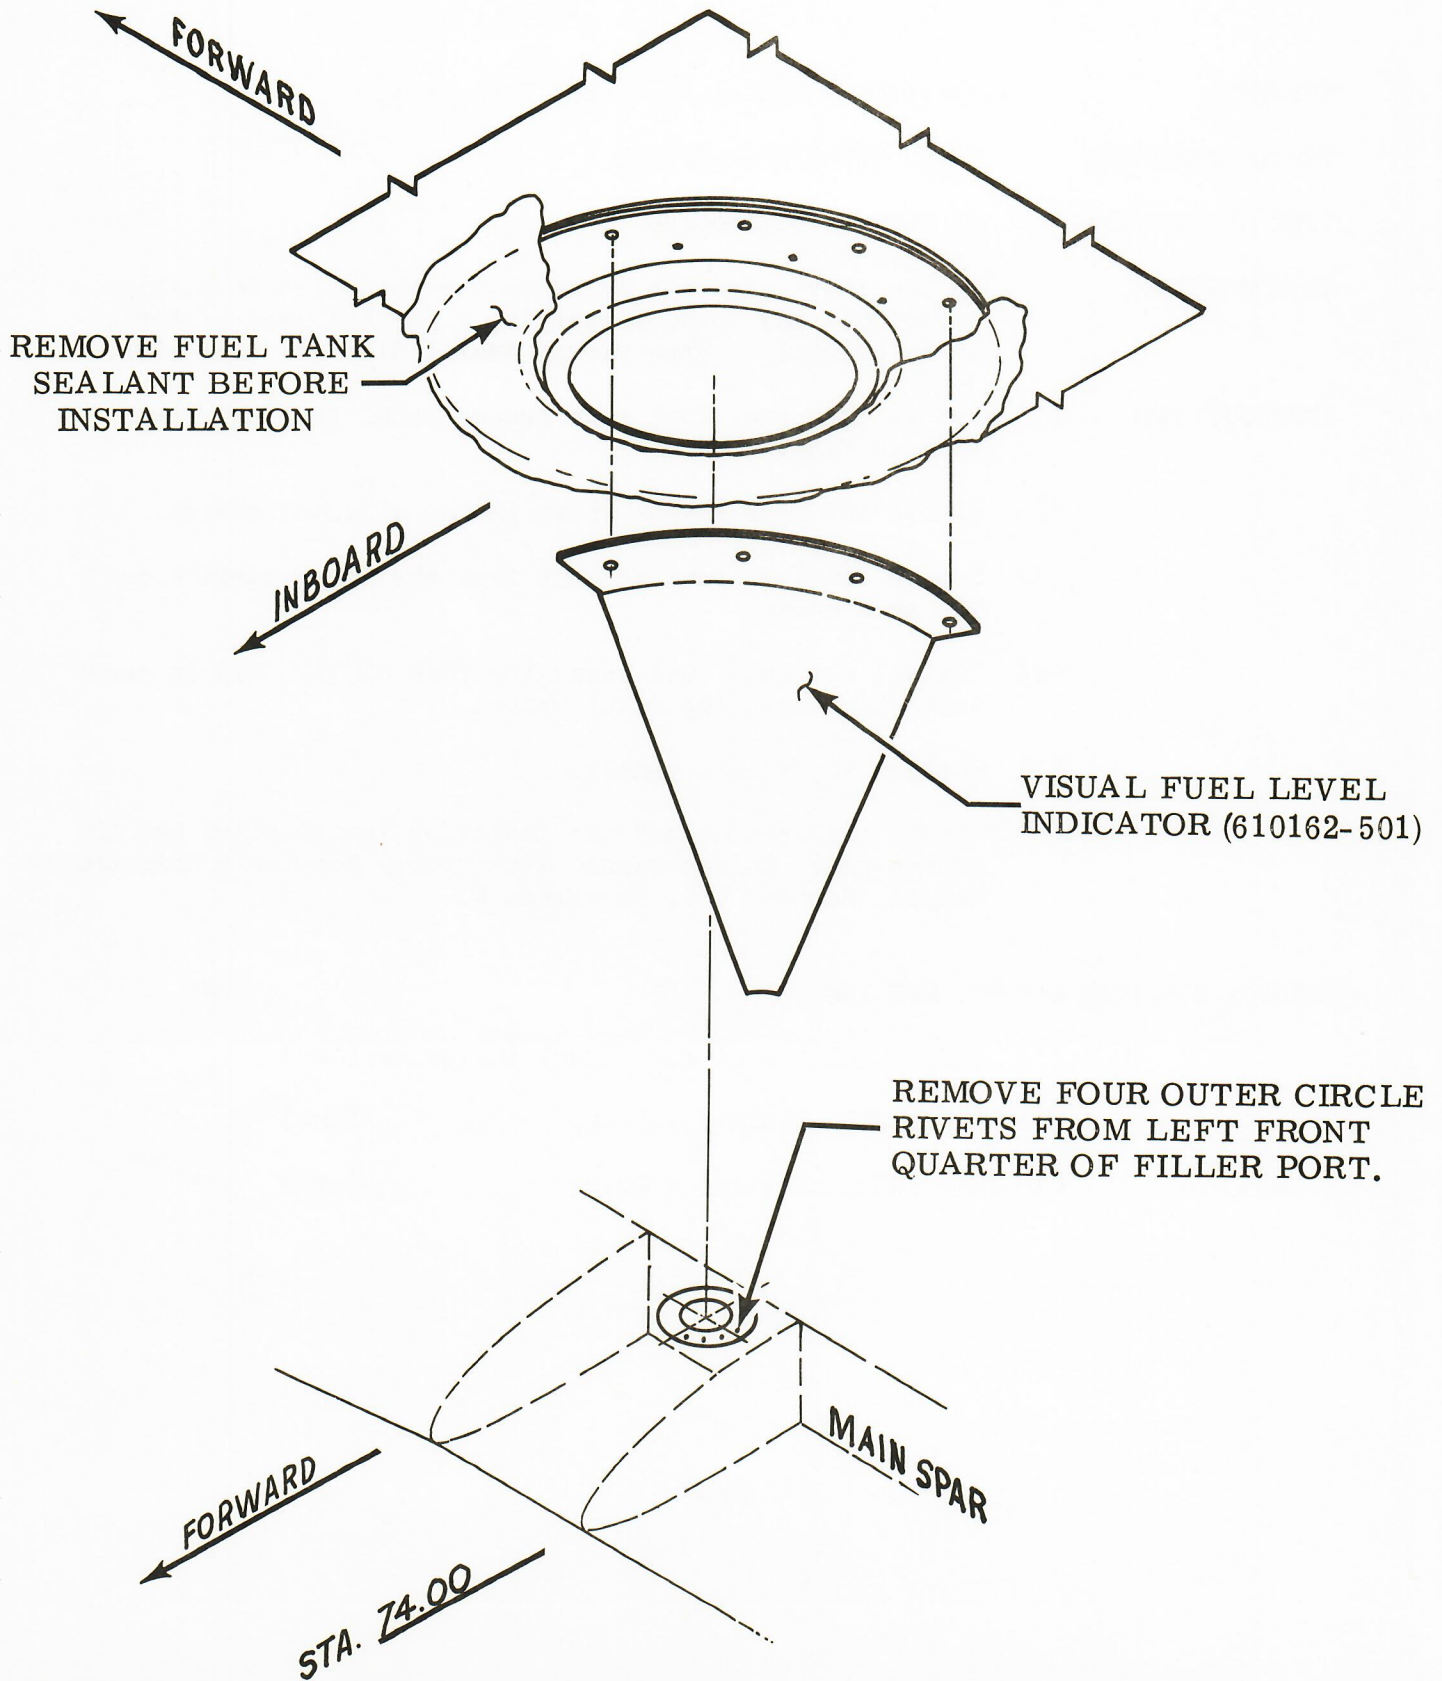
- (1) Remove the outer fuel tank access panel from the lower wing surface.
- (2) Remove the four rivets shown in the attached sketch.
- (3) Remove the fuel tank sealant from the inner surface in the area shown.
- (4) Install a visual fuel indicator (P/N 610162-501) in each tank using existing rivet holes.
- (5) Replace the access panels.
- (6) Reseal the area around the indicator installation and the access panel in accordance with Mooney Service & Maintenance Manual, Section VII, Paragraph E.
