**SUBJECT:** ALTERNATE AIR DOOR ASSEMBLY DUCT  
MODIFICATION, P/N 600378-503

**MODELS/  
SERIAL NUMBERS  
AFFECTED:** M20K - S/N 25-0265 thru 25-0420 and ALL aircraft  
that have had the alternate air duct  
assembly replaced since October, 1979.

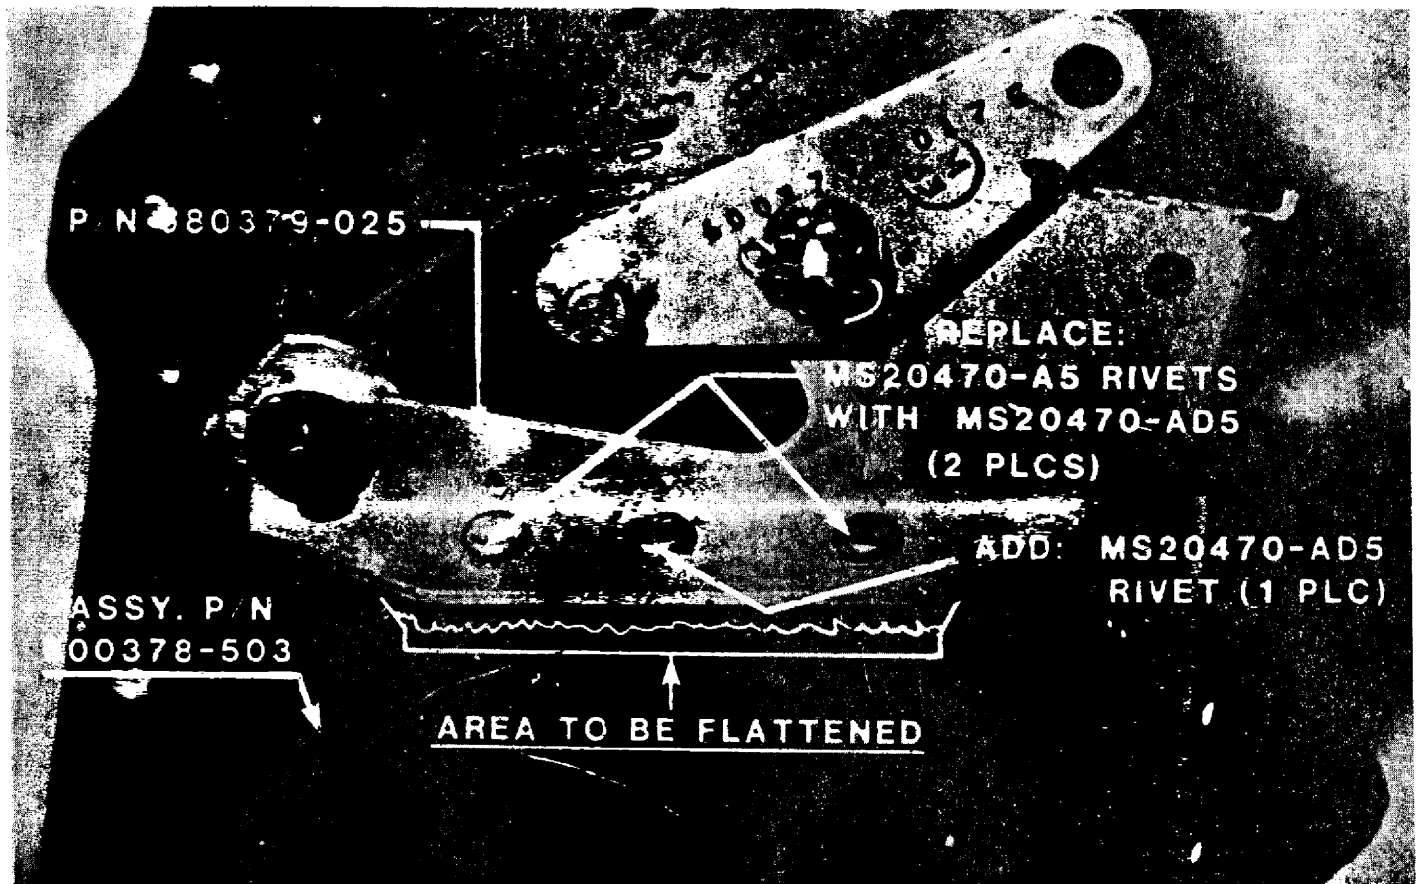
**FIGURES/TABLES:** See illustration.

**INTRODUCTION:** It has been determined that some of the subject  
duct assys may have been assembled with soft rivets.

- 4) Drill out the two bottom rivets, MS20470-A5, which attach the hinge fitting assy, P/N 600379-025, to the duct, P/N 600378-503. (Use AC 43.13-1C.64.C, Maintenance Procedures).

- 5) Use a hammer and rounded hardwood drift from the inside of the duct to flatten the area where the hinge fitting assy will lay when attached; (the duct housing now has a radius along this area). Carefully work this area adjacent to the outer extremities of the hinge fitting assy to raise it to the same height and plane as the center portion. Back up the housing as required while forming. Inspect for cracks before proceeding with modification.

- 6) When this area has been prepared to accept the hinge fitting assy without placing any of the rivets in stress, it will be ready for reassembly.
- 7) Reassemble the hinge fitting assy to the duct housing using MS20470-AD5 rivets of proper length.

- 8) Drill a third hole, #21 drill size, centered between the existing two holes to accept an additional MS20470-AD5 rivet.
- 9) Reinstall the duct assembly to the induction system and secure all fittings, filters, cables, clamps, etc.
