# Visual Inspection of Pipe Supports using the PTZx40 Camera

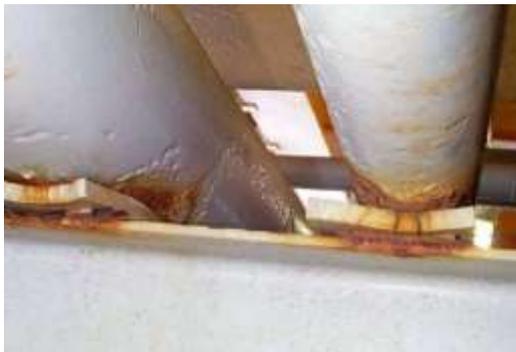
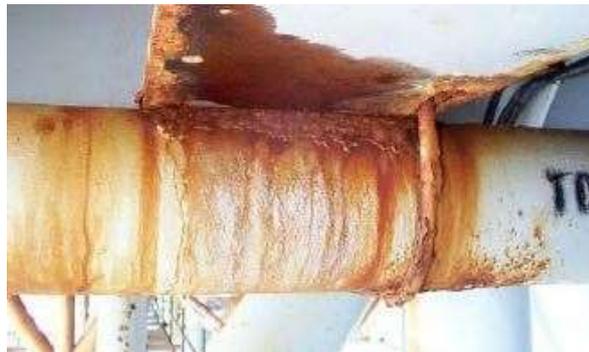
The main reason for external corrosion of piping is water/moisture trapping. Being exposed to the elements, piping is especially vulnerable at pipe supports as they tend to trap water/moisture due to its geometry. To a lesser degree, pipe supports and piping, due to metallurgical differences, at times develop bi-metallic contacts which provides small potential differences that drives and/or accelerates corrosion (Galvanic Corrosion).

The geometry of typical pipe supports makes it difficult to be completely painted over for corrosion prevention and maintenance. Even if achievable, paints tend to degrade over extended periods of exposure to water as they are designed for atmospheric exposure not immersion.

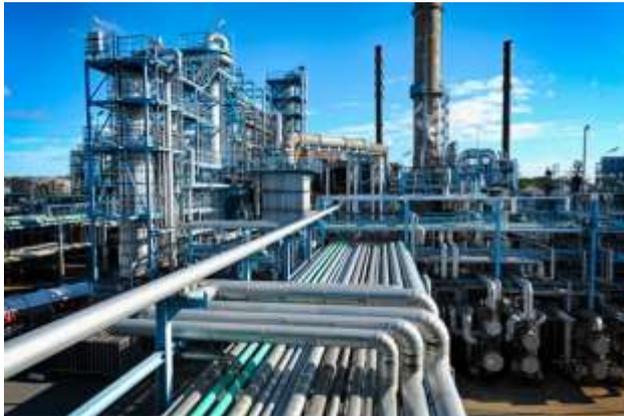
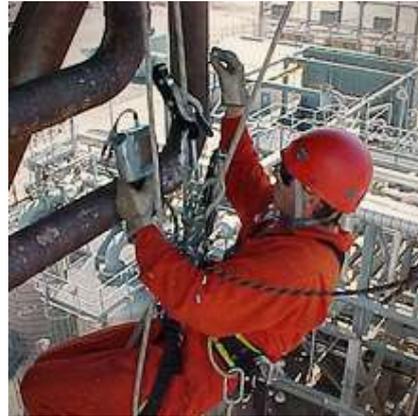
In the plant environment, piping networks are often complex and run over multiple tiers on pipe racks. These racks range from heights of 5 meters to 15 meters. Piping networks are typically dense with different pipe sizes and myriad of bends. Some piping carries heated products which are dangerous to touch. All these limits accessibility, impeding the ability to gain access to pipe supports for inspections.

The geometry of typical pipe supports also does not lend itself for easy visual inspection. Corrosion usually develops from contact surfaces where water/moisture tends to be trapped. Hence, inspection images will need to be taken from multiple angles.

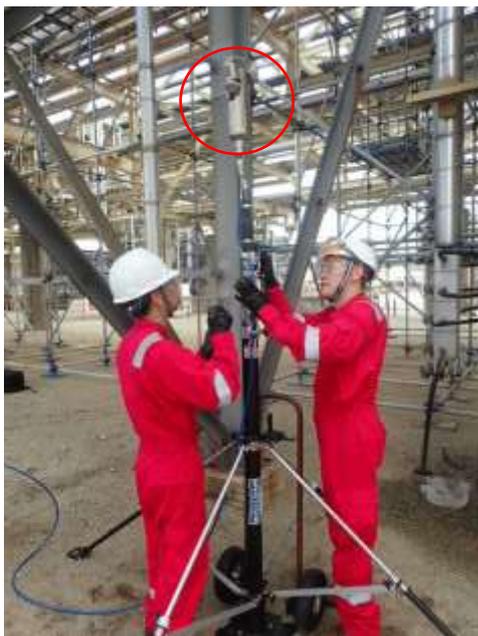
PTZx40 on Telescopic Tower (before extension)

For inspection of pipe supports, the PTZx40 is mounted on a Telescopic Pole or Tower that can be extended and raised up to 9 meters in height. The PTZx40 in this configuration allows for “stand-off” inspections of pipe supports at various heights. The pan, tilt and zoom function allows for inspection of multiple pipe supports in one single vertical deployment. The portable Telescopic Tower can be easily deployed in multiple locations. This increases the efficiency and enables the easy collection of inspection images of pipe supports from multiple angles.

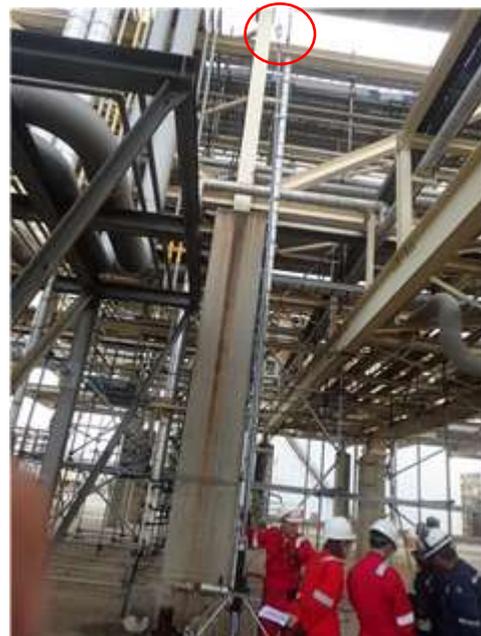
PTZx40 on Telescopic Tower (extended 9m)

Deployment of the PTZx40 on Telescopic Tower enables the inspection of pipe supports at heights of up to 9 meters. This eliminates a significant portion of pipe support inspection via rope access or scaffoldings.

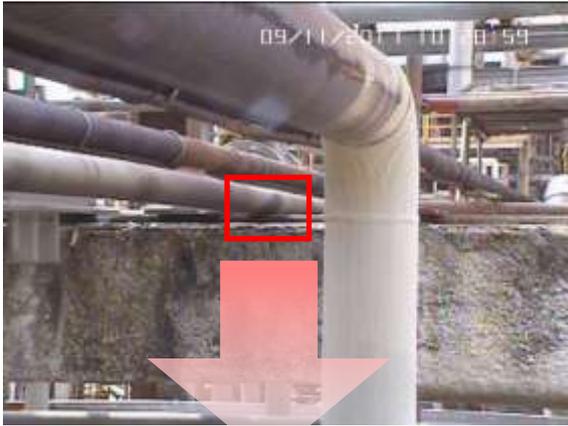
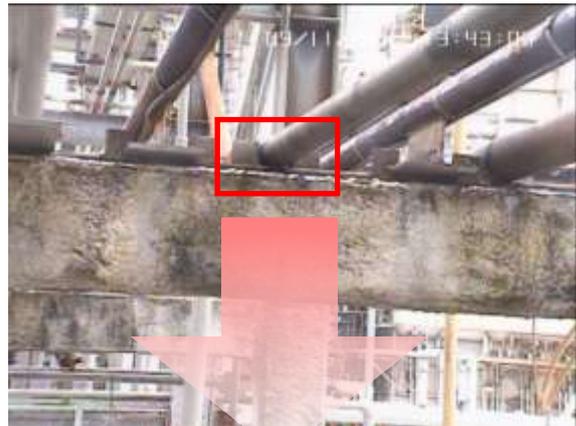
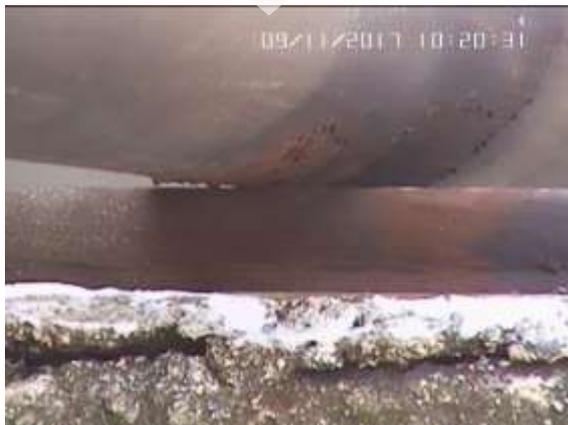
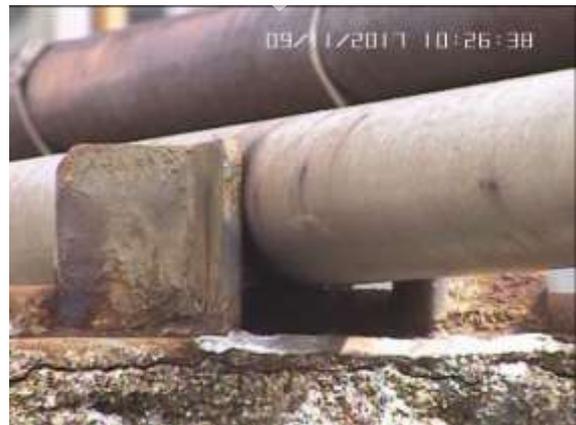
*Inspection images: Top shows overview images to give viewer an idea of where the pipe support is located. Bottom shows close-up “zoomed-in” images of the pipe support using powerful x40 zoom.*
