INDUSTRY MYTHS REGARDING CORROSION IN FIRE SPRINKLER SYSTEMS

By Jeffrey T. Kochelek

Original article published in Fire Protection Contractor Magazine

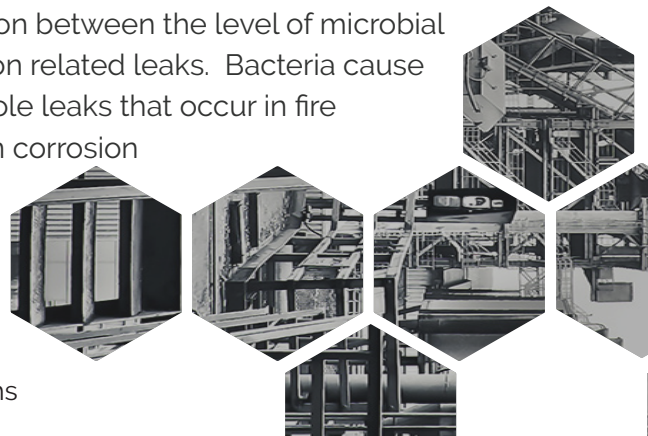
Oxygen gas is the primary cause of corrosion and pinhole leaks in **fire sprinkler systems**.

Oxygen gas is the primary cause of corrosion and pinhole leaks in fire sprinkler systems. Oxygen removes metal from the pipe walls and creates insoluble solid byproducts which can create obstructions within the piping. Bacteria are always present in fire sprinkler systems. If you look for them you will find them. There is very little correlation between the level of microbial contamination and corrosion related leaks. Bacteria cause fewer than 10% of the pinhole leaks that occur in fire sprinkler systems¹. Oxygen corrosion produces the balance of the leaks.

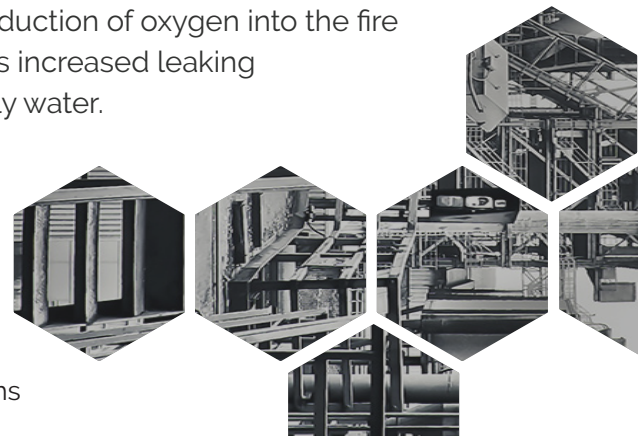
For the most part fire supply water is very fresh and very clean

Almost all fire supply water comes from municipal water purveyors. For the most part fire supply water is very fresh and very clean. Water chemistry does vary throughout the country but in general it is the introduction of oxygen into the fire sprinkler piping that causes increased leaking not the quality of the supply water.

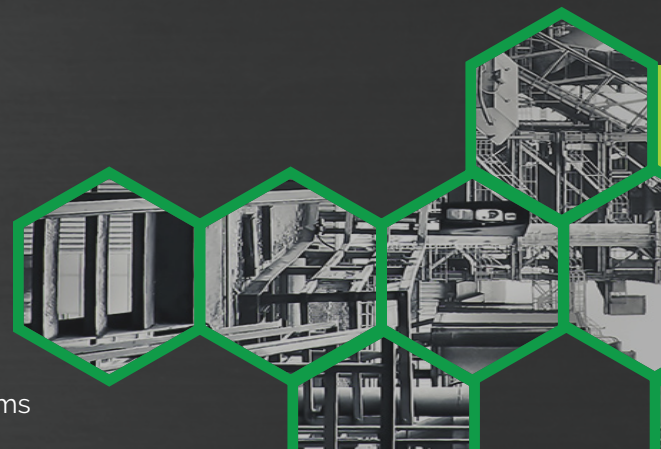
Corrosion at weld seams **is not** the result of materially **defective piping**.

Failed fire sprinkler piping that shows evidence of material defect from the manufacturer is very rare. The quality of fittings and tubular goods being used today in fire sprinkler systems generally meets or exceeds the ASTM standards. Corrosion at weld seams that is often recognized as the cause of leaks is not the result of materially defective piping. It is the lack of heat annealing the piping and the subsequent exposure to oxygenated water that causes accelerated attack at the weld seams. Leaks that occur at weld seams in fire sprinkler piping can be completely controlled by keeping the oxygen out of the fire sprinkler system.
