White Paper

Managing Fire Sprinkler System Risk in a Mission Critical
Data Center Setting
(October 2012)

By Jeffrey T. Kochelek

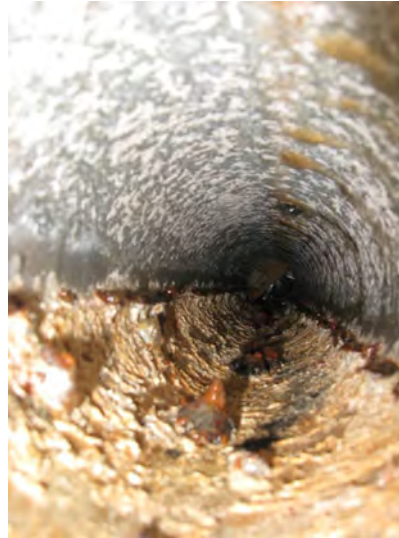
Evidence of trapped water in piping

The National Fire Protection Association (NFPA) requires that all dry and preaction fire sprinkler systems be hydrostatically tested before they are commissioned for service. The result of this necessary exercise is that there are always small pools of trapped water in the fire sprinkler piping. It is virtually impossible to drain out all of the water after the test. Additional amounts of water are added to the piping during periodic system testing (also required by the NFPA). A third source adds moist air each time the pressure maintenance compressor clicks on to keep the piping pressurized. The moisture in the air eventually condenses to produce condensate water within the piping. Until the 2007 edition of the installation standard for fire sprinkler systems, NFPA 13 did not require preaction fire sprinkler systems be “pitched” to allow draining of trapped water from the piping. This means that most preaction systems installed before enforcement of the 2007 edition of NFPA 13 are not pitched and invariably contain significant amounts of trapped water.

Corrosion cannot occur without liquid water. In the case of preaction fire sprinkler pipes, all of the necessary elements are present: the steel piping, water and plenty of oxygen. Corrosion is inevitable in these systems and depending on the number of trapped pools of water, the amount of water and the amount of oxygen the corrosion rates can be quite high.

One other ironic twist in the corrosion equation is that any pin holes that develop are always in intimate contact with the pool of water that formed them. Further, they are almost always located at the 6 o'clock position in the fire sprinkler piping. The net result is that the corrosion hole almost always delivers a significant quantity of water into the protected space when the leak finally breaks open. The pressurized air pushes rusty water through the pin hole as a fine mist propelled by the pressurized air in the system onto the electrical circuitry of the servers below.

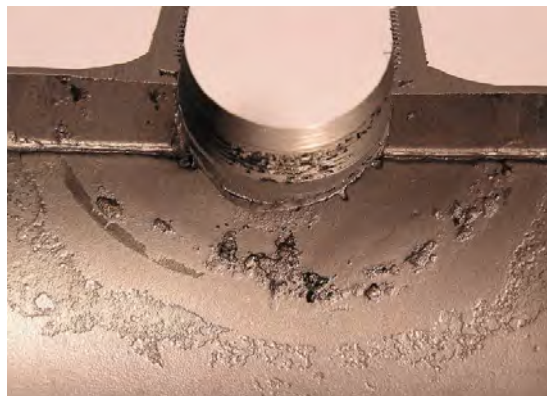
Anodic hot spot due to weld-o-let installation

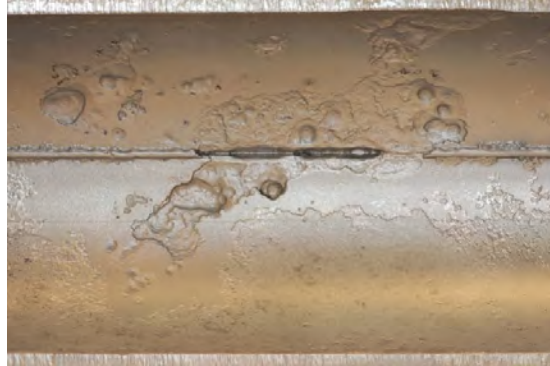
**Knife cut corrosion on submerged weld seam
(galvanized steel pipe)**

Another factor contributing to corrosion related leaks is the lack of heat annealing of the weld seam on fire sprinkler piping. The current ASTM Standards for the fire sprinkler industry do not require that the weld seams be heat annealed, the result is that the piping is subject to “knife cut” corrosion wherein the weld metal and the heat affected zone adjacent to the weld

corrode preferentially to the rest of the pipe. If the weld seam happens to end up installed under trapped water, failures in schedule 10 galvanized steel piping have occurred in as little as 12 months.
