CASE STUDY / ISABELLA COMBINED RELIEF SEWER

FLOOD MITIGATION STRATEGY CREATES PEACE OF MIND

STUDY, DESIGN AND CONSTRUCTION SERVICES EXCEED EXPECTATIONS

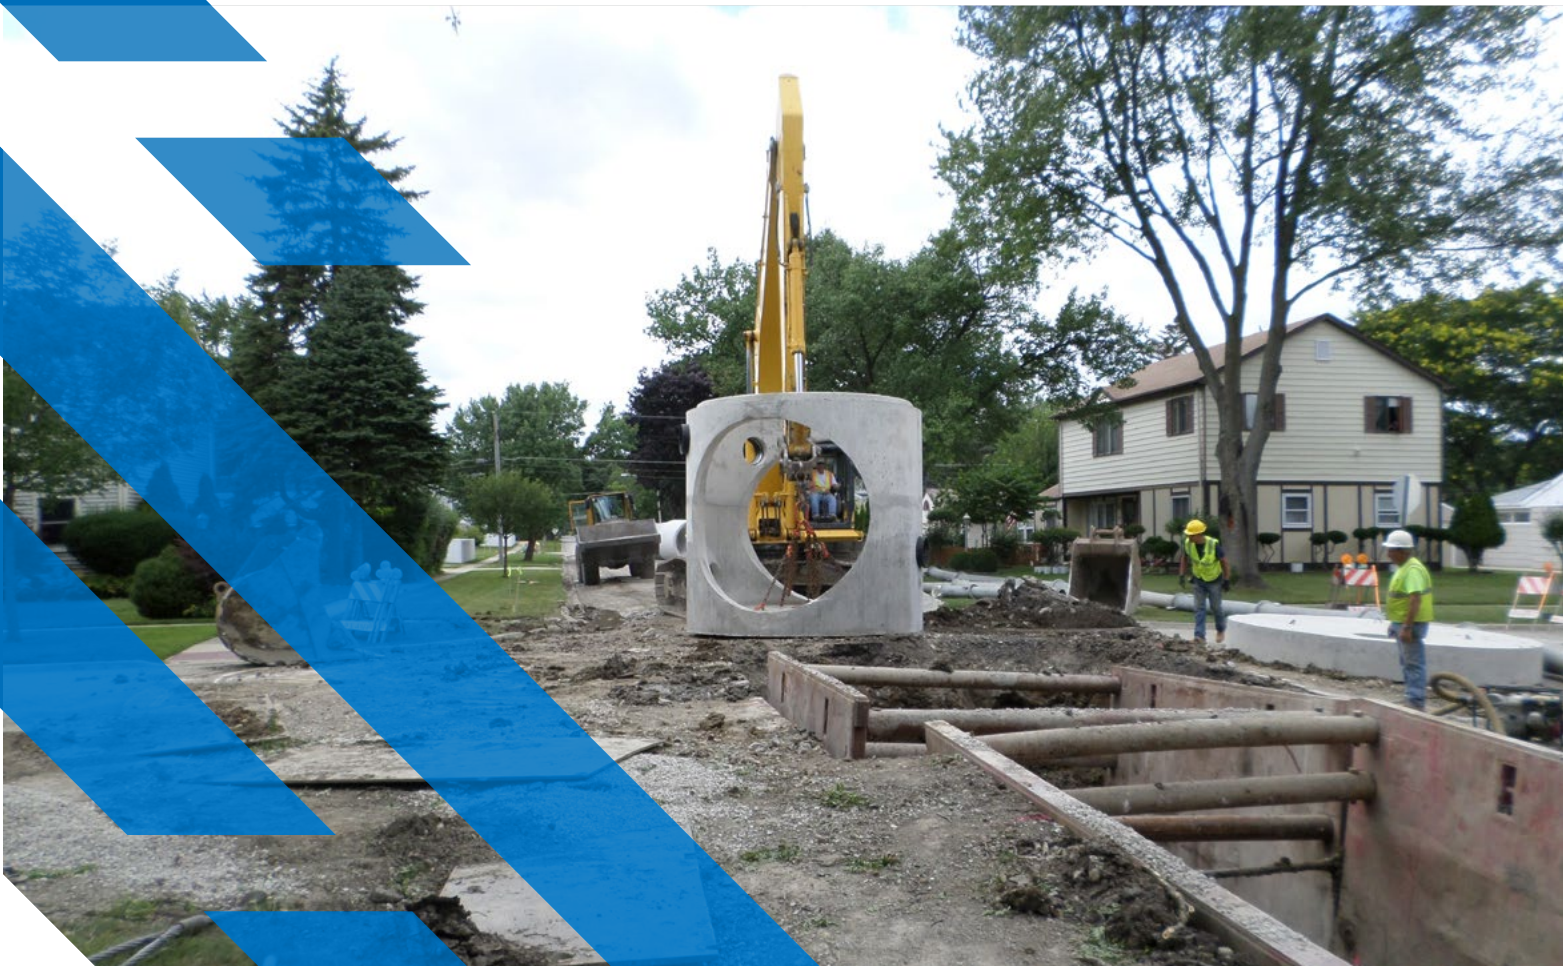
ON COVER: *Installation of 10-foot diameter manhole along Isabella Street.*

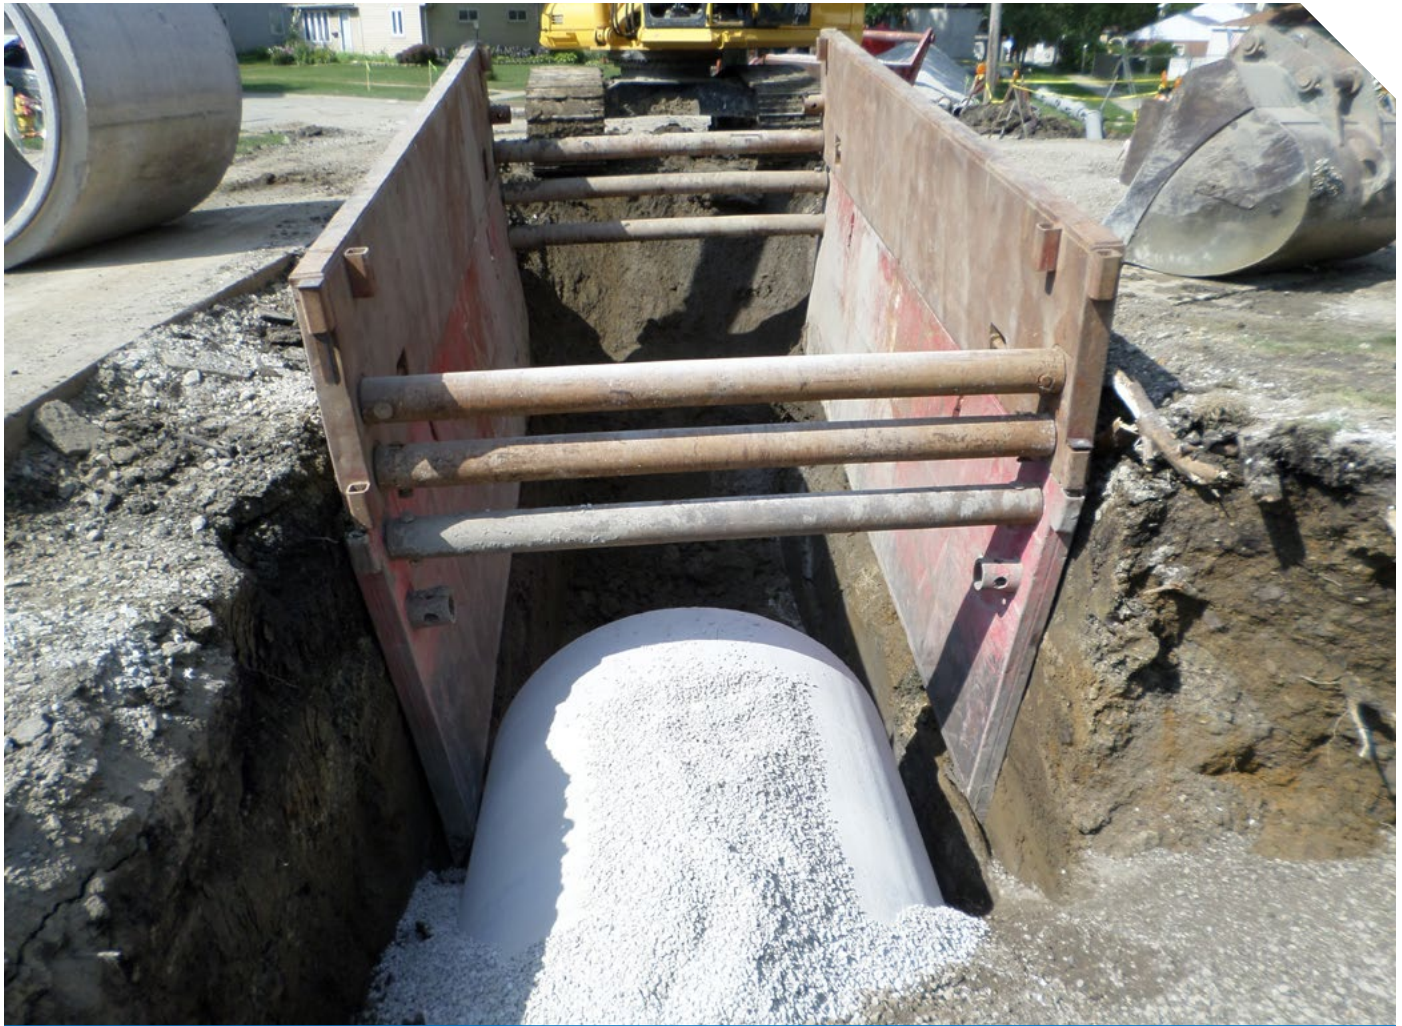
Installation of 84-inch combined sewer along Isabella Street.

The Isabella combined relief sewer improvements project required over 17,000 linear feet of sewer ranging from 12 to 84 inches in diameter. In addition, approximately 15,000 linear feet of asphalt roadway, curb and gutter, driveway aprons and sidewalk needed to be removed and replaced. Due to the size and depth of the new sewer, there were numerous locations where the existing water main had to be relocated.
