Repair of Glass Lined Tank

Induction Heating Application Notes

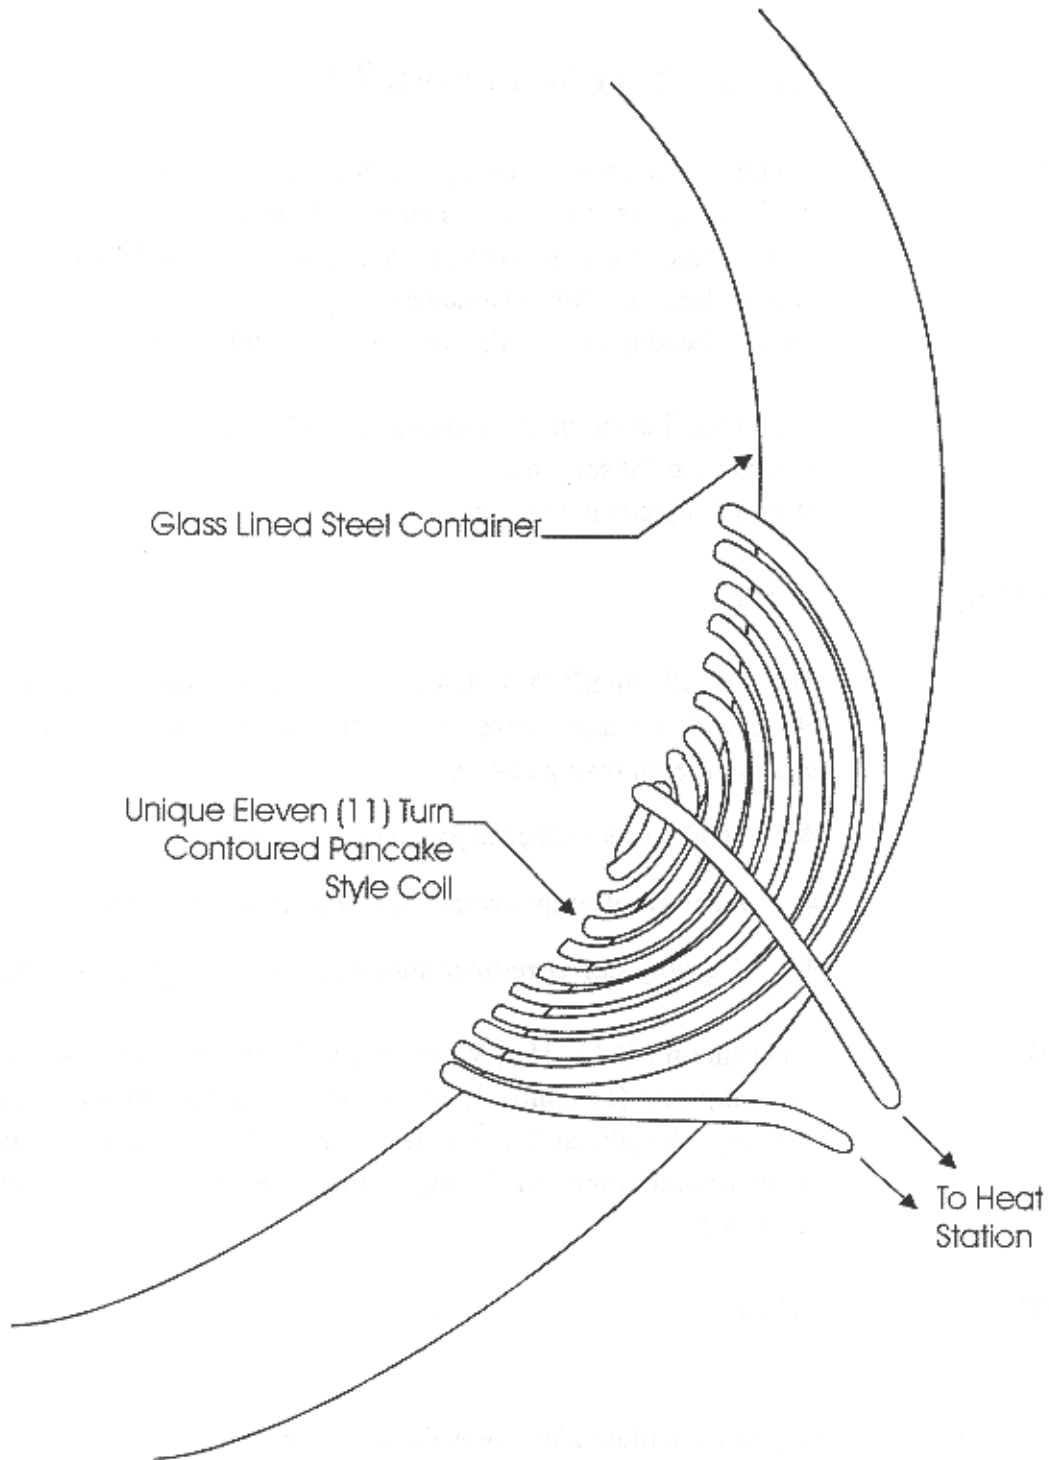
*Application Illustration Located on Reverse

- Application:** The Ameritherm SP 15, 15kW output solid state induction power supply along with a unique eleven (11) turn pancake style coil were utilized to achieve the following results:

- Equipment:** Ameritherm SP 15, 15kW output solid state induction power supply including one (1) remote heat station containing eight (8) capacitors totaling 0.66 μ F, and a unique eleven (11) turn pancake style coil manufactured from 3/16" copper tubing formed to the curve of the tanks wall.
