# Deep Bed™ Thickener in High Rainfall Area

## Design Incorporates Benefits of Surface Stacking for Effective Water Management

CASE STUDY

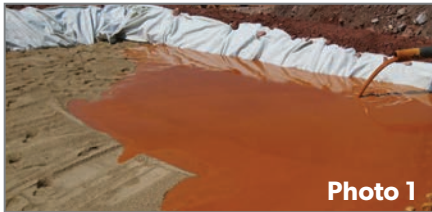
Photo 1

the installation of the paste thickener to quantify the benefits and refine the site management plan. A 10 m by 10 m test site was prepared next to the TSF and was filled to about 500 mm deep with P&TT. Due to the very fine PSD, this non-Newtonian underflow has the design yield stress at about 28-29 weight percent (wt%) solids (see Photo 1).

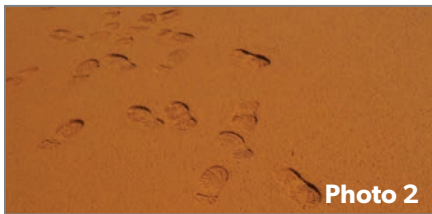
Photo 2

The rapid consolidation and drying allowed foot traffic by the fourth day, despite 15 mm of rain that day (photo 2). Drying continues quickly with large cracks developing by day seven (see photo 3). Day 10 shows the deposit after two rain events, dried to significant cracking. At this point about half of the water has evaporated (see photo 4).

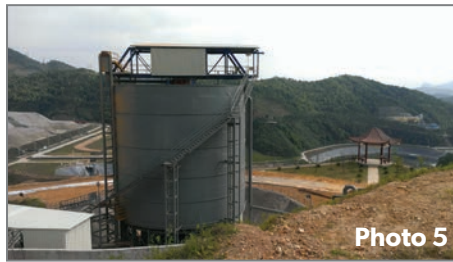
Photo 5

The installed 15 m diameter WesTech [Deep Bed™ Paste Thickener](#) on a hill near

the TSF (Photo 5) effectively dewateres to a non-Newtonian density, P&TT, and recovers clear water for recycling. The low-yield stress P&TT is pumped a short distance to the TSF by centrifugal pumps.

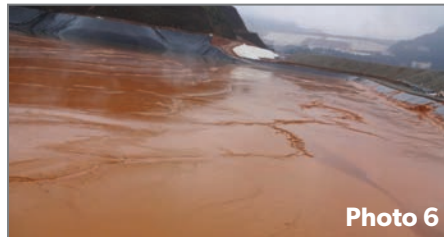
The initial spigots were placed along one side of the TSF, forcing the pond water from the previous pond slurry to collect near the dam where this water was recovered. The TSF had relatively no standing water after about three months of operation. Photo 6 shows the TSF during the first monsoon season.

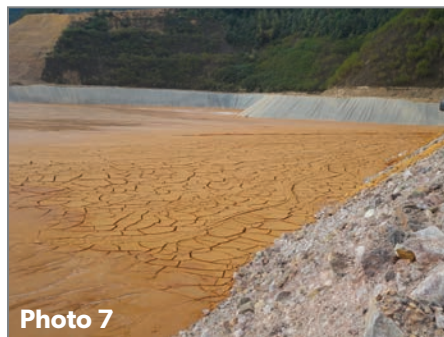
Photo 7

Once the water was collected, the spigot placement was shifted to other locations around the TSF, eventually settling on the arrangement of spigots located along the dam. Rotating active spigot locations allows drying between layers for stability (see photo 7). The gentle 1-3 percent deposition slope drains rain from the surface at mild velocities to minimize erosion of the solids and keep the solids exposed for continued air drying. The site management plan did not recover rain runoff collected in the TSF footprint but left it in the TSF to absorb and ultimately evaporate.

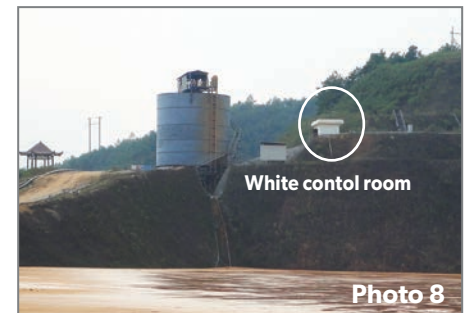
Photo 8

Over five years of operation, the dam elevation increased over 20 meters. Comparing photos 8 and 9, the white control room building can be used as an elevation reference. At this point, the TSF filled to capacity, encroaching on roadways and other facilities.

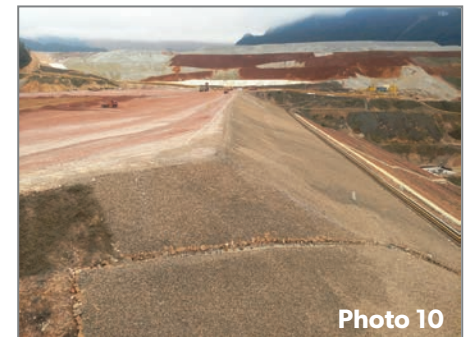
Photo 10

Rapid drying of the Deep Bed thickener underflow throughout the years allowed the plant to have quick access to the TSF once it was filled. The capping process quickly followed closure of the site (see photo 10).
