Abrasive Dust Causes Rough Issues

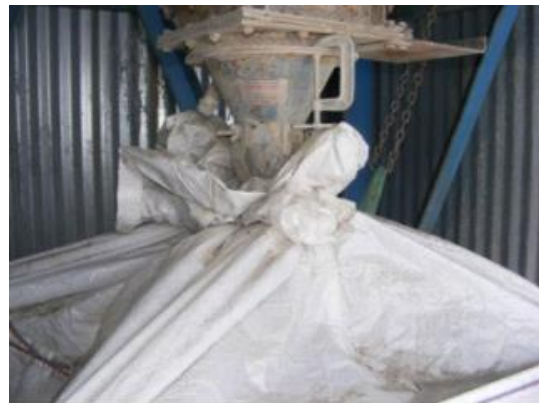
The Vacu-Valve is an easy replacement for a rotary valve in many applications. The lack of moving and internal metal parts reduces the long-term damage caused by abrasives compared to rotary valves. In addition, replacing the duckbill sleeves takes no more than 5 minutes. Different sizes of the Vacu-Valves create greater flexibility in terms of capacity, fitting different input and output requirements.
