Flight 93 Structural Fire

Serious Accident Investigation
Factual Report
October 3, 2014

SERIOUS ACCIDENT INVESTIGATION FACTUAL REPORT

Accident Name: Headquarters Structural Fire
Description: Structural Fire
Location: Flight 93 National Memorial
Date: October 3, 2014

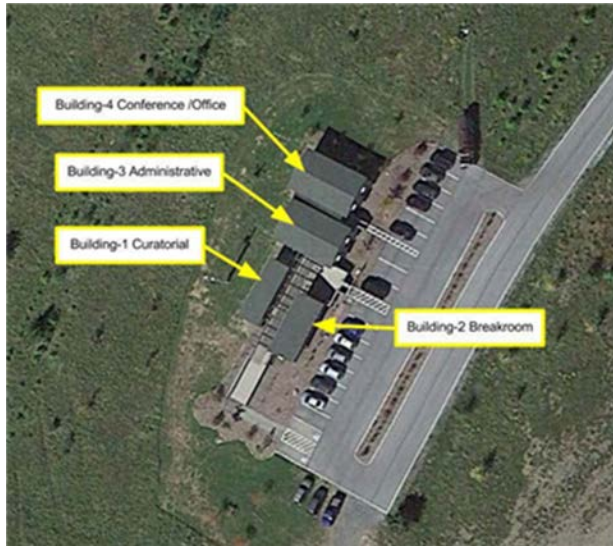
Figure 2 Administrative and curatorial offices

The curatorial building was used as an office, processing space and museum storage to store accessioned and unaccessioned collections. The buildings were connected by an exterior deck platform constructed of a lumber substructure and a plasticized decking material provided by the National Park Foundation through a grant. The deck could be accessed by a handicap ramp and exterior stairs also constructed with a lumber substructure and the same plasticized decking material. Entrance into the buildings and egress from them required occupants to access the deck. *Otherwise stated egress to the public way¹ could only be gained by accessing the deck first.*

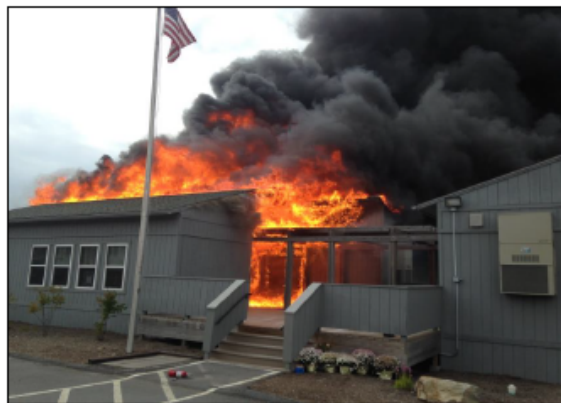
Issue: On the afternoon of Friday, October 3, 2014, a fire occurred at Flight 93 National Memorial (FLNI) park headquarters. Three of the four mobile buildings used as the headquarters complex were completely destroyed. The remaining building, utilized as office space, was severely damaged. Plasticized lumber decking connecting the buildings was a major contributing factor to the speed and intensity of the fire. Because plastic decking was used to construct the walkways and stairs between the buildings, the emergency exits were also affected.

The plasticized lumber decking used at FLNI was primarily composed of high-density polyethylene (HDPE) plastic. This type of material is sold under several trade names and is available from a variety of manufacturers. HDPE-based building materials have a relatively low melting point, typically close to 250F degrees. Once ignited, the solid plastic quickly liquefies allowing it to spread rapidly. Unlike traditional building materials, the melted plastic behaves like a flammable liquid, burning rapidly and generating heavy smoke.

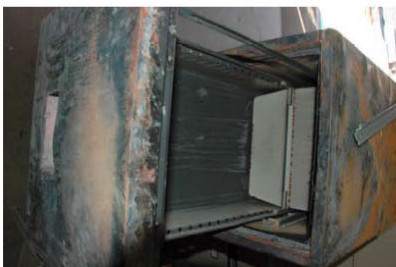
DSC_0535, 20141007, Don Boucher, 40° 3'18" N 78°54'25" W, , Recovered Fire resistant file cabinet

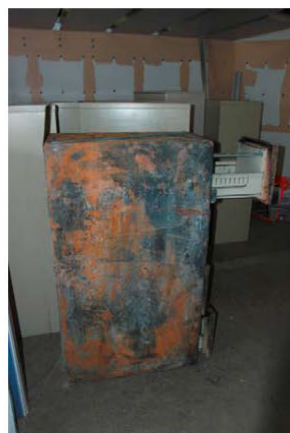
DSC_0536, 20141007, Don Boucher, 40° 3'18" N 78°54'25" W, , Recovered Fire resistant file cabinet

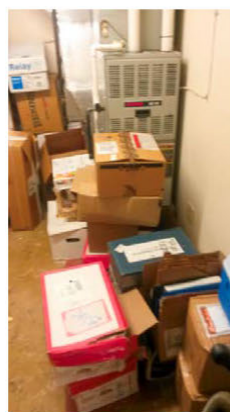
20141008_095848, 20141008, Don Boucher, 40°0'29" N 79°4'45" W, , Museum storage in former Somerset headquarters

Finding 8: Fire and security concerns at the Somerset facility, which were noted in the Collection Management Plan (CMP), had not been addressed.

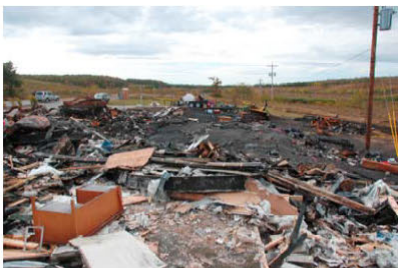
DSC_0002, 20141009, Don Boucher, 40° 4'2" N 78°53'15" W, South, Looking South from decking connected to remaining structure

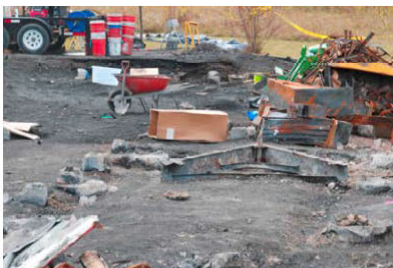
DSC_0003, 20141009, Don Boucher, 40° 4'2" N 78°53'15" W, South, Looking South from decking connected to remaining structure

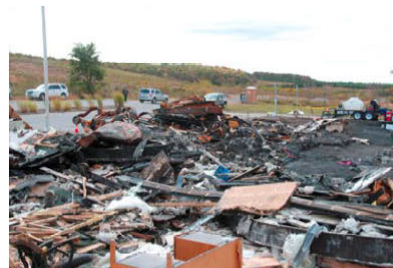
DSC_0004, 20141009, Don Boucher, 40° 4'2" N 78°53'15" W, South, Looking South from decking connected to remaining structure

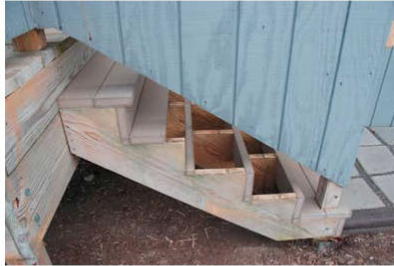
DSC_0006, 20141009, Don Boucher, 40° 4'2" N 78°53'15" W, , Rear Steps of remaining structure. Boards removed for fire testing.

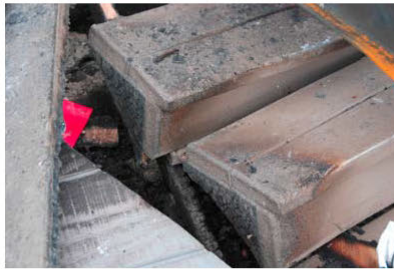
DSC_0008, 20141009, Don Boucher, 40° 4'2" N 78°53'15" W, West, Chared decking material

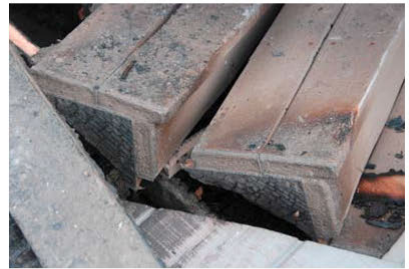
DSC_0009, 20141009, Don Boucher, 40° 4'2" N 78°53'15" W, West, Chared decking material

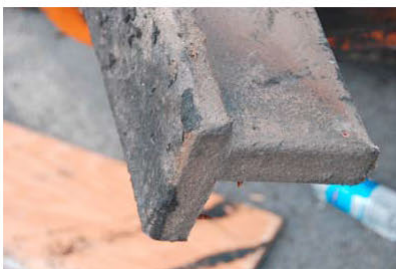
DSC_0010, 20141009, Don Boucher, 40° 4'2" N 78°53'15" W, West, Chared decking material

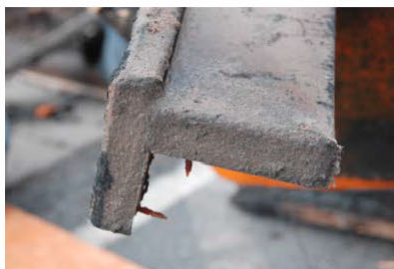
DSC_0011, 20141009, Don Boucher, 40° 4'2" N 78°53'15" W, West, Chared decking material

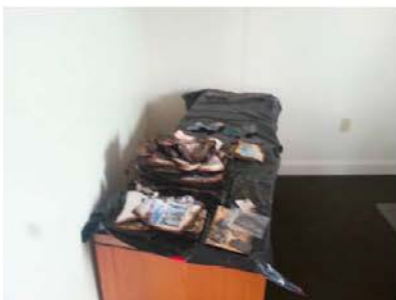
20141009_132227, 20141009, S.Stephens, 40°4'2" N 78°53'15" W, , Recovered museum object

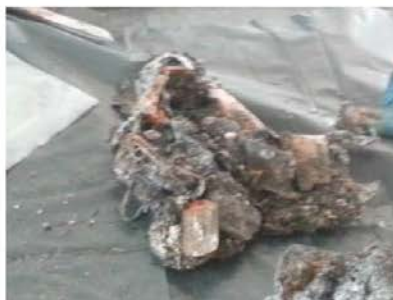
20141009_132231, 20141009, S.Stephens, 40°4'2" N 78°53'15" W, , Recovered museum object

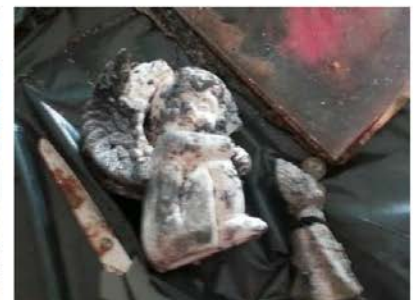
20141009_132247, 20141009, S.Stephens, 40°4'2" N 78°53'15" W, , Recovered museum object

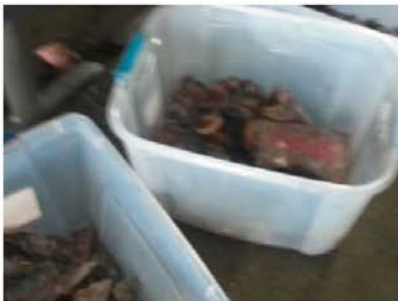
20141009_132257, 20141009, S.Stephens, 40°4'2" N 78°53'15" W, , Recovered museum object

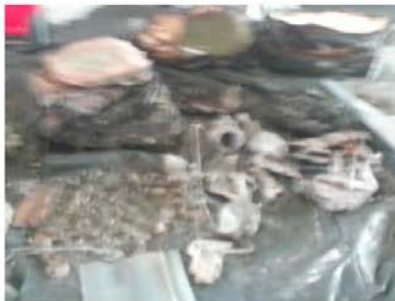
20141009_132302, 20141009,
S.Stephens, 40°4'2" N 78°53'15" W, ,
Recovered museum object

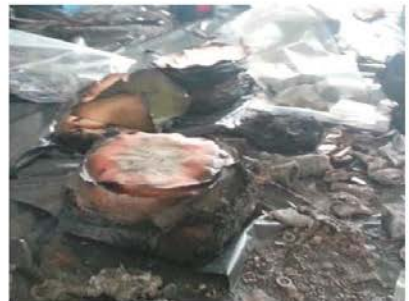
20141009_132307, 20141009,
S.Stephens, 40°4'2" N 78°53'15" W, ,
Recovered museum object

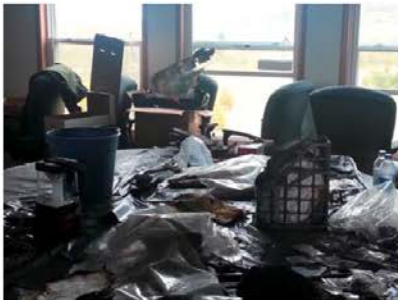
20141009_132408, 20141009,
S.Stephens, 40°4'2" N 78°53'15" W, ,
Recovered museum object

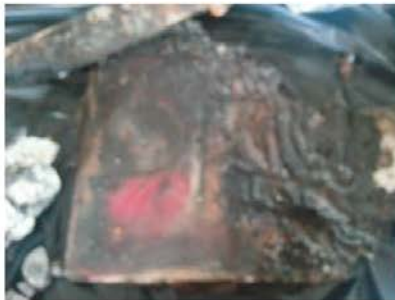
20141009_132414, 20141009,
S.Stephens, 40°4'2" N 78°53'15" W, ,
Recovered museum object

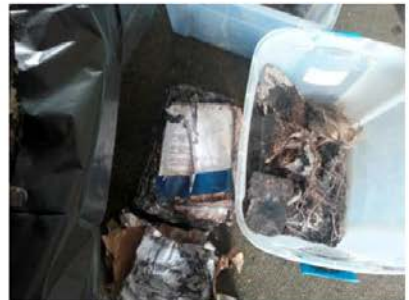
20141009_132423, 20141009,
S.Stephens, 40°4'2" N 78°53'15" W, ,
Recovered museum object

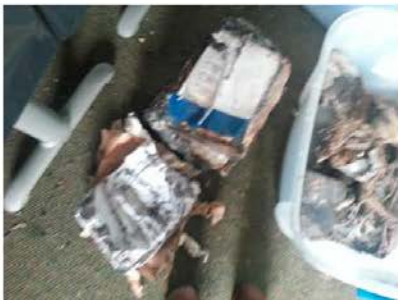
20141009_132437, 20141009,
S.Stephens, 40°4'2" N 78°53'15" W, ,
Recovered museum object

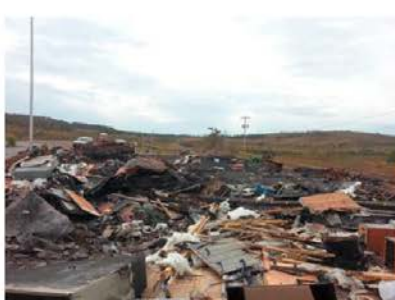
20141009_132445, 20141009,
S.Stephens, 40°4'2" N 78°53'15" W, ,
Recovered museum object

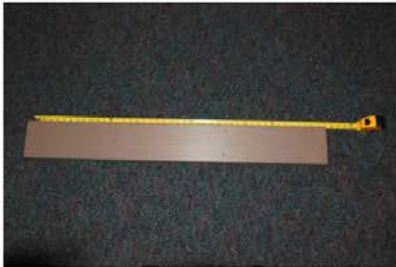
DSC_0058, 20141020, Don Boucher, 38° 52'35" N 77°2'1" W, , Boards removed for fire testing

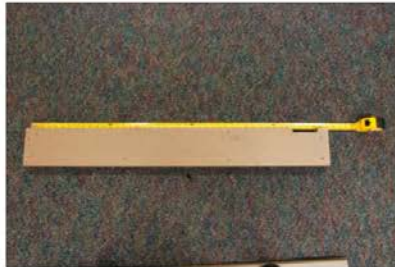
DSC_0059, 20141020, Don Boucher, 38° 52'35" N 77°2'1" W, , Boards removed for fire testing

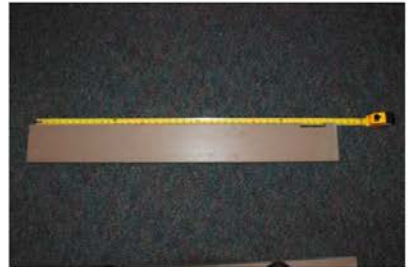
DSC_0060, 20141020, Don Boucher, 38° 52'35" N 77°2'1" W, , Boards removed for fire testing

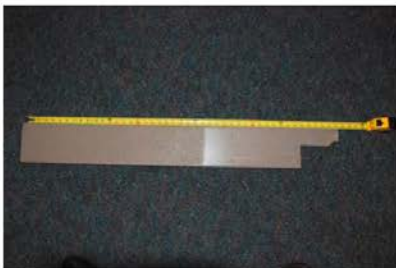
DSC_0061, 20141020, Don Boucher, 38° 52'35" N 77°2'1" W, , Boards removed for fire testing

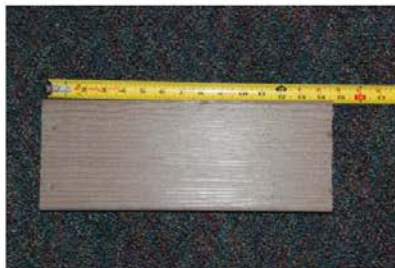
DSC_0062, 20141020, Don Boucher, 38° 52'35" N 77°2'1" W, , Boards removed for fire testing

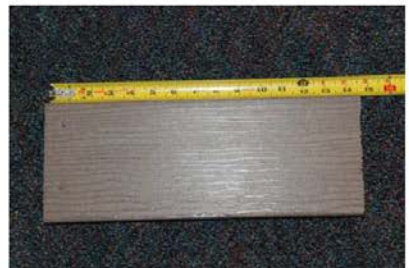
DSC_0063, 20141020, Don Boucher, 38° 52'35" N 77°2'1" W, , Boards removed for fire testing

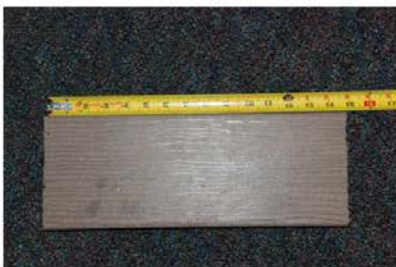
DSC_0064, 20141020, Don Boucher, 38° 52'35" N 77°2'1" W, , Boards removed for fire testing

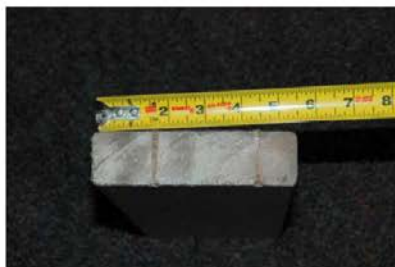
DSC_0065, 20141020, Don Boucher, 38° 52'35" N 77°2'1" W, , Boards removed for fire testing

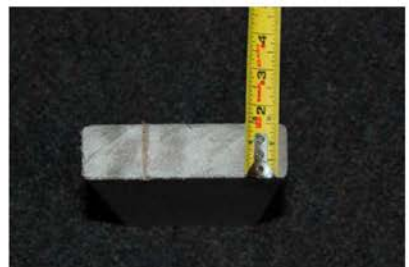
DSC_0066, 20141020, Don Boucher, 38° 52'35" N 77°2'1" W, , Boards removed for fire testing

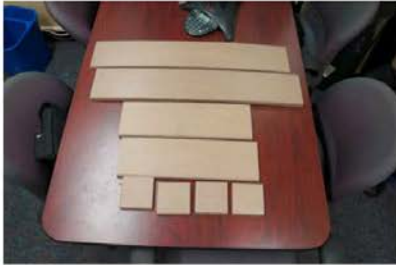
DSC_0067, 20141020, Don Boucher, 38° 52'35" N 77°2'1" W, , Boards removed for fire testing

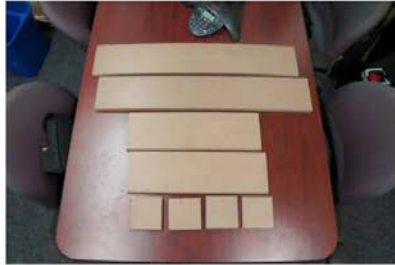
DSC00504, 20141208, Don Boucher, 38° 52'35" N 77°2'1" W, , Cut board samples for fire testing

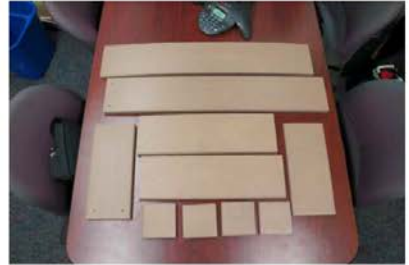
DSC00505, 20141208, Don Boucher, 38° 52'35" N 77°2'1" W, , Cut board samples for fire testing

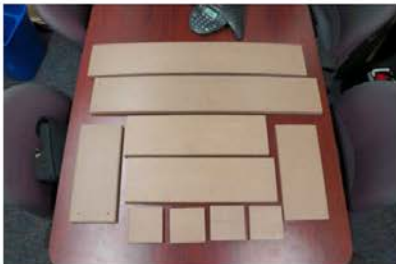
DSC00506, 20141208, Don Boucher, 38° 52'35" N 77°2'1" W, , Cut board samples for fire testing
